ANNUAL REPORT FOR 2020

B-4138WM UT to Cape Fear River
Harnett County
TIP No. B-4138WM
USACE Action ID: SAW-2003-00357
DWR Project #: 20091321

Prepared By:
Environmental Analysis Unit & Roadside Environmental Unit
North Carolina Department of Transportation
November 2020

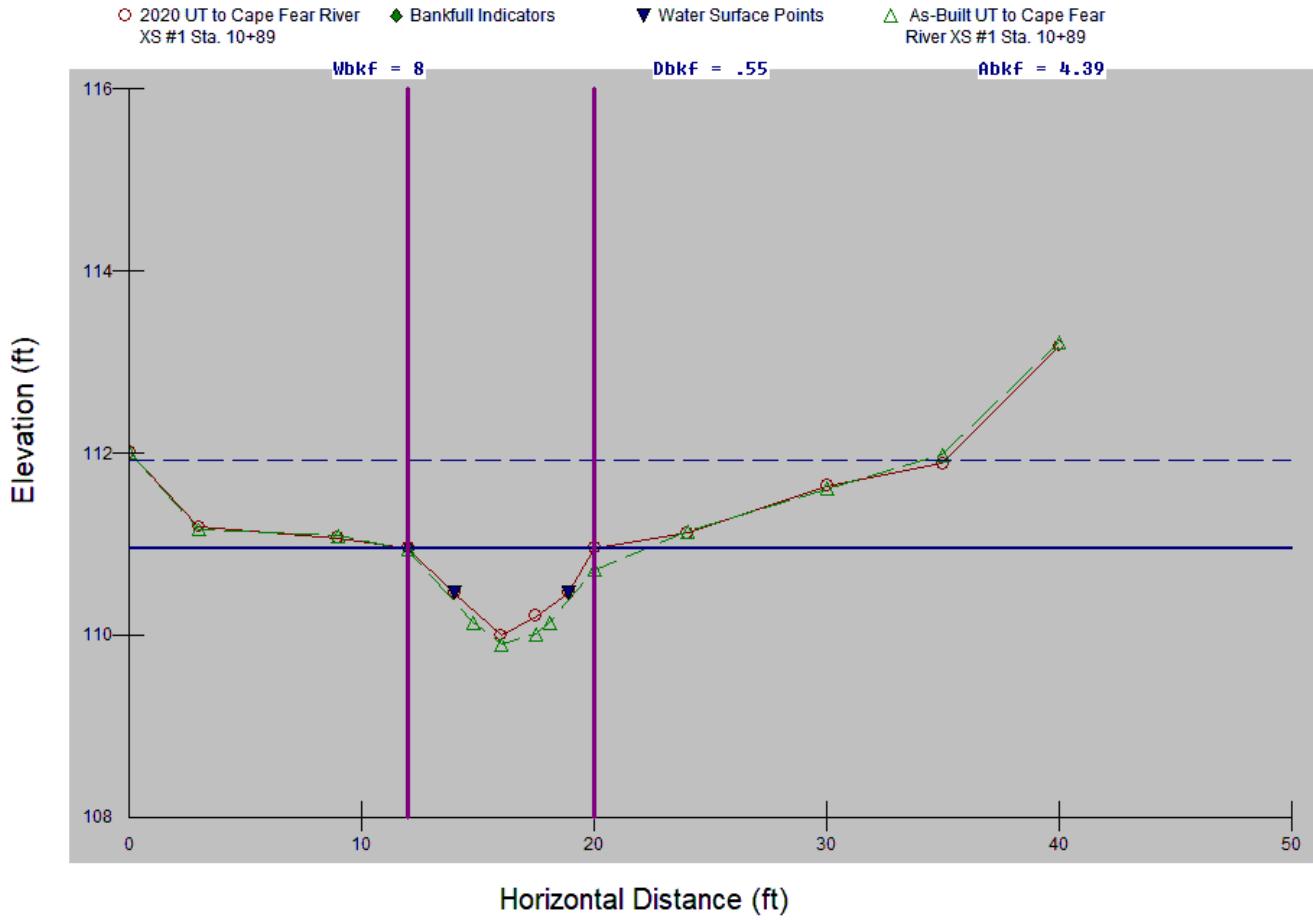
2020 UT to Cape Fear River XS #1 Sta. 10+80

Cross-Section #1 (Riffle) Abbreviated Morphological Summary						
	As-built	2020	2021	2022	2023	2024
Bankfull Width (ft)	10.00	8.00				
Bankfull Mean Depth (ft)	0.54	0.55				
Width/Depth Ratio	18.52	14.55				
Bankfull Cross Sectional Area (ft ²)	5.42	4.39				
Maximum Bankfull Depth (ft)	1.04	0.96				
Width of the Floodprone Area (ft)	34.89	34.79				
Entrenchment Ratio	3.49	4.35

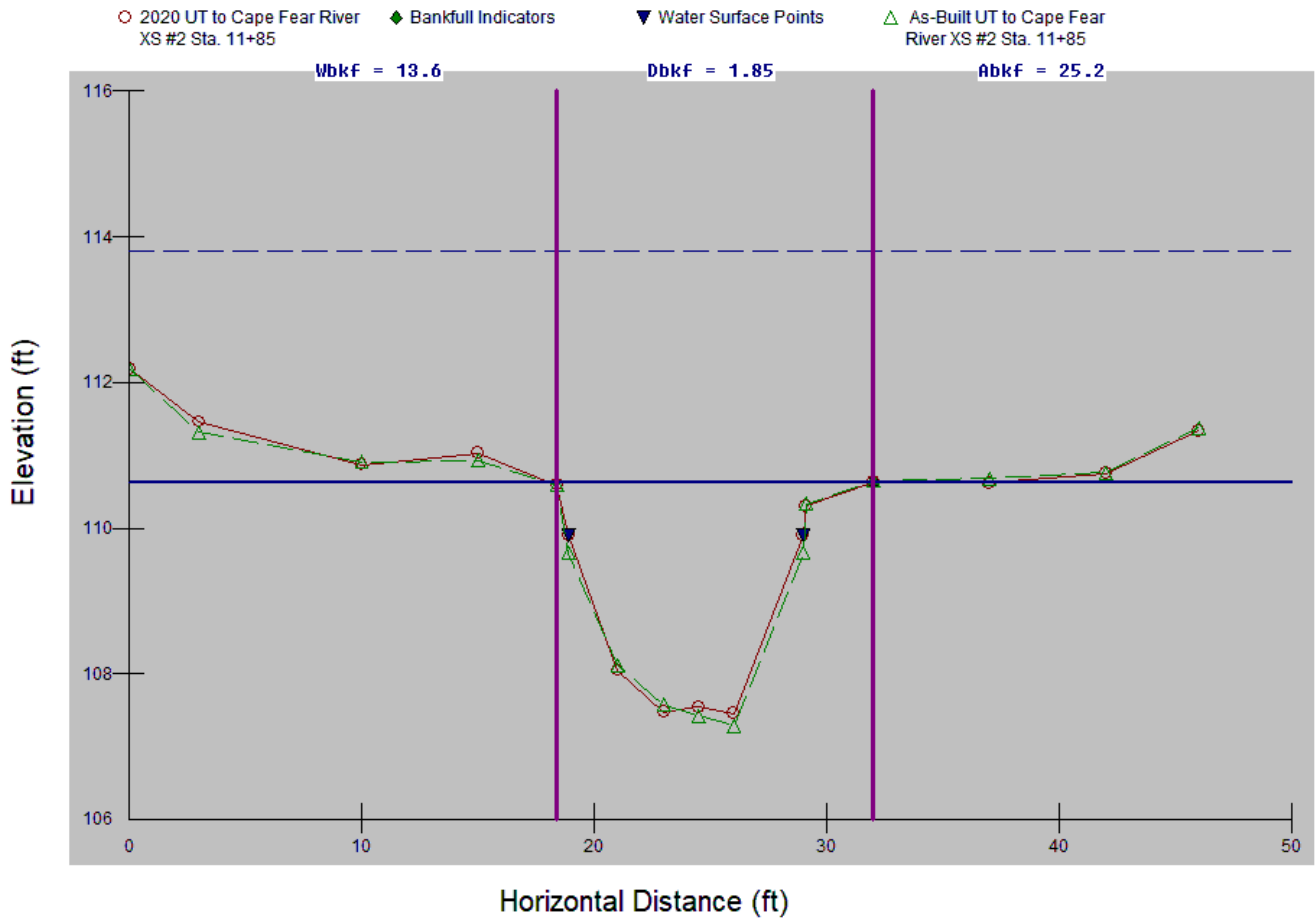
UT to Cape Fear River XS #2 Sta. 11+85

Cross-Section #2 (Pool) Abbreviated Morphological Summary						
	As-built	2020	2021	2022	2023	2024
Bankfull Width (ft)	14.2	13.6				
Bankfull Mean Depth (ft)	1.86	1.85				
Bankfull Cross Sectional Area (ft ²)	26.363	25.21				
Maximum Bankfull Depth (ft)	3.37	3.18

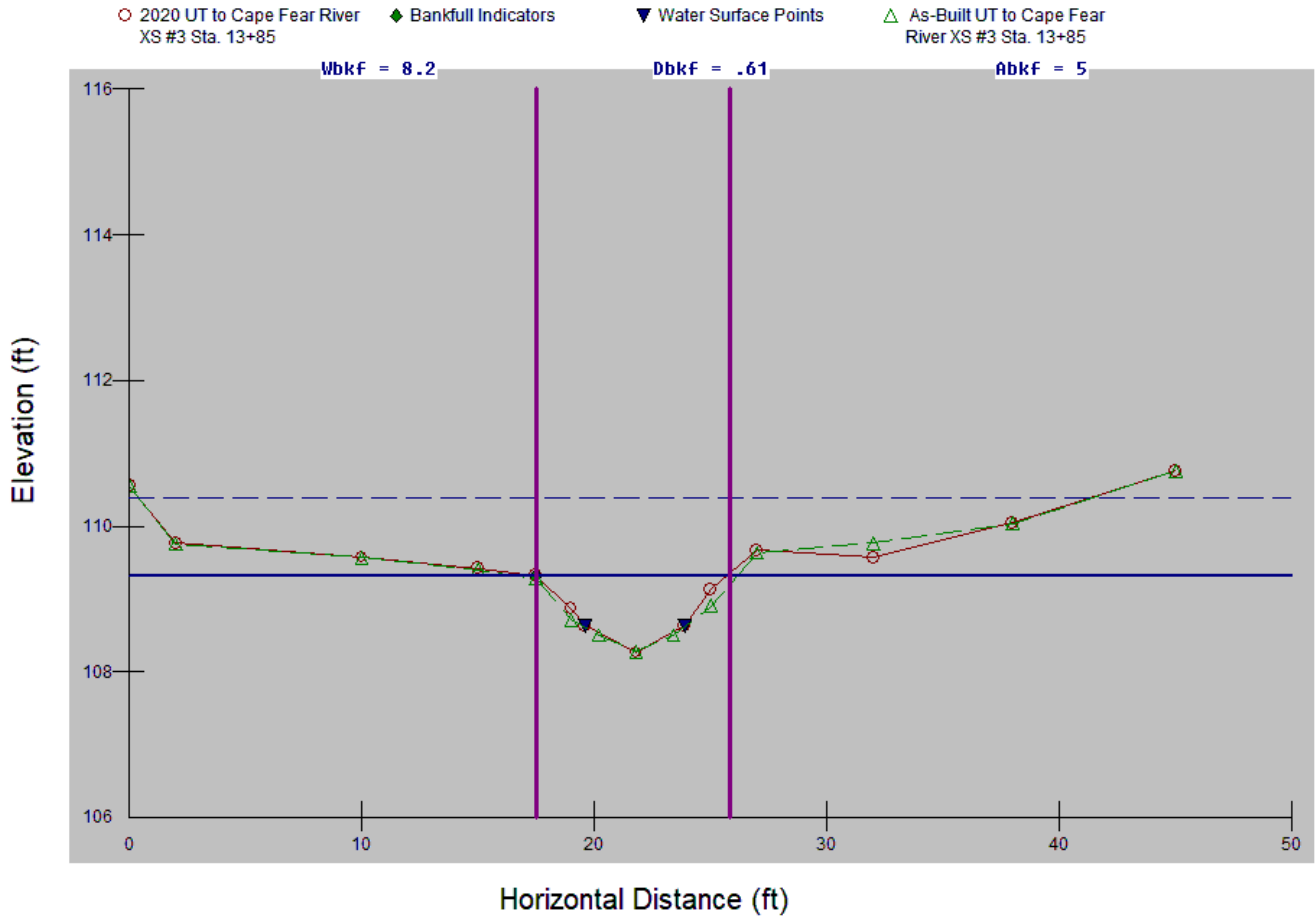
2020 UT to Cape Fear River XS #3 Sta. 13+85

Cross-Section #3 (Riffle) Abbreviated Morphological Summary						
	As-built	2020	2021	2022	2023	2024
Bankfull Width (ft)	8.5	8.2				
Bankfull Mean Depth (ft)	0.61	0.61				
Width/Depth Ratio	13.93	13.44				
Bankfull Cross Sectional Area (ft²)	5.23	5.00				
Maximum Bankfull Depth (ft)	1.01	1.06				
Width of the Floodprone Area (ft)	39.84	40.88				
Entrenchment Ratio	4.69	4.98

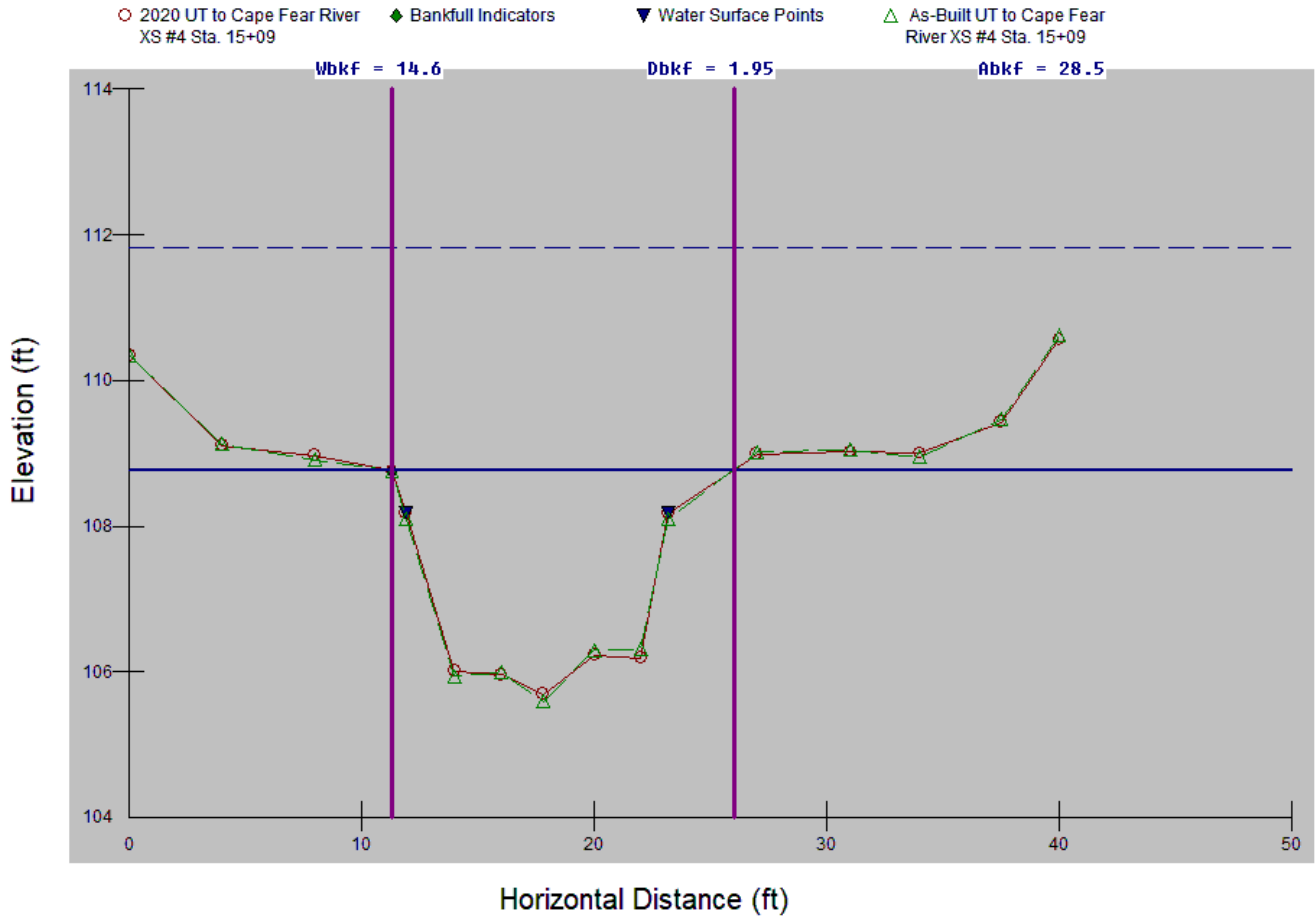
2020 UT to Cape Fear River XS #4 Sta. 15+09

Cross-Section #4 (Pool) Abbreviated Morphological Summary						
	As-built	2020	2021	2022	2023	2024
Bankfull Width (ft)	14.67	14.63				
Bankfull Mean Depth (ft)	1.96	1.95				
Bankfull Cross Sectional Area (ft ²)	28.74	28.48				
Maximum Bankfull Depth (ft)	3.17	3.07

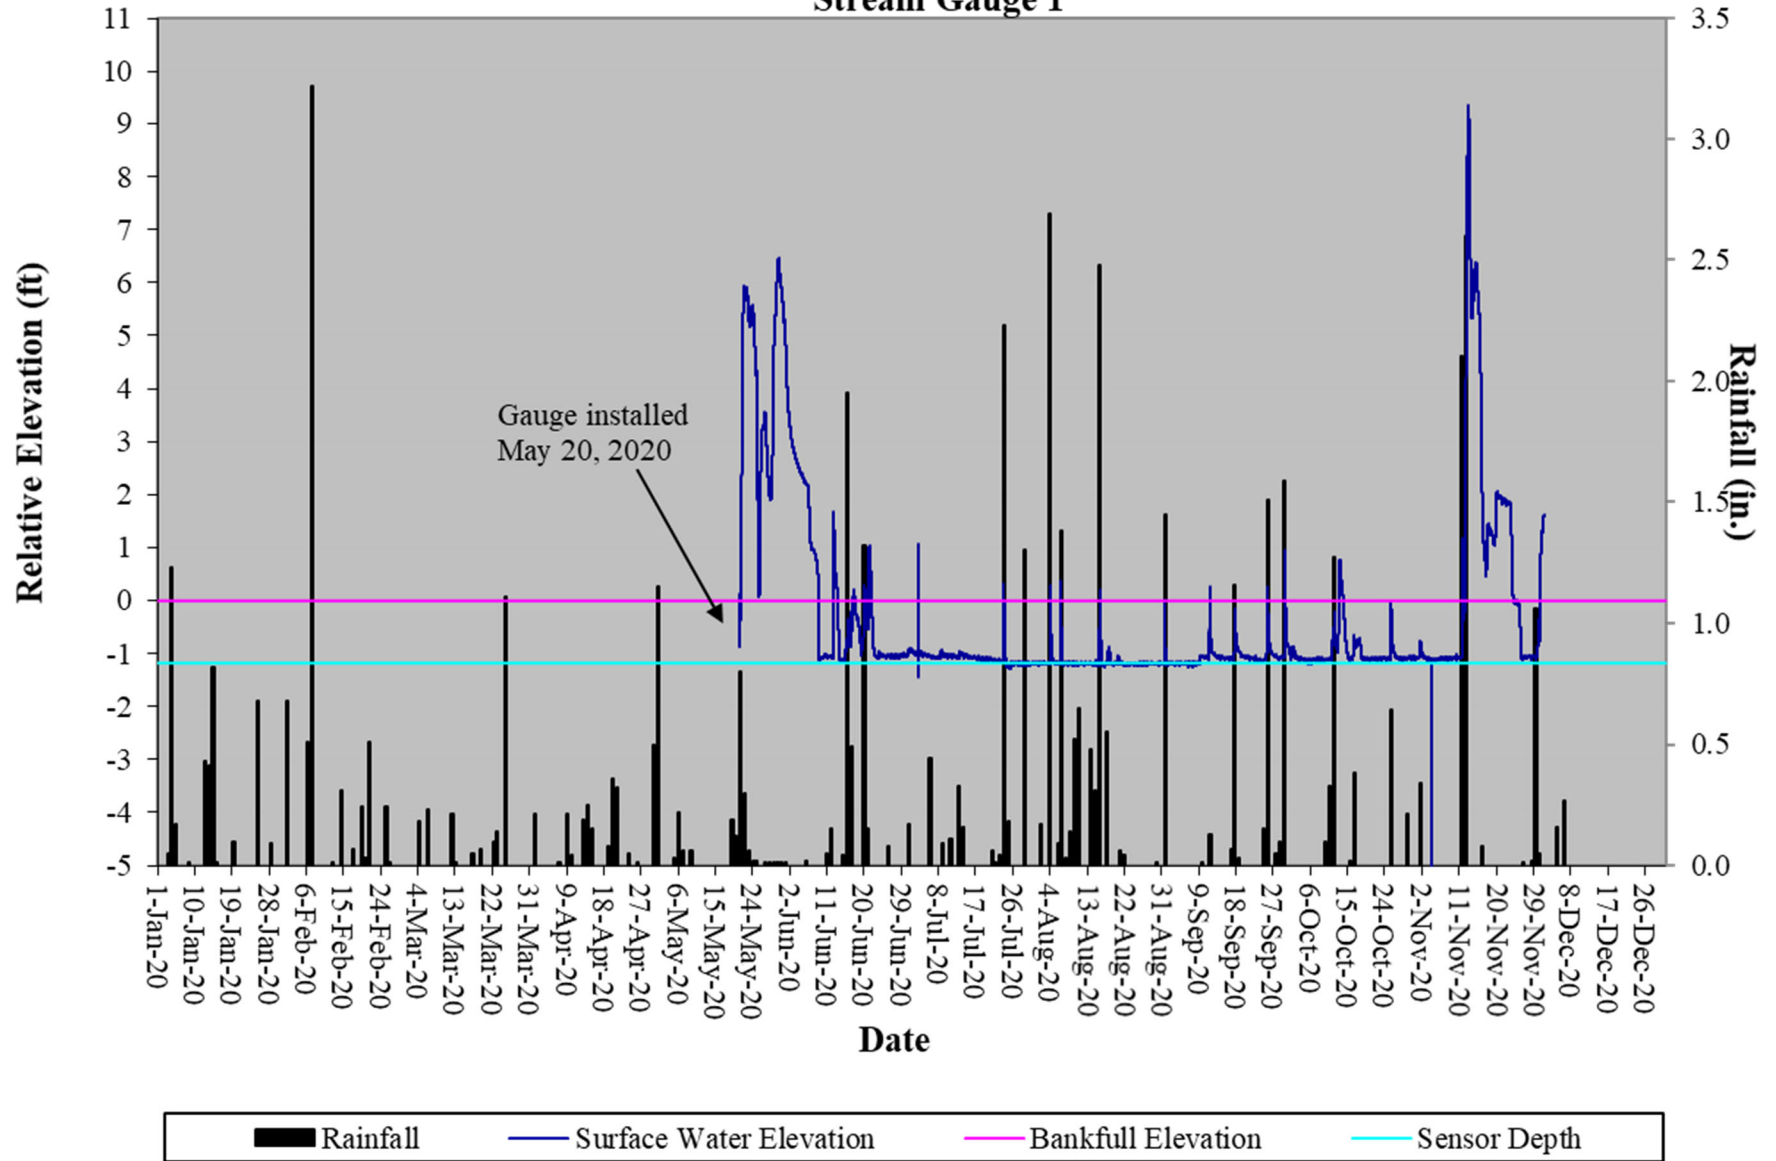
UT Cape Fear River Restoration Site Hydrograph Stream Gauge 1

An on-site stream gauge was installed at the site in May 2020. Numerous bankfull events were documented by the on-site stream gauge at UT to Cape Fear River during the 2020 monitoring year. A graph of the stream gauge data is presented in Appendix A.

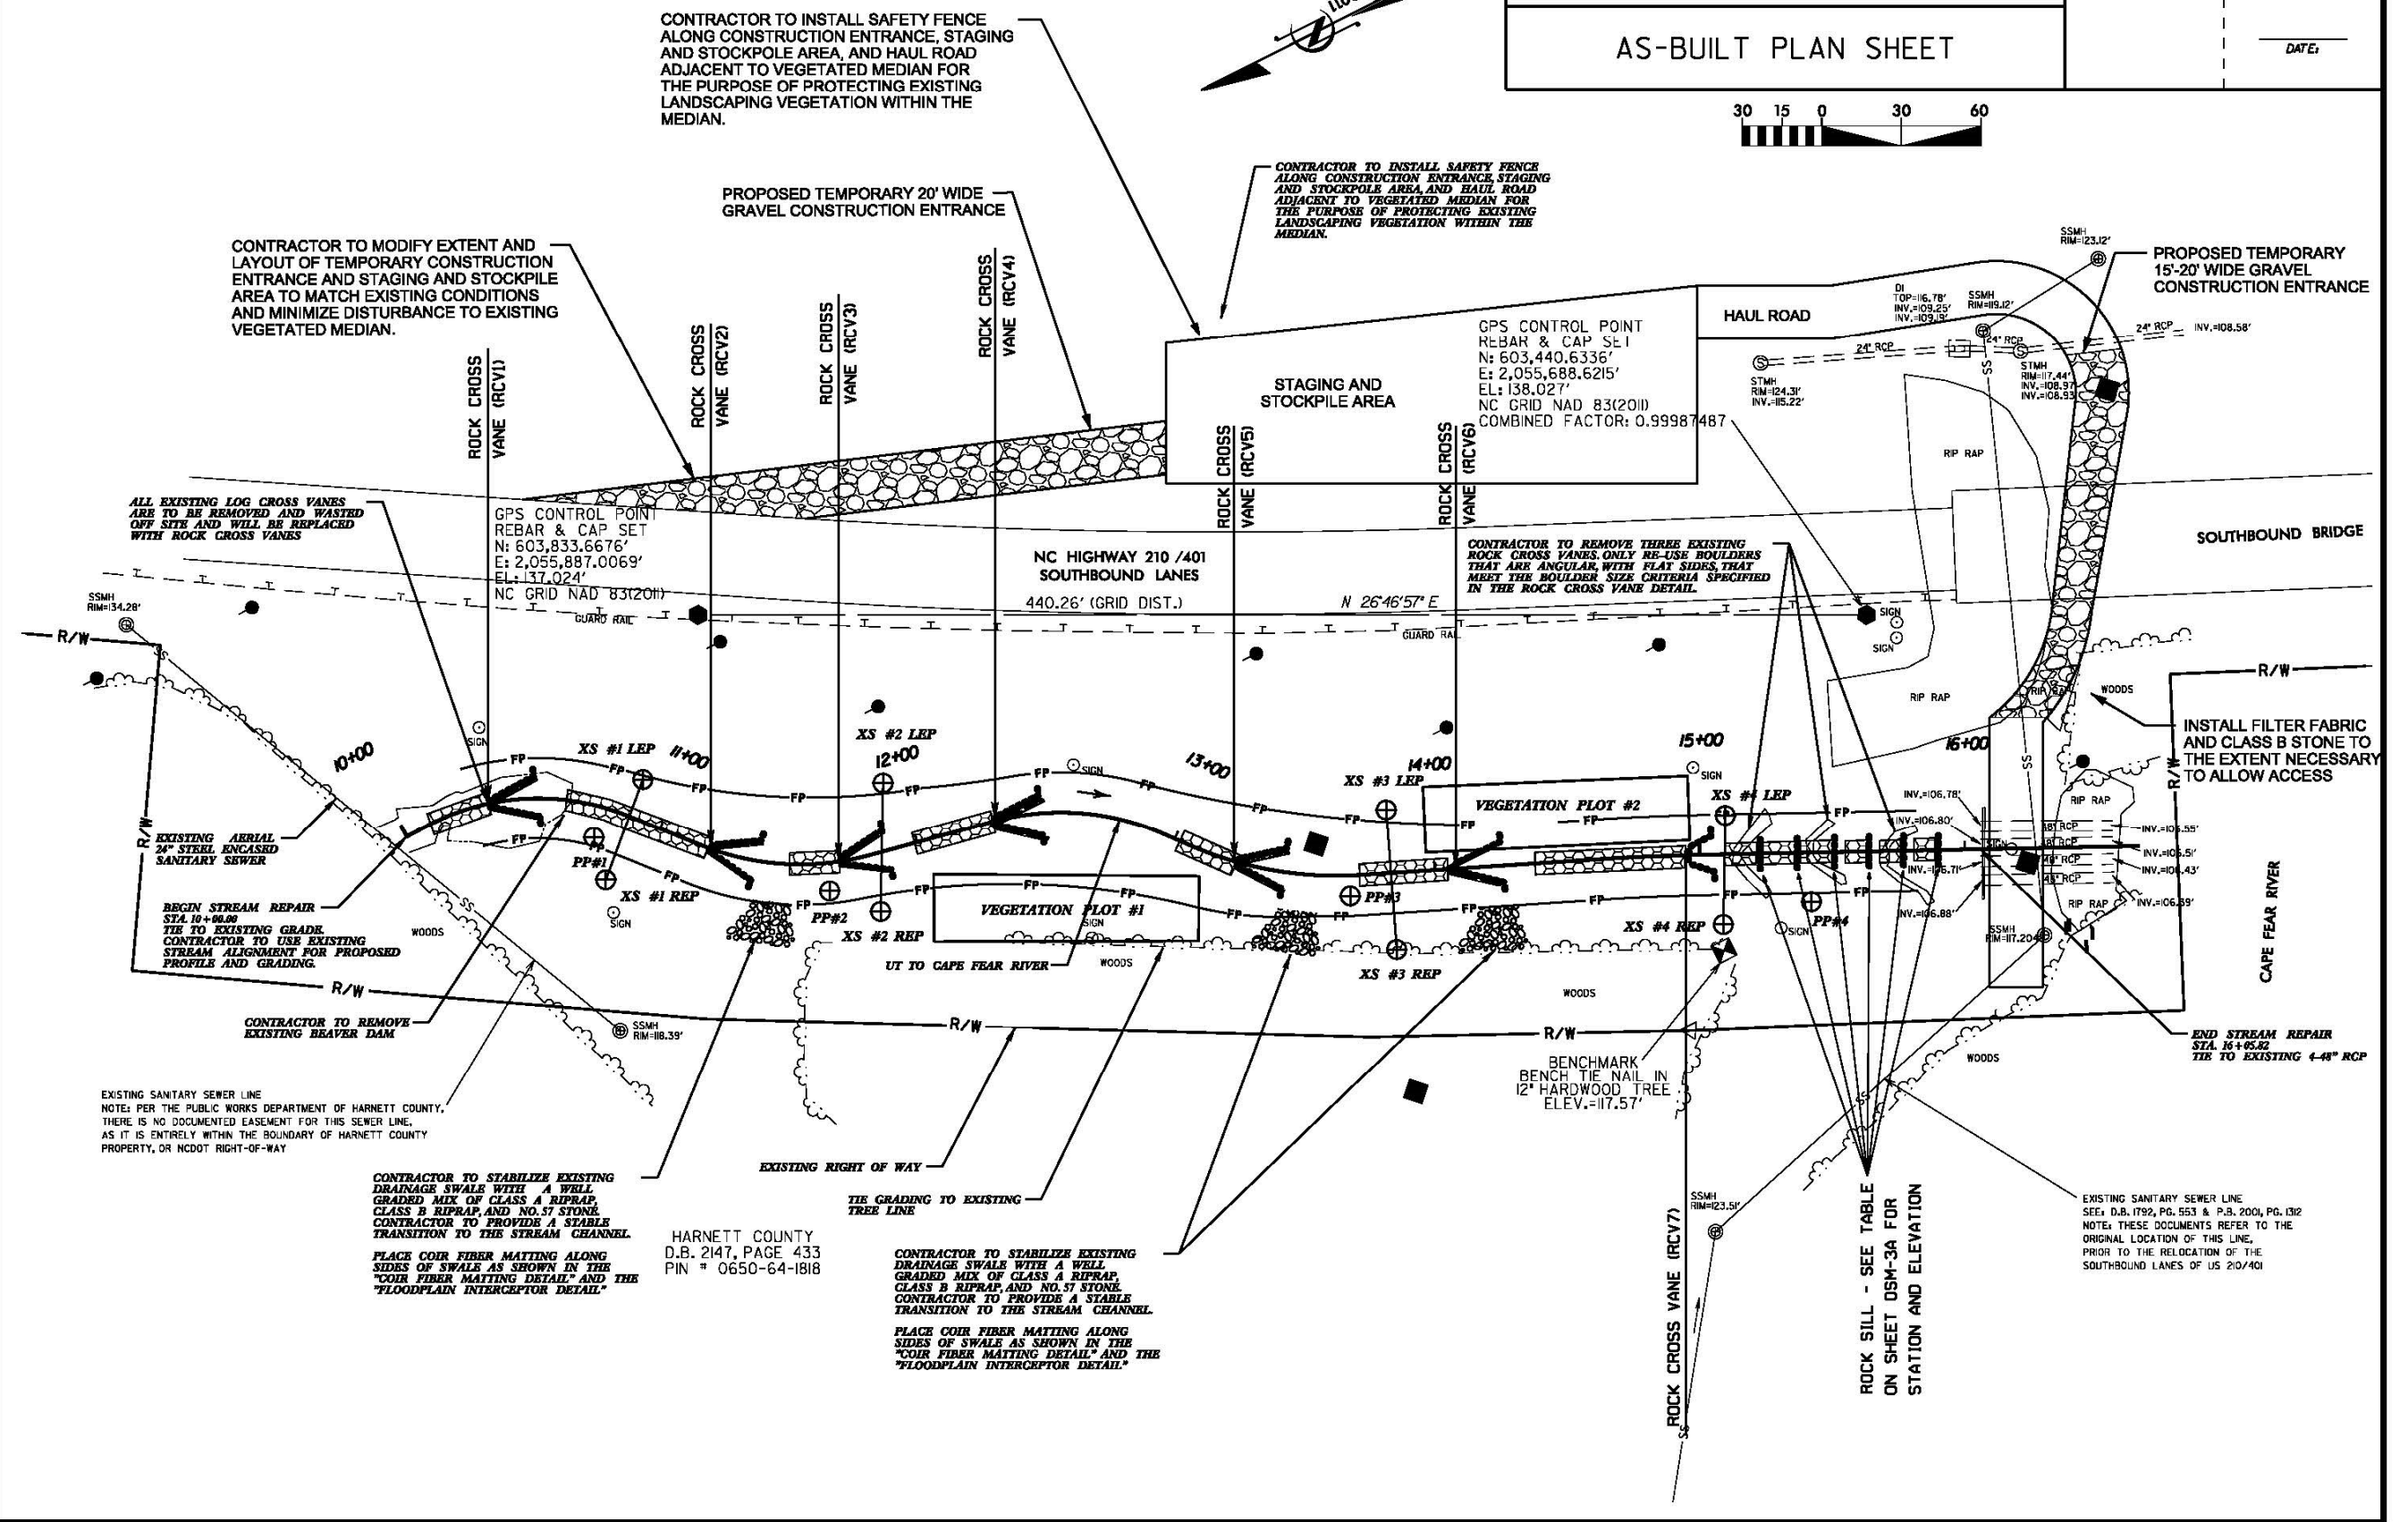
AS-BUILT PLAN SHEET

ALL EXISTING LOG CROSS VANES ARE TO BE REMOVED AND WASTED OFF SITE AND WILL BE REPLACED WITH ROCK CROSS VANES

CONTRACTOR TO REMOVE THREE EXISTING ROCK CROSS VANES, ONLY RE-USE BOULDERS THAT ARE ANGULAR, WITH FLAT SIDES, THAT MEET THE BOULDER SIZE CRITERIA SPECIFIED IN THE ROCK CROSS VANE DETAIL.

BEGIN STREAM REPAIR STA. 10+00.00 TIE TO EXISTING GRADE. CONTRACTOR TO USE EXISTING STREAM ALIGNMENT FOR PROPOSED PROFILE AND GRADING.

CONTRACTOR TO REMOVE EXISTING BEAVER DAM

CONTRACTOR TO STABILIZE EXISTING DRAINAGE SWALE WITH A WELL GRADED MIX OF CLASS A RIPRAP, CLASS B RIPRAP, AND NO. 57 STONE. CONTRACTOR TO PROVIDE A STABLE TRANSITION TO THE STREAM CHANNEL.
PLACE COIR FIBER MATTING ALONG SIDES OF SWALE AS SHOWN IN THE "COIR FIBER MATTING DETAIL" AND THE "FLOODPLAIN INTERCEPTOR DETAIL."
