ANNUAL REPORT FOR 2023

B-4138WM UT to Cape Fear River
Harnett County
TIP No. B-4138WM
USACE Action ID: SAW-2003-00357
DWR Project #: 20091321

Prepared By:
Environmental Analysis Unit & Roadside Environmental Unit
North Carolina Department of Transportation
December 2023

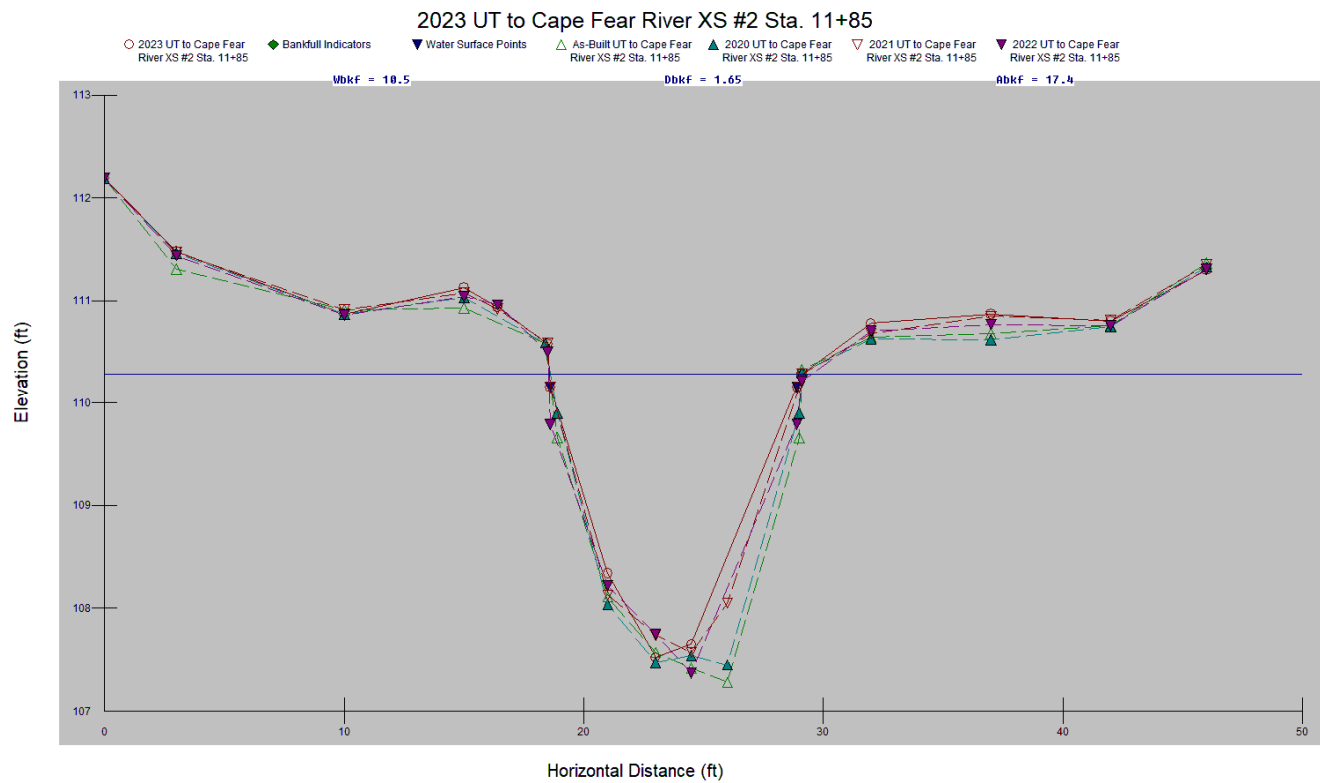
Cross-Section #2 (Pool) Abbreviated Morphological Summary						
	As-built	2020	2021	2022	2023	2024
Bankfull Width (ft)	14.2	13.6	10.53	10.56	10.53	
Bankfull Mean Depth (ft)	1.86	1.85	1.78	1.77	1.8	
Bankfull Cross Sectional Area (ft ²)	26.36	25.21	18.69	18.65	17.38	
Maximum Bankfull Depth (ft)	3.37	3.18	2.72	2.85	2.77

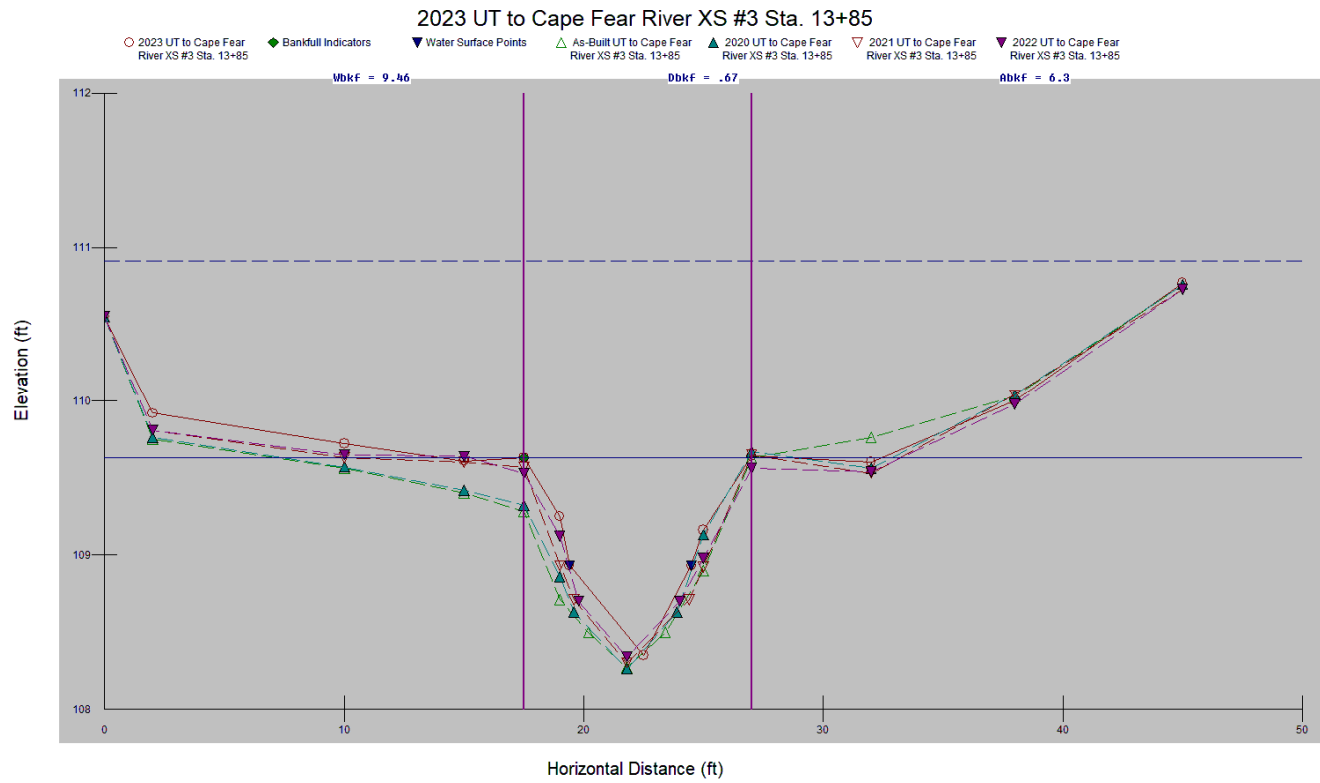
Cross-Section #3 (Riffle) Abbreviated Morphological Summary						
	As-built	2020	2021	2022	2023	2024
Bankfull Width (ft)	8.5	8.2	9.28	9.4	9.46	
Bankfull Mean Depth (ft)	0.61	0.61	0.76	0.67	0.67	
Width/Depth Ratio	13.93	13.44	12.21	14.03	14.12	
Bankfull Cross Sectional Area (ft2)	5.23	5.00	7.07	6.26	6.3	
Maximum Bankfull Depth (ft)	1.01	1.06	1.27	1.19	1.28	
Width of the Floodprone Area (ft)	39.84	40.88	45	44.91	45	
Entrenchment Ratio	4.69	4.98	4.85	4.78	4.76

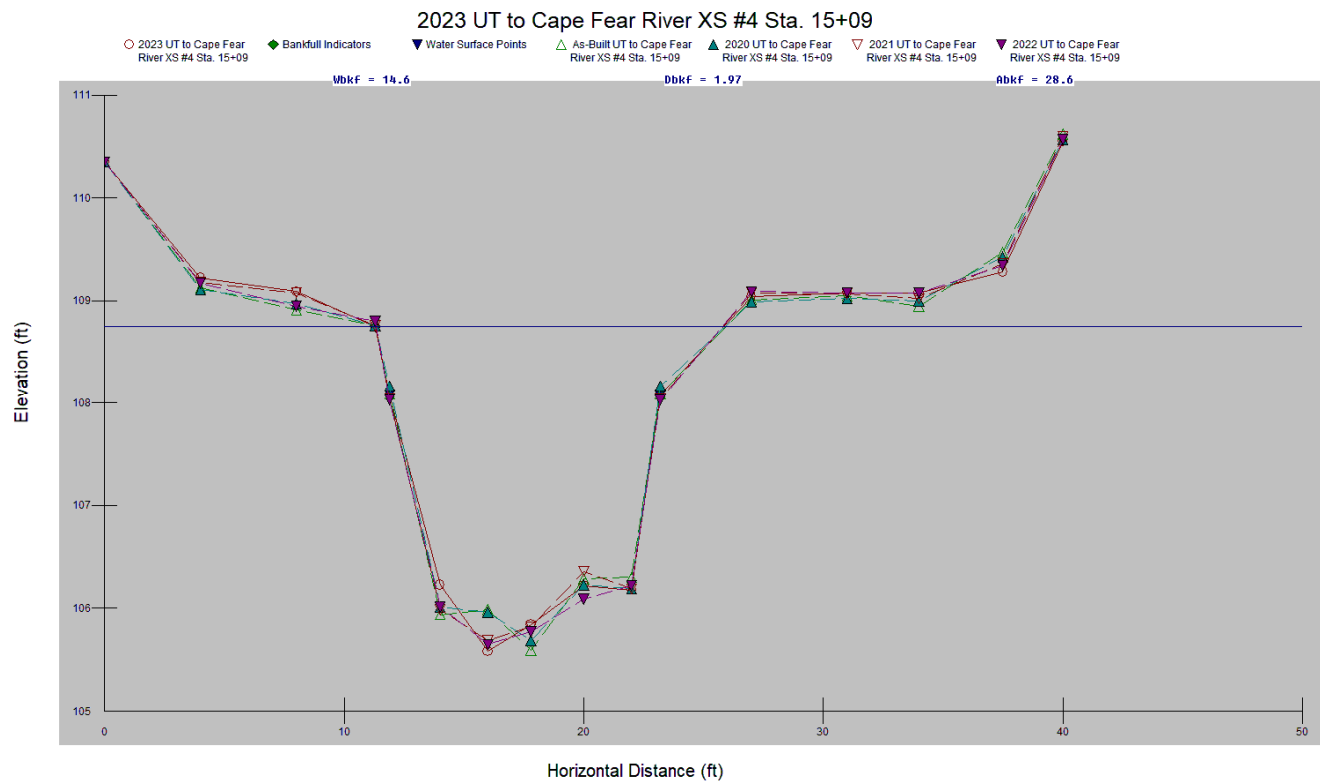
Cross-Section #4 (Pool) Abbreviated Morphological Summary						
	As-built	2020	2021	2022	2023	2024
Bankfull Width (ft)	14.67	14.63	14.52	14.66	14.55	
Bankfull Mean Depth (ft)	1.96	1.95	1.99	2.06	1.97	
Bankfull Cross Sectional Area (ft ²)	28.74	28.48	28.86	30.15	28.63	
Maximum Bankfull Depth (ft)	3.17	3.07	3.07	3.15	3.17

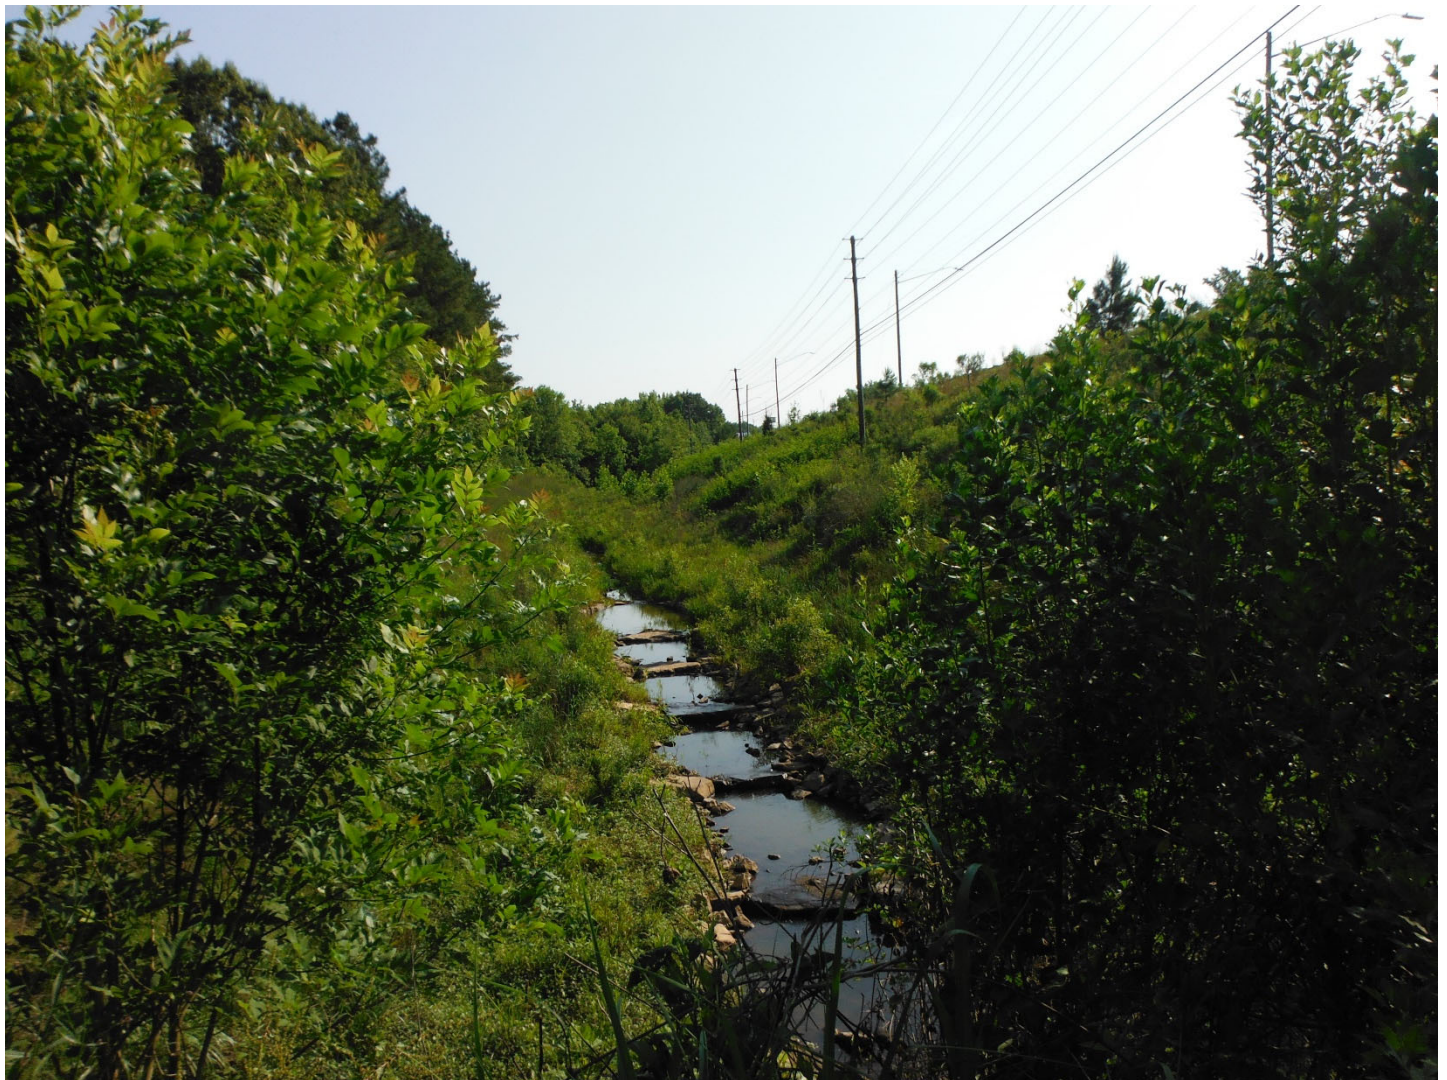
Overview Looking Upstream from Cape Fear River

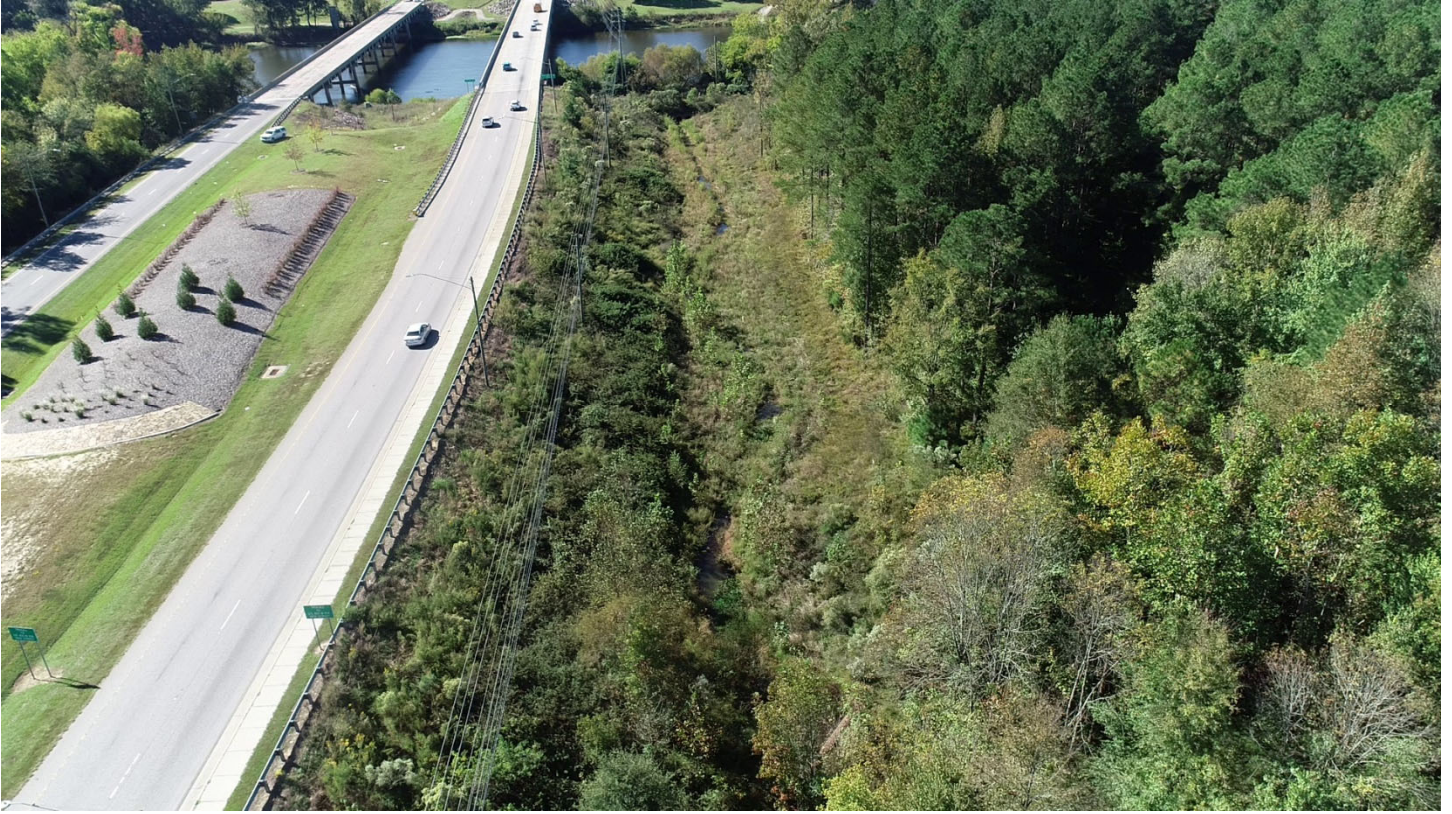
Aerial Drone View Looking Downstream
