ANNUAL REPORT FOR 2020

Mason Creek Bridge Temporary Impact Site
Pamlico County
TIP No. B-4598
CAMA Permit No. 50-17

Prepared By:
Roadside Environmental Unit and Environmental Analysis Unit
North Carolina Department of Transportation
September 2020

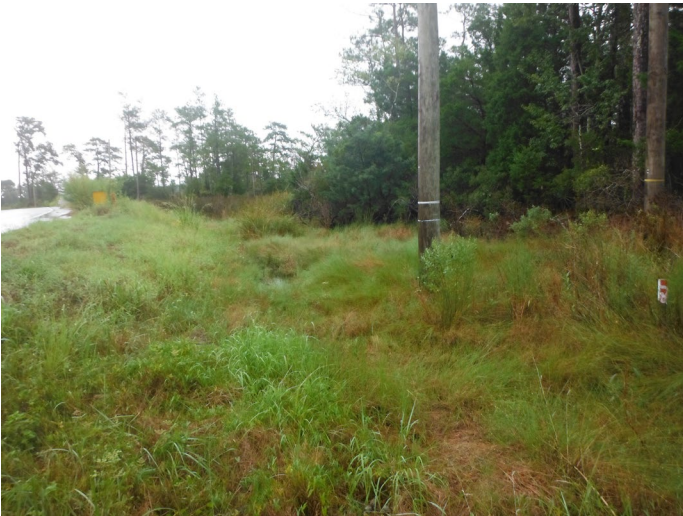
Photo 1

The impacted area where the temporary impacts occurred is re-attaining wetland jurisdictional status and re-vegetation of these areas has occurred. Utility tracks noted by CAMA during the 2019 Monitoring Meeting have re-vegetated. See photos in Appendix A. Other species noted within the temporary impacted areas included saltmeadow cordgrass, black needle rush, marsh-elder, *Scirpus* sp., saltgrass, cattail, sawgrass, and various grasses.

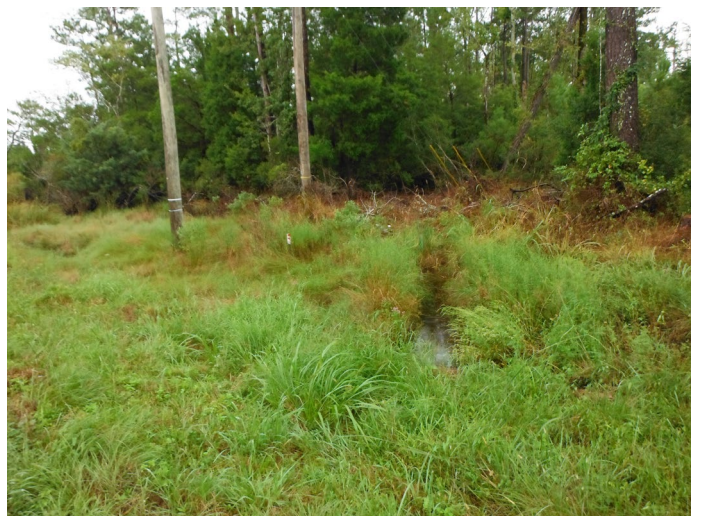
Utility truck tracks have re-vegetated
