# ANNUAL REPORT FOR 2023

**Br. 9 over South River Overflow Temporary Impact Site  
Sampson County**

**TIP No. B-4635**

Prepared By:  
Roadside Environmental Unit and Environmental Analysis Unit  
North Carolina Department of Transportation  
June 2023

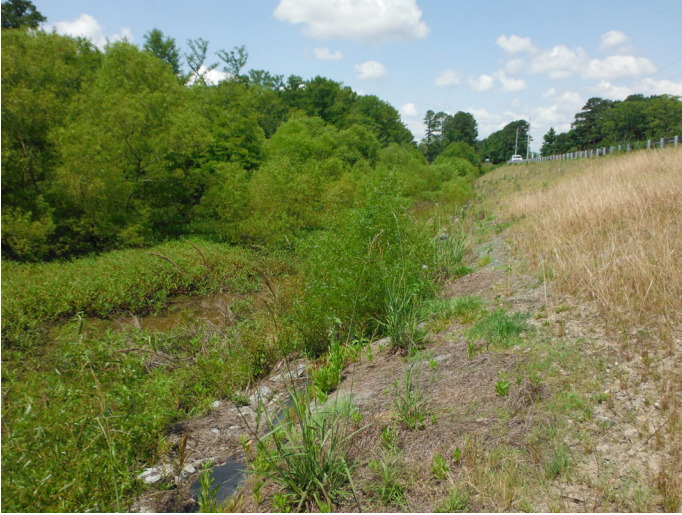
PP#1

The impacted area where the temporary impacts occurred has re-attained jurisdictional wetland status. Other species noted within the temporary wetland impact area included black willow, *Scirpus* sp., sweetgum, smartweed, soft rush, red maple, baccharis, cattail, baldcypress and various grasses. The temporary wetland impact area had areas of inundation at the time of monitoring.

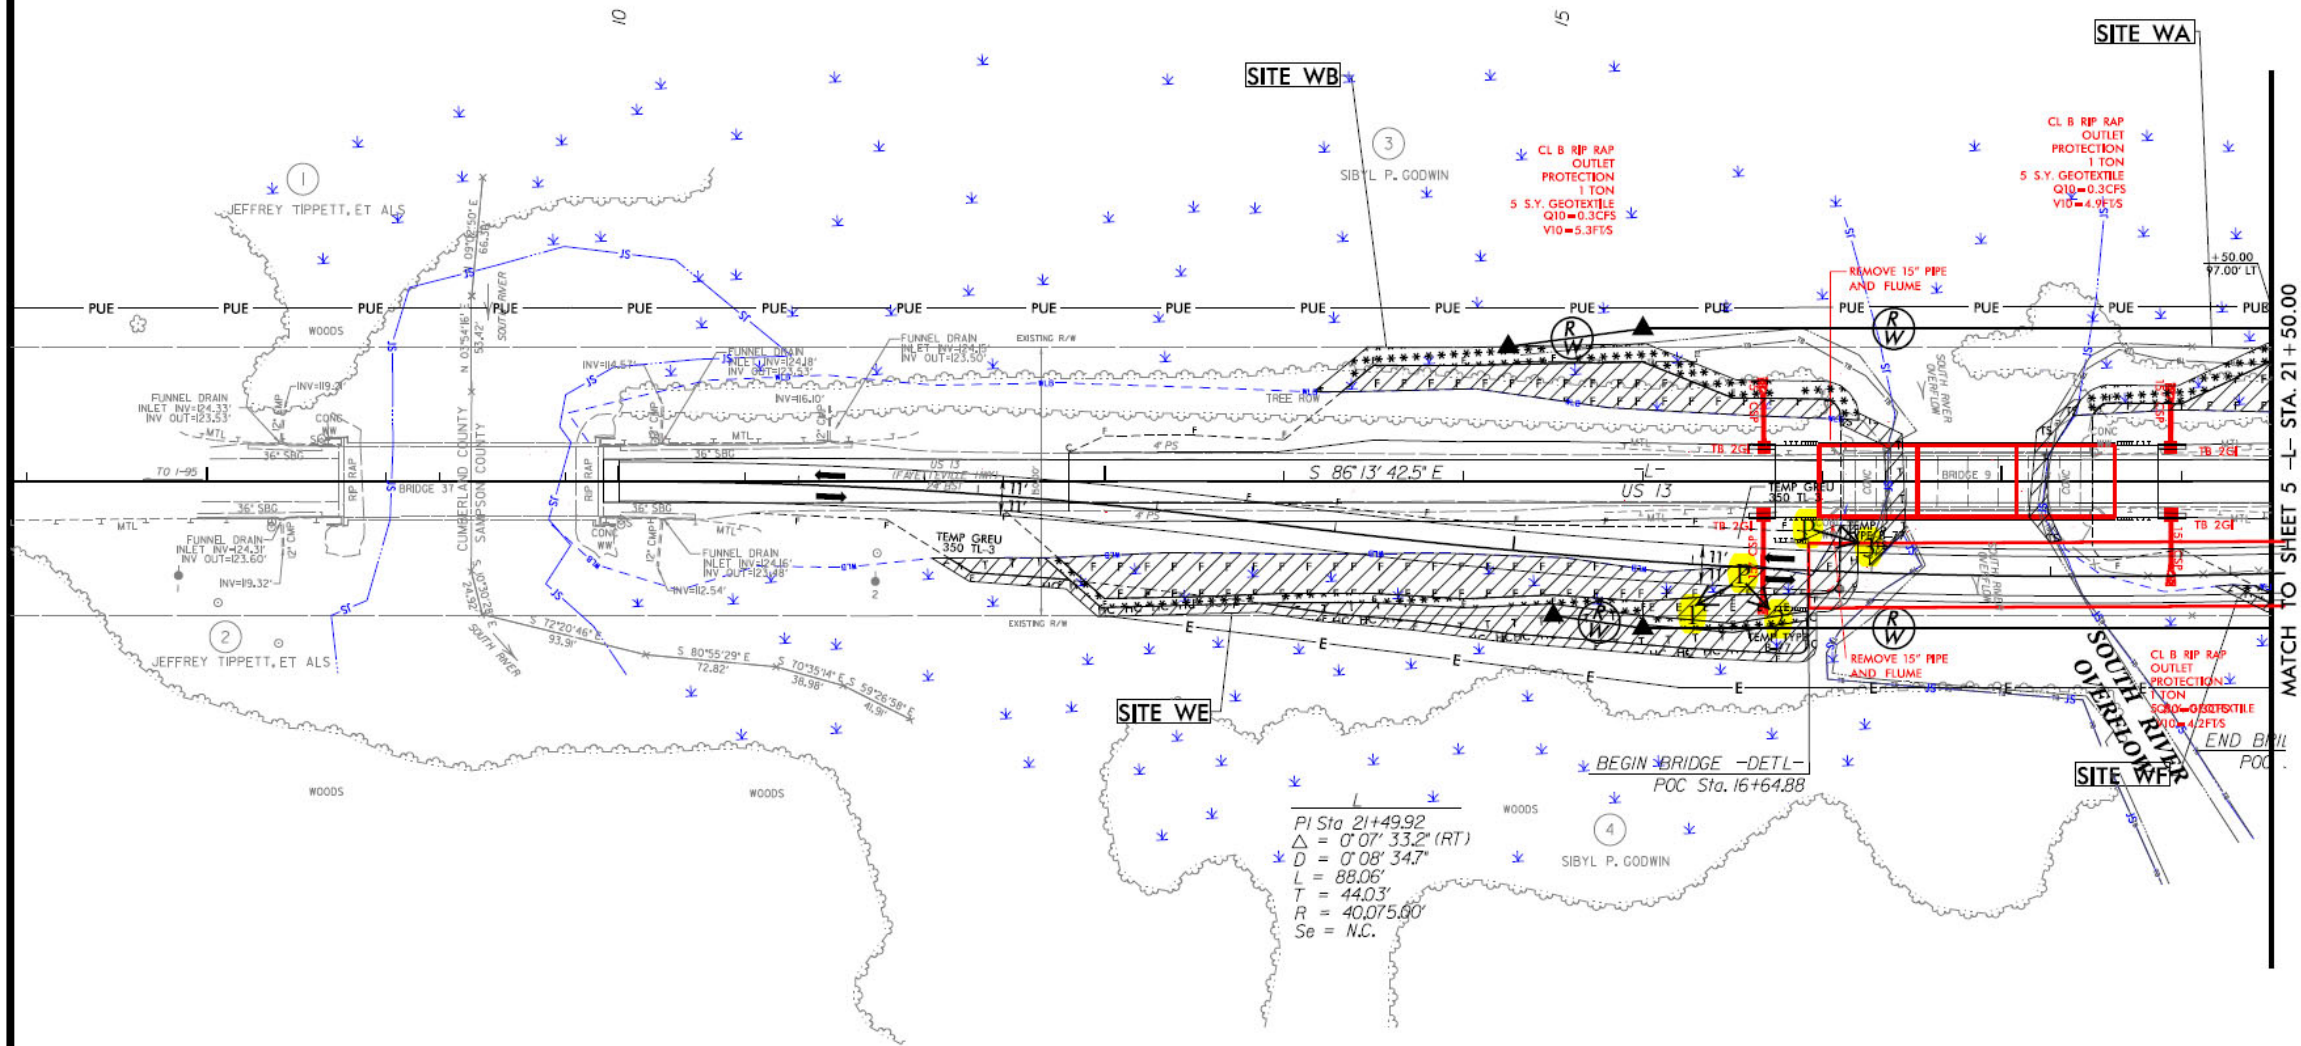
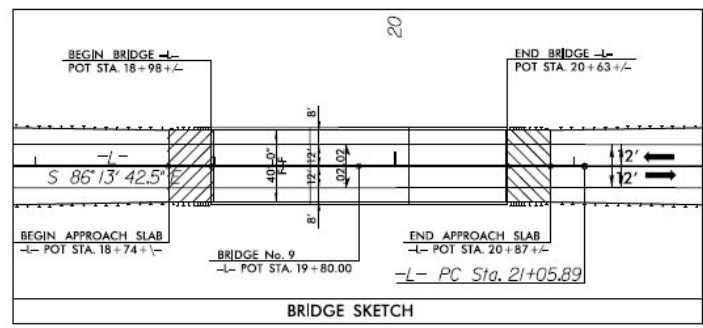
# PERMIT DRAWING SHEET 2 OF 18

- DENOTES FILL IN WETLAND
- DENOTES MECHANIZED CLEARING
- DENOTES TEMPORARY FILL IN WETLAND
- DENOTES TEMPORARY IMPACTS IN SURFACE WATER
- DENOTES HAND CLEARING
- DENOTES EXCAVATION IN WETLAND

P: Photo Point Locations

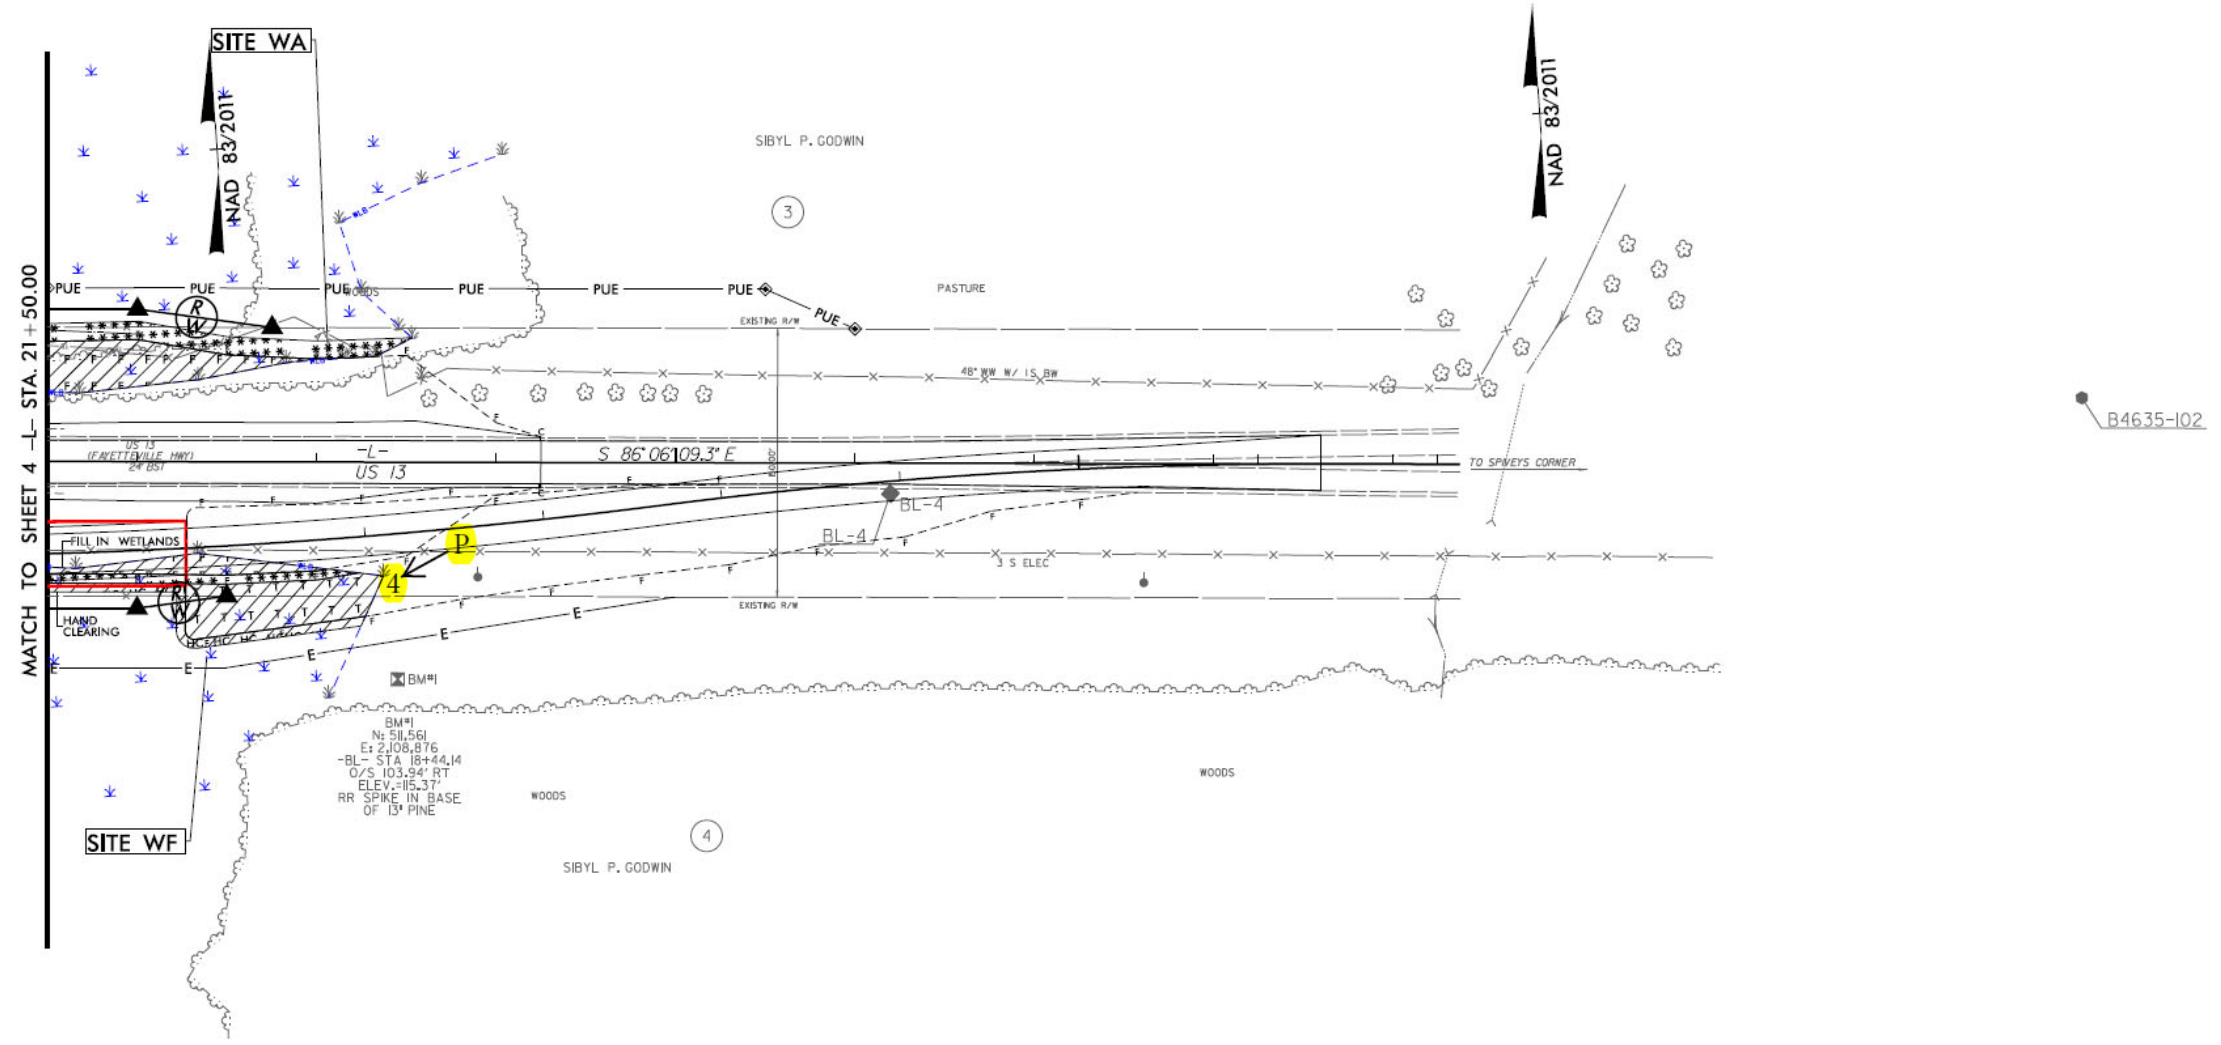
**PERMIT DRAWING  
SHEET 4 OF 18**

DENOTES TEMPORARY FILL IN WETLAND
- P: Photo Point Locations
