ANNUAL REPORT FOR 2020

Duck Creek Temporary Impact Site

Beaufort County

2.0 VEGETATION: DUCK CREEK TEMPORARY IMPACT SITE (YEAR 1 MONITORING)

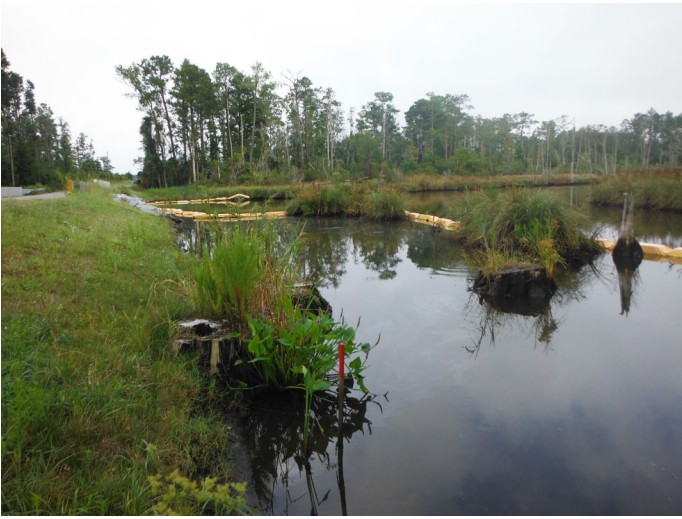
Photo 1

The impacted area where the temporary impacts occurred is starting to partially re-attain jurisdictional wetland status within the 401 temporary impacted area. Tulip Poplar, Sycamore, Willow Oak, and River Birch were noted surviving from approximately Sta. 18+50 to 19+00 -L- RT. The planted vegetation in the remaining 401 and CAMA temporary impact areas did not survive. Excessively high water levels occurred during and after planting within these areas. Also, the CAMA temporary impact area was planted outside of the seasonal planting window of April 15 to May 15 due to construction delays to raise the wetland elevation in this area. Other species noted within the temporary impacted areas included stinkweed, *Scirpus* sp., cattail, fennel, baldcypress, baccharis, soft rush, *Juncus* sp., smartweed, black willow, and various grasses.

NCDOT proposes to complete a supplemental planting with baldcypress and water tupelo seedlings within the 401 temporary impact area and to replant the CAMA temporary impact area with sawgrass in 2021. NCDOT will continue vegetation monitoring at the Duck Creek Temporary Impact Site in 2021.

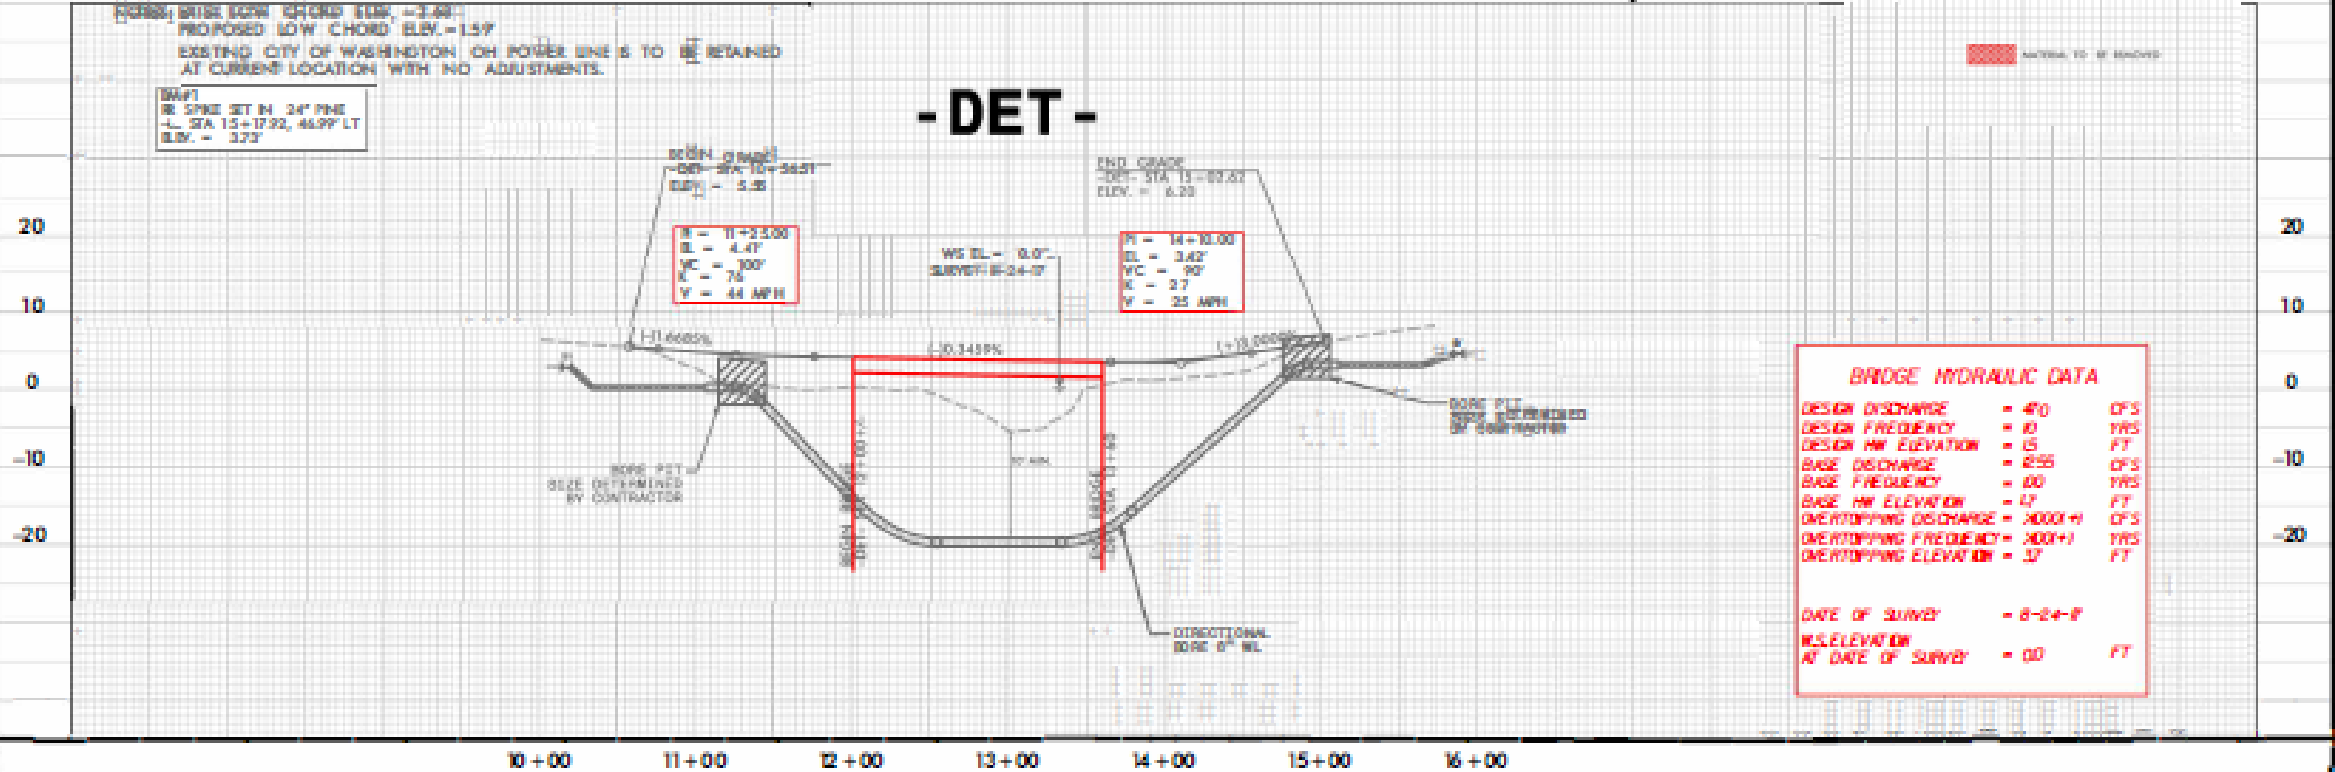
PERMIT DRAWING SHEET 4 OF 14

TEMPORARY DETOUR (-DET-) DETAIL SHEET

WETLAND & STREAM IMPACTS

TEMP. FILL IN CAMA WETLAND = 0.04 AC/1807 SF
 TEMP. FILL IN WETLAND = <0.01 AC/3 SF
 TEMPORARY IMPACTS IN SURFACE WATER = 0.01 AC/531 SF

TEMP. FILL IN WETLANDS = 0.05 AC/2091 SF
 TEMP. FILL IN CAMA WETLAND = <0.01 AC/83 SF
