ANNUAL REPORT FOR 2021

Duck Creek Temporary Impact Site

Beaufort County

Prepared By:
Roadside Environmental Unit and Environmental Analysis Unit
North Carolina Department of Transportation
September 2021

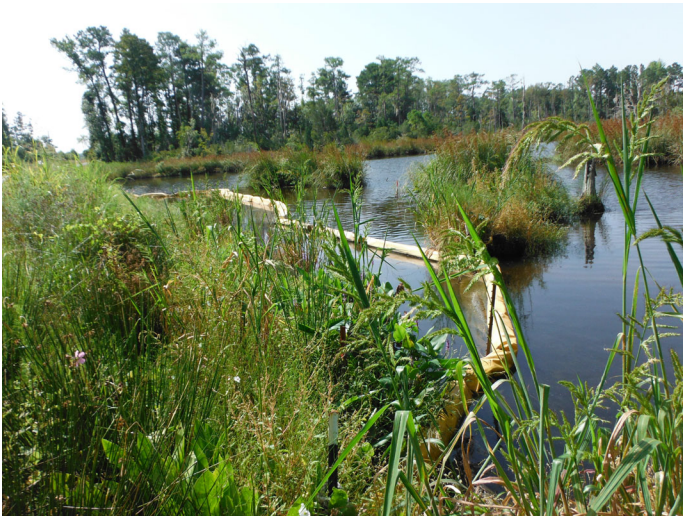
Photo 1

The impacted area where the temporary impacts occurred is re-attaining jurisdictional wetland status within the 404 and CAMA temporary impacted areas. The 404 area noted tulip poplar, sycamore, willow oak, river birch, and baldcypress trees surviving. Other species noted within the 404 area included black needle rush, woolgrass, wax myrtle, baccharis, fennel, marsh-elder sweetgum and various grasses. The CAMA area that was recently planted had sawgrass sprigs surviving. This area was inundated at the time of monitoring. Other species noted within the CAMA area included *Scirpus* sp., wiregrass, stinkweed, cattail, and various grasses.

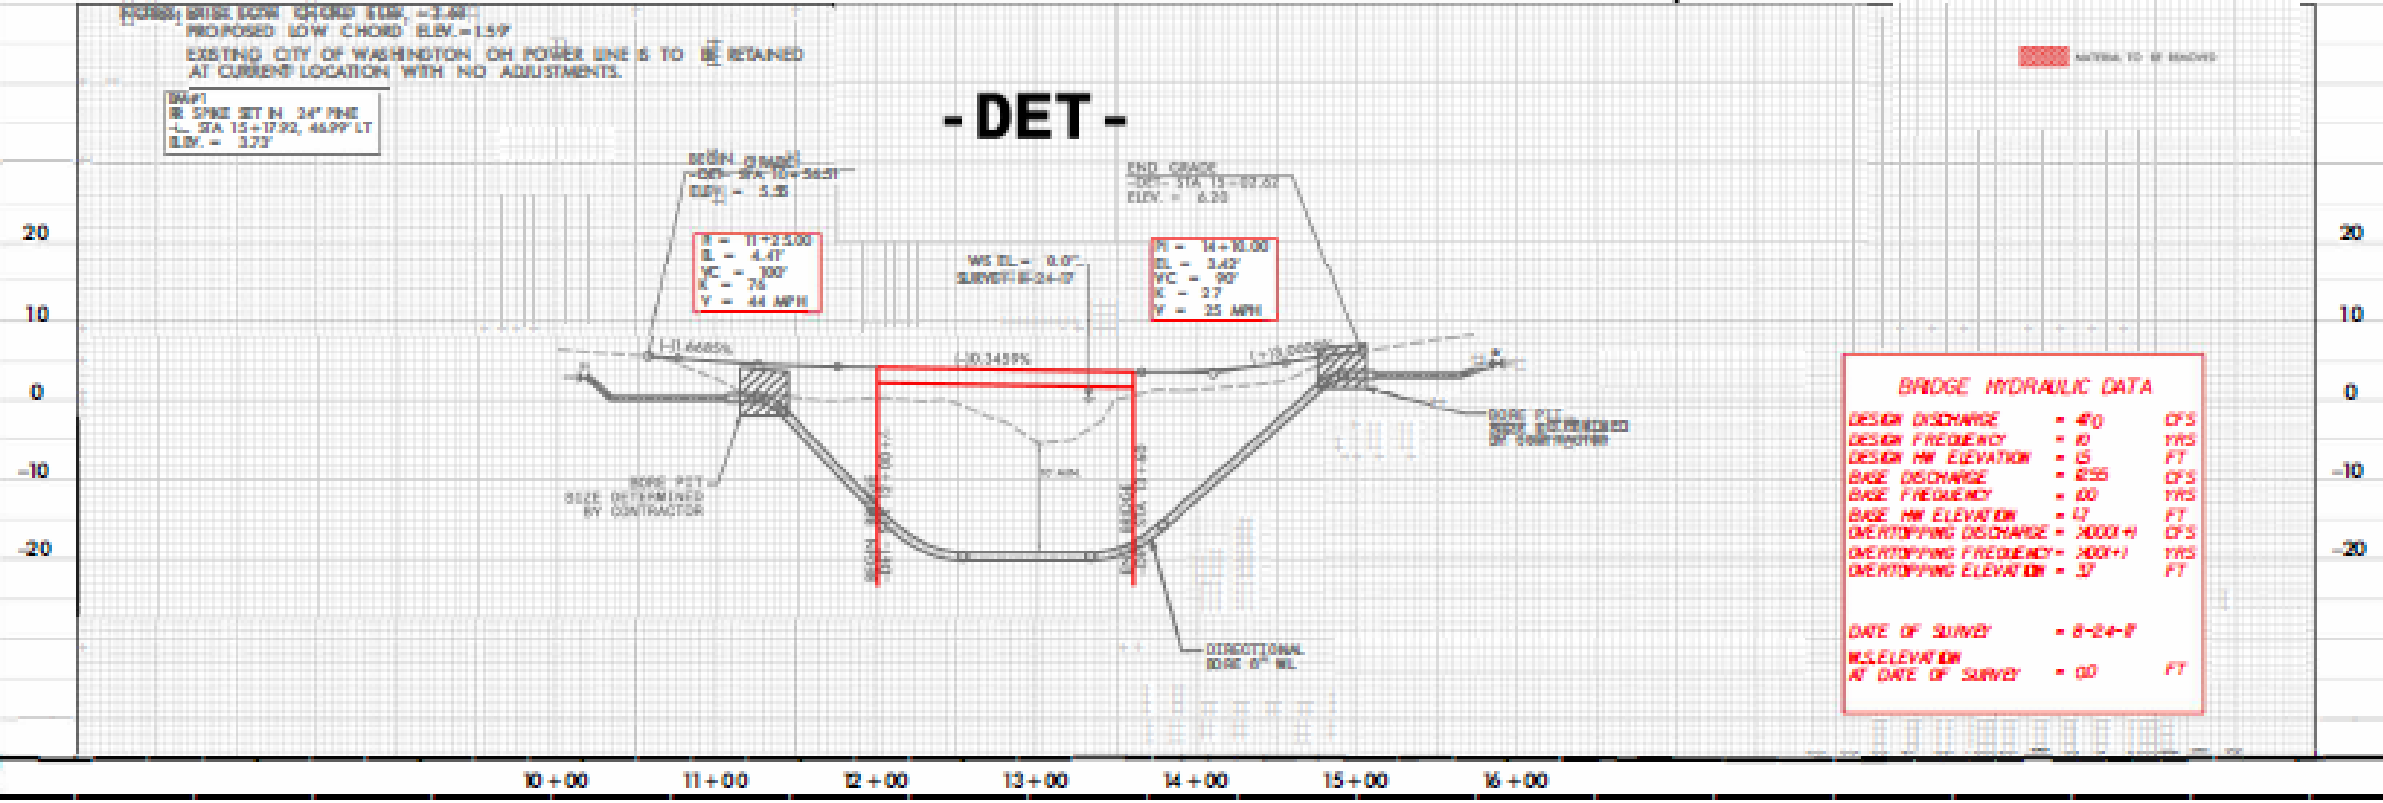
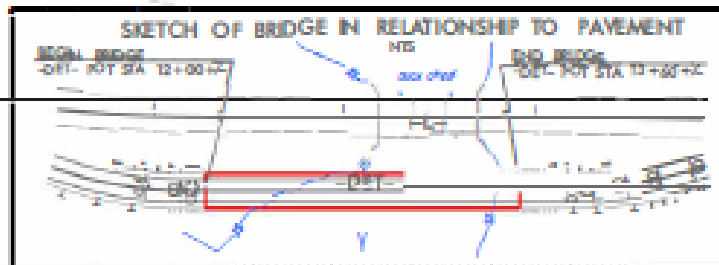
PERMIT DRAWING
SHEET 4 OF 14

TEMPORARY DETOUR (-DET-) DETAIL SHEET

WETLAND & STREAM IMPACTS

TEMP. FILL IN CAMA WETLAND = 0.04 Ac/1807 SF
 TEMP. FILL IN WETLAND = <0.01 Ac/3 SF
 TEMPORARY IMPACTS IN SURFACE WATER = 0.01 Ac/321 SF

W4
 TEMP. FILL IN WETLANDS = 0.05 Ac/2091 SF
 TEMP. FILL IN CAMA WETLAND = <0.01 Ac/85 SF
