ANNUAL REPORT FOR 2020

**UT to Fourth Creek
Iredell County
TIP No. I-3819A
USACE Action ID: 2005-31626
NCDWR Project #: 11-1044**

Prepared By:
Environmental Analysis Unit & Roadside Environmental Unit
North Carolina Department of Transportation
December 2020

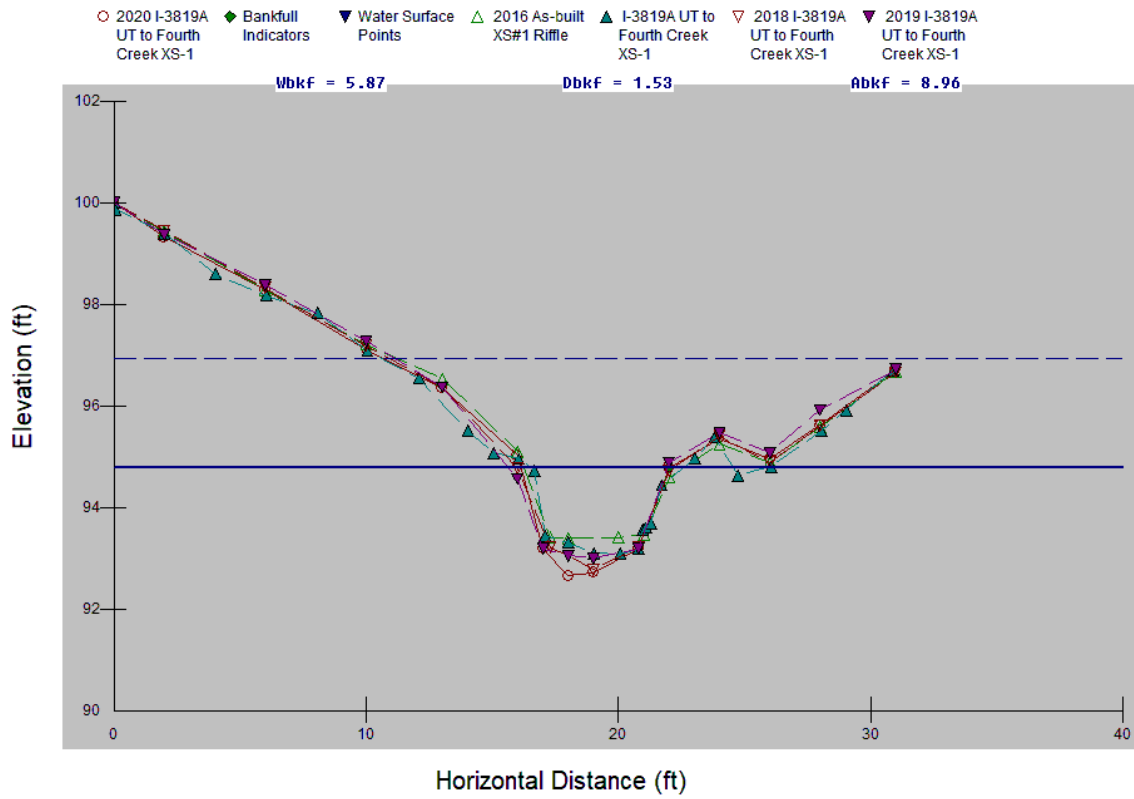
2020 I-3819A UT to Fourth Creek XS-1

Cross-Section #1 (Riffle) Abbreviated Morphological Summary					
	2016	2018	2019	2020	2021
Bankfull Width (ft.)	5.36	6.0	5.77	5.87	
Bankfull Mean Depth (ft.)	1.14	1.35	1.21	1.53	
Width/Depth Ratio	4.7	4.44	4.77	3.84	
Bankfull Cross Sectional Area (ft ²)	6.1	8.11	6.96	8.96	
Maximum Bankfull Depth (ft.)	1.49	1.98	1.56	2.14	
Width of the Floodprone Area (ft.)	16.44	19.37	15.35	20.29	
Entrenchment Ratio	3.07	3.23	2.66	3.46

Based on visual assessment and comparisons of the as-built plans to MY4 monitoring data, the channel and all four cross sections appear stable at time of survey. Graphs of the cross sections are presented in Appendix A. Cross section's #3 and #4 continue to show some aggradation of both the channel and floodplain due to flattening of the valley slope and deposition of sediment from upstream. Photo points at the vegetation plots presented in Appendix B show steady growth of herbaceous and woody vegetation. Pebble counts were not required per the permit conditions and therefore were not completed. All other monitoring activities will continue to be completed by NCDOT throughout the five-year monitoring period.

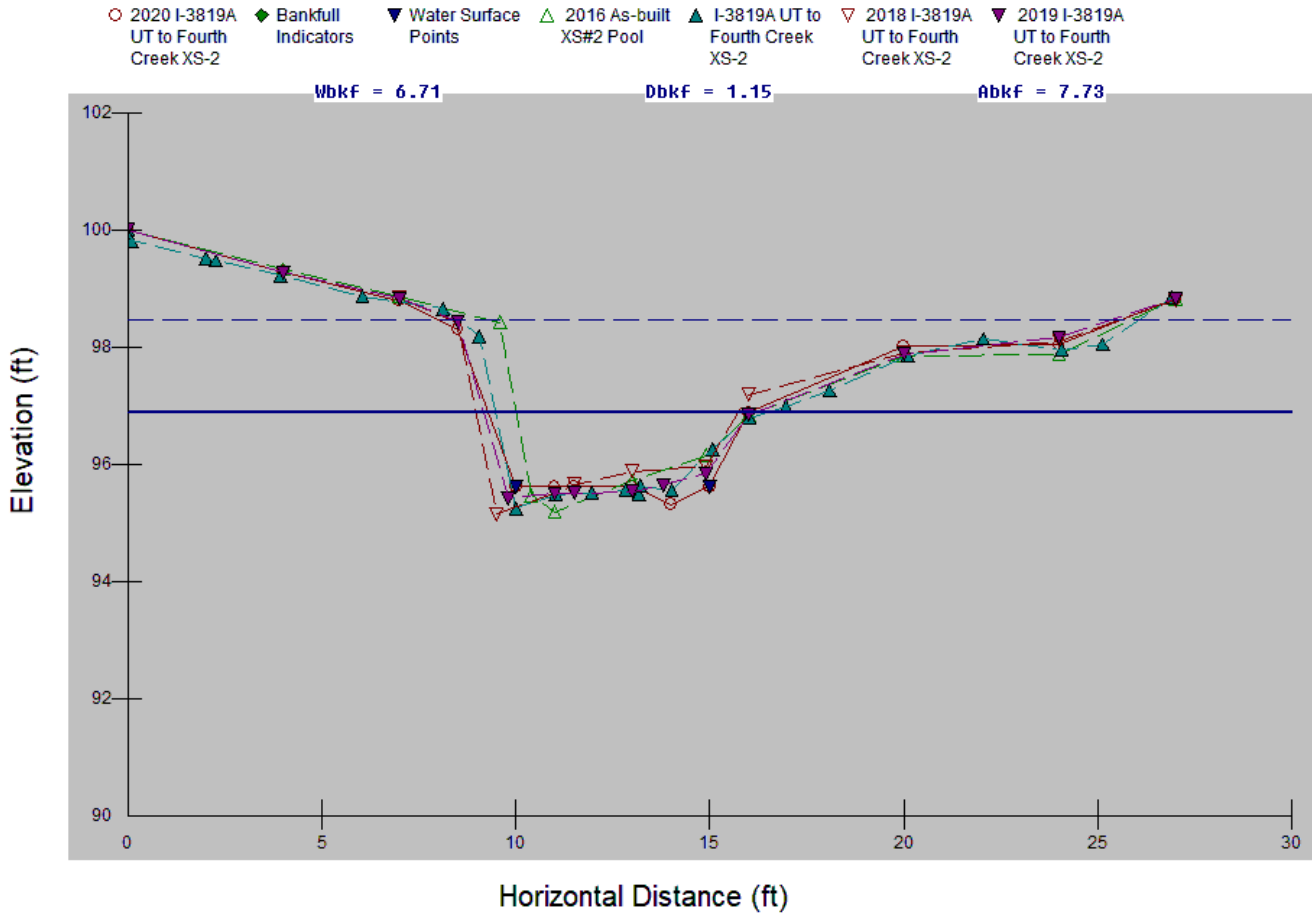
2020 I-3819A UT to Fourth Creek XS-2

Cross-Section #2 (Pool) Abbreviated Morphological Summary					
	2016	2018	2019	2020	2021
Bankfull Cross Sectional Area (ft ²)	12.08	9.48	7.51	7.73	
Bankfull Mean Depth (ft.)	1.30	1.33	1.1	1.15	
Maximum Bankfull Depth (ft.)	2.45	2.04	1.42	1.57	
Bankfull Width (ft.)	7.53	7.12	6.81	6.71

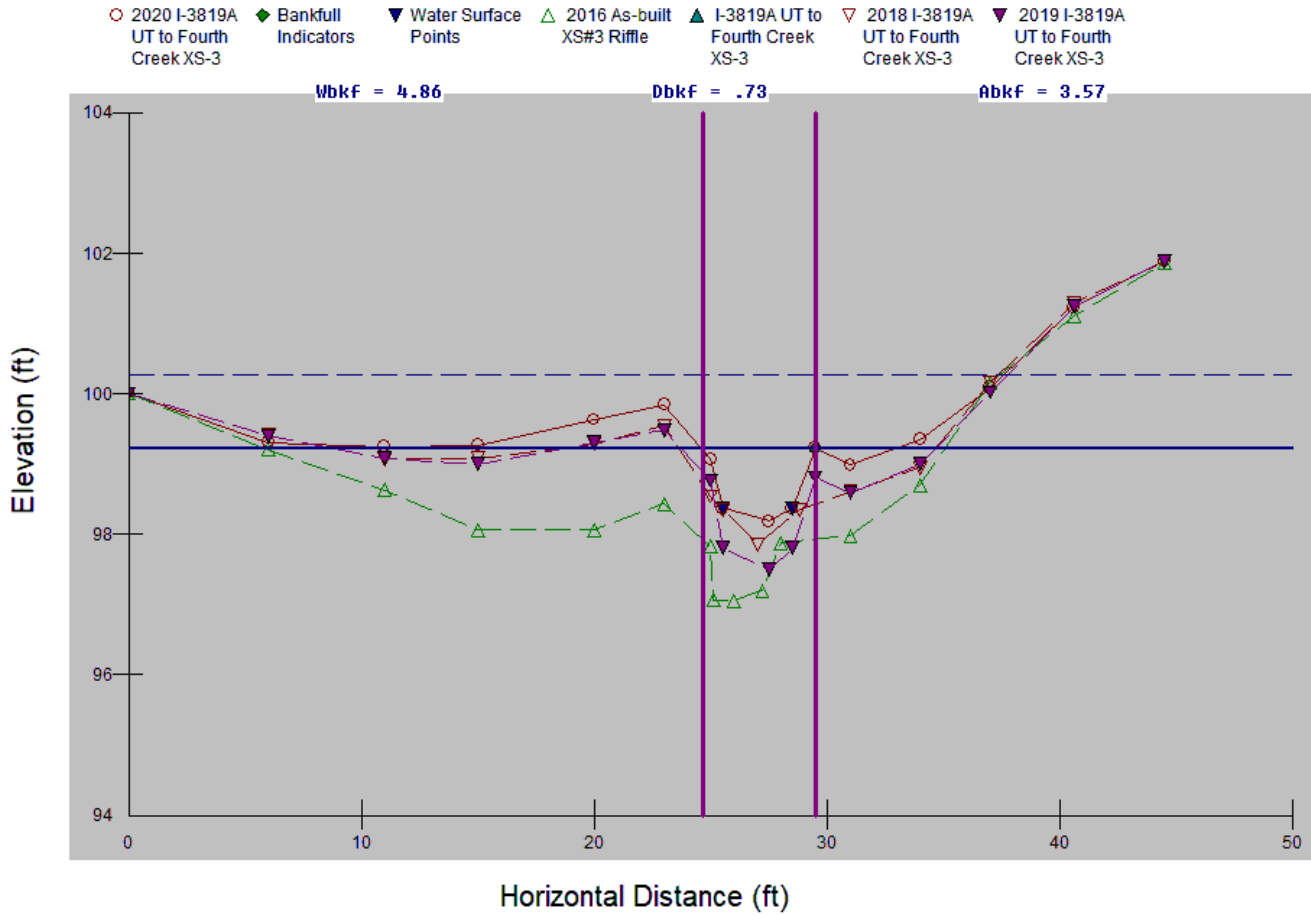
2020 I-3819A UT to Fourth Creek XS-3

Cross-Section #3 (Riffle) Abbreviated Morphological Summary					
	2016	2018	2019	2020	2021
Bankfull Width (ft.)	3.46	6.14	4.46	4.86	
Bankfull Mean Depth (ft.)	0.68	0.33	0.91	0.73	
Width/Depth Ratio	5.09	18.61	4.9	6.66	
Bankfull Cross Sectional Area (ft²)	2.35	2.04	4.05	3.57	
Maximum Bankfull Depth (ft.)	0.91	0.75	1.27	1.04	
Width of the Floodprone Area (ft.)	29.31	25.76	37.06	37.57	
Entrenchment Ratio	8.48	4.20	8.31	7.73

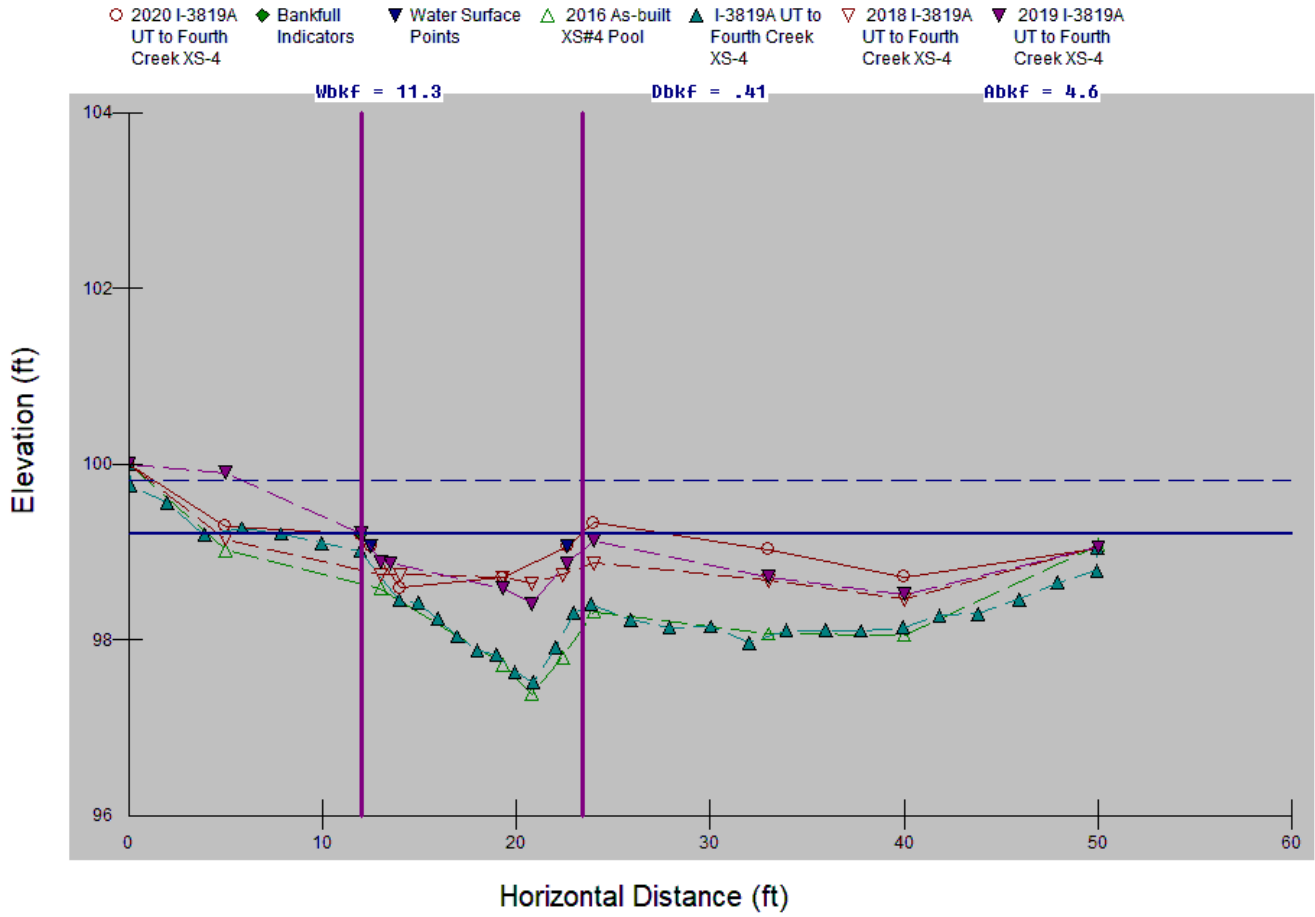
2020 I-3819A UT to Fourth Creek XS-4

Cross-Section #4 (Pool) Abbreviated Morphological Summary					
	2016	2018	2019	2020	2021
Bankfull Cross Sectional Area (ft ²)	3.93	1.75	4.58	4.6	
Bankfull Mean Depth (ft.)	0.45	0.13	0.39	0.41	
Maximum Bankfull Depth (ft.)	0.90	0.41	0.72	0.61	
Bankfull Width (ft.)	8.82	13.6	11.75	11.33

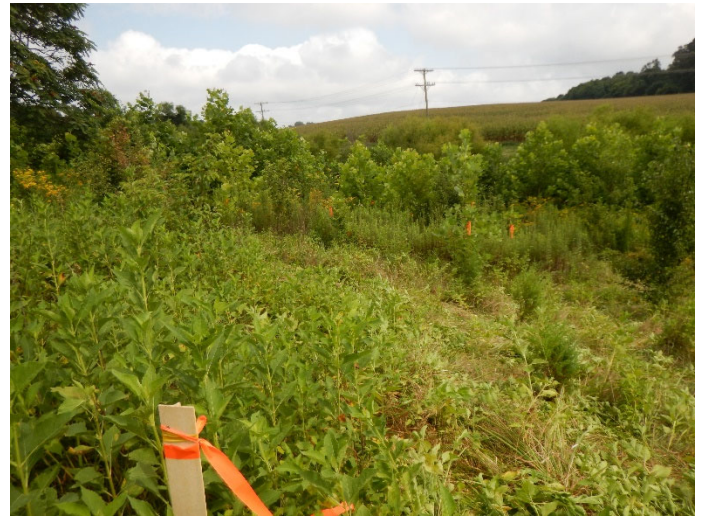
Vegetation Plot #1

Plot #	Yellow Poplar	Sycamore	Northern Red Oak	White Oak	Black Walnut	River Birch	Total (Year 4)	Total (at planting)	Density (Trees/Acre)
1	2	25			5	2	34	34	680
2	1	8	1		3		13	47	188
3							0	50	0
4		31		2		4	37	40	629
Year 4 Average Density (Trees/Acre)									374
Year 3 Average Density (Trees/Acre)									655
Year 2 Average Density (Trees/Acre)									655
Year 1 Average Density (Trees/Acre)									162

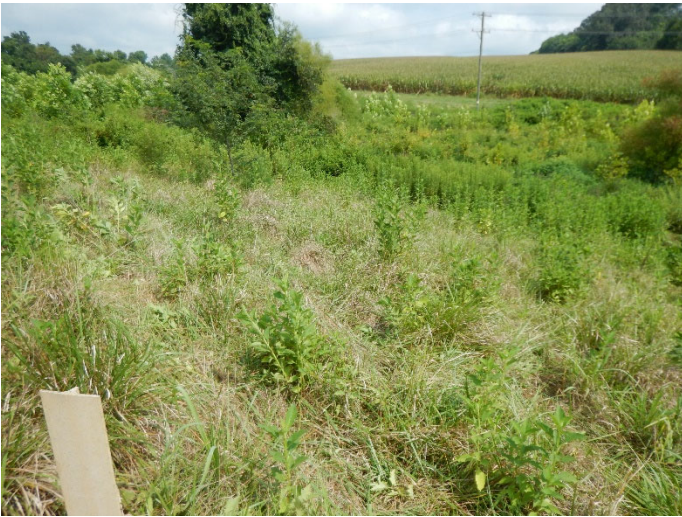
Vegetation Plot #2

All vegetation monitoring plots were monitored in Year 4. Vegetation Plots 2 and 3 are now included in the Year 4 monitoring evaluation. Once the I-3819B permit drawings were finalized, it was determined that this portion of the buffer would not be impacted and should be included in future monitoring reports. There are a total of 4 vegetation monitoring plots established throughout the buffer enhancement area. The 2020 vegetation monitoring of the site revealed an average tree density of 374 trees per acre. This average is above the minimum success criteria of 260 trees per acre for Year 4 but, Plots 2 and 3 are showing very low tree survival.

The April 2018 supplemental buffer planting did not include the area surrounding Plots 2 and 3, per the low stem count in 2020. NCDOT proposes to complete a supplemental planting of 2.2 acres in 2021 (see attached Supplemental Planting Map) to increase the survival rates within this area and continue vegetation monitoring in 2021.

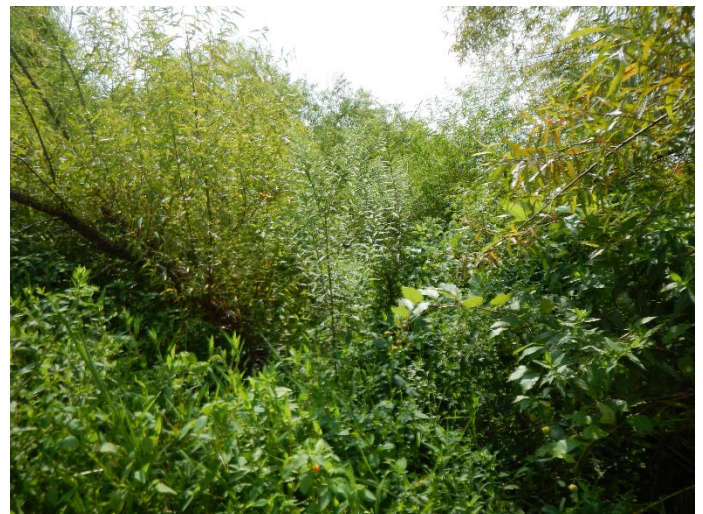
Streambank Vegetation

Site Notes: Buttonbush and silky dogwood live stakes that were planted along the streambank and noted during the monitoring evaluation were surviving. Other vegetation noted onsite included briars, goldenrod, pokeberry, black willow, elderberry, soft rush, *Scirpus* sp., jewelweed, tearthumb, fescue, red maple and various grasses.
