**UT to Fourth Creek Stream Mitigation Site
Water Sampling and Benthic Macroinvertebrate Survey
TIP I-3819A**

Iredell County, North Carolina

Year 6 Monitoring Report

**The North Carolina Department of Transportation
Environmental Analysis Unit**

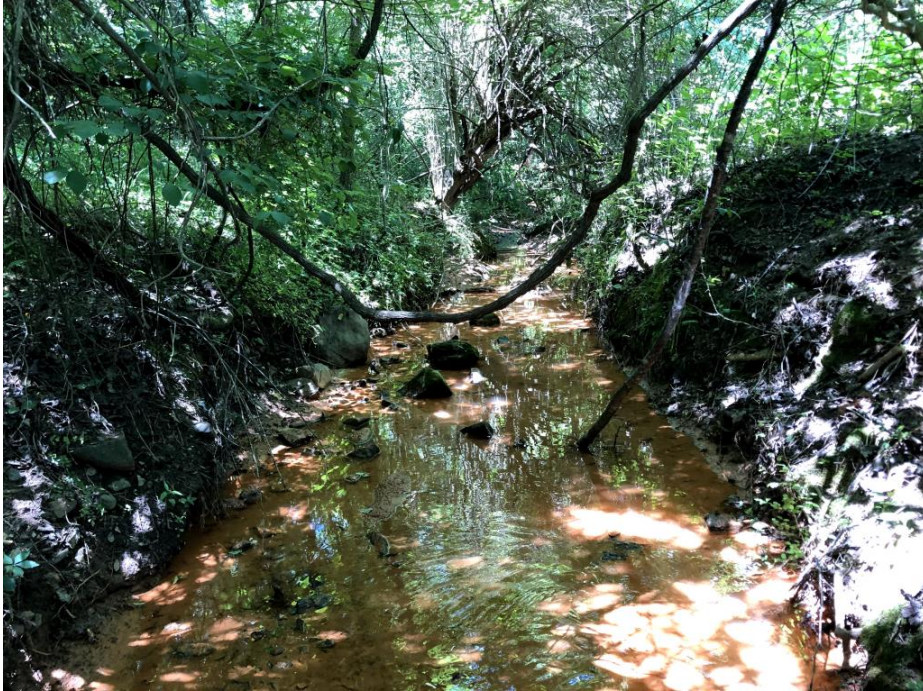
UT to Fourth Creek, Site 2 during 2021 survey

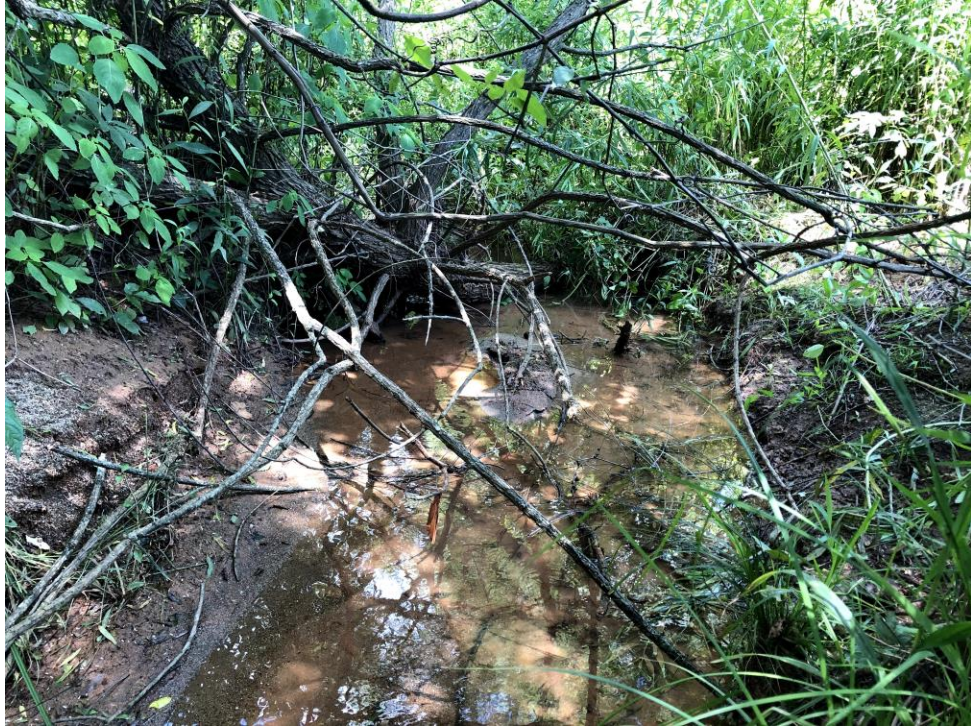
Site 1. Site 1 is the most upstream site located on UT to Fourth Creek. At the time of the surveys, top of bank width was approximately 3 meters (m) while wetted width was between 1 and 2 m. The bank height was approximately 3 m from the deepest part of the channel to the top of bank with moderate bank erosion evident on the left descending bank. Water depth ranged from 0.2 to 0.3 m. Flow conditions were moderate and the channel was wetted in most of the reach with substrate exposed at the edges of meanders and in bars. The habitat consisted of a riffle/pool/run complex. Substrate was composed of cobble, gravel, sand, and silt. No aquatic vegetation was present (Appendix C, Photos 1 and 2). The riparian canopy on the left descending bank was narrow with mature trees, shrubs, and grasses; the riparian buffer on right descending bank was moderate with construction beyond the buffer. The surrounding buffer was dominated by shrubs and grasses with few mature trees. Significant red silt was present in the stream channel covering the substrate; this was not observed in previous survey years.

Photo 1. Upstream facing view of Site 1.

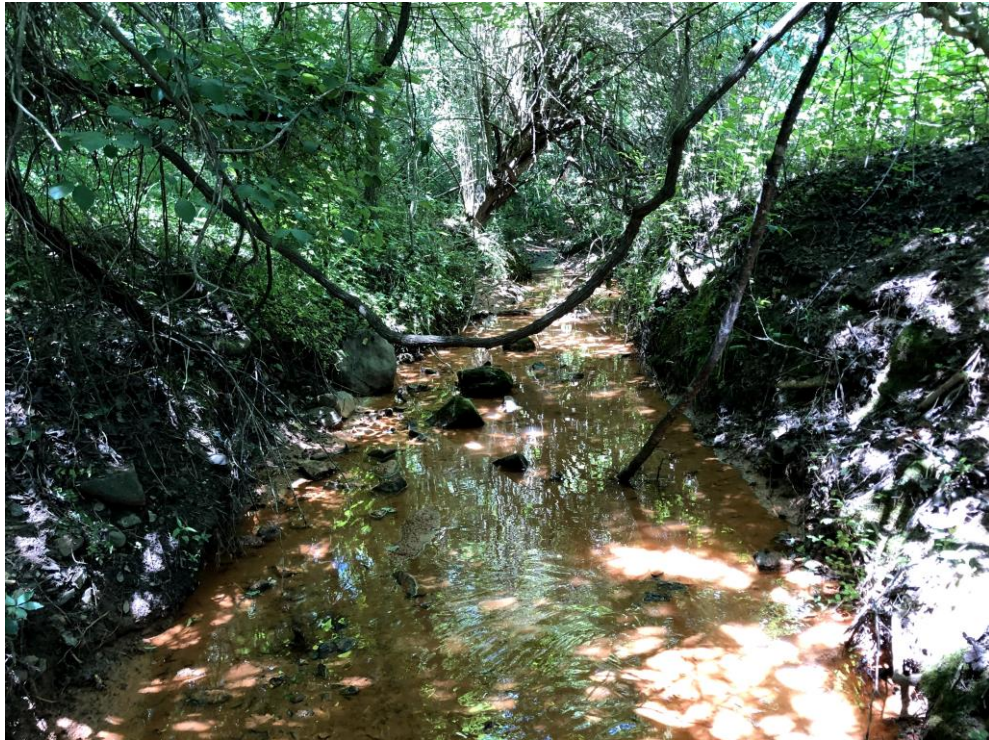
Photo 2. Downstream facing view of Site 1

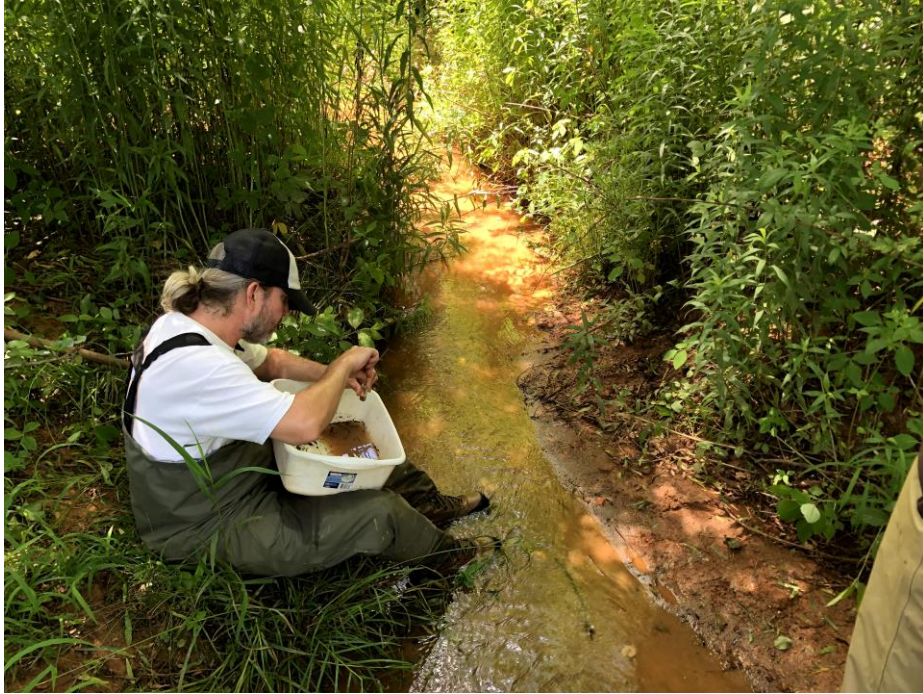
Site 2. Site 2 is located approximately 200 m downstream of Site 1. The stream was moderately channelized and narrow. The top of bank width was estimated to be 2 m and stream wetted width was approximately 1 m. The bank height from the deepest part of the channel to the top of bank was approximately 2 m, while water depth ranged from 0.1 to 0.2 m. Flow conditions were normal; the channel was wetted with little to no substrate exposed. In-stream habitat consisted of a riffle/pool/run complex with a run dominating the survey reach. The substrate was composed mainly of sand with some gravel and silt. There was very little aquatic vegetation (Appendix C, Photos 3 and 4). In contrast to Site 1 and Site 3, the riparian buffer was composed mostly of grasses and shrubs with only partial canopy shading by black willow saplings and herbaceous vegetation. Similar to Site 1, the right descending bank buffer was bordered by active construction and significant red silt deposition was present in the stream channel.

Photo 3. Downstream facing view of Site 2.

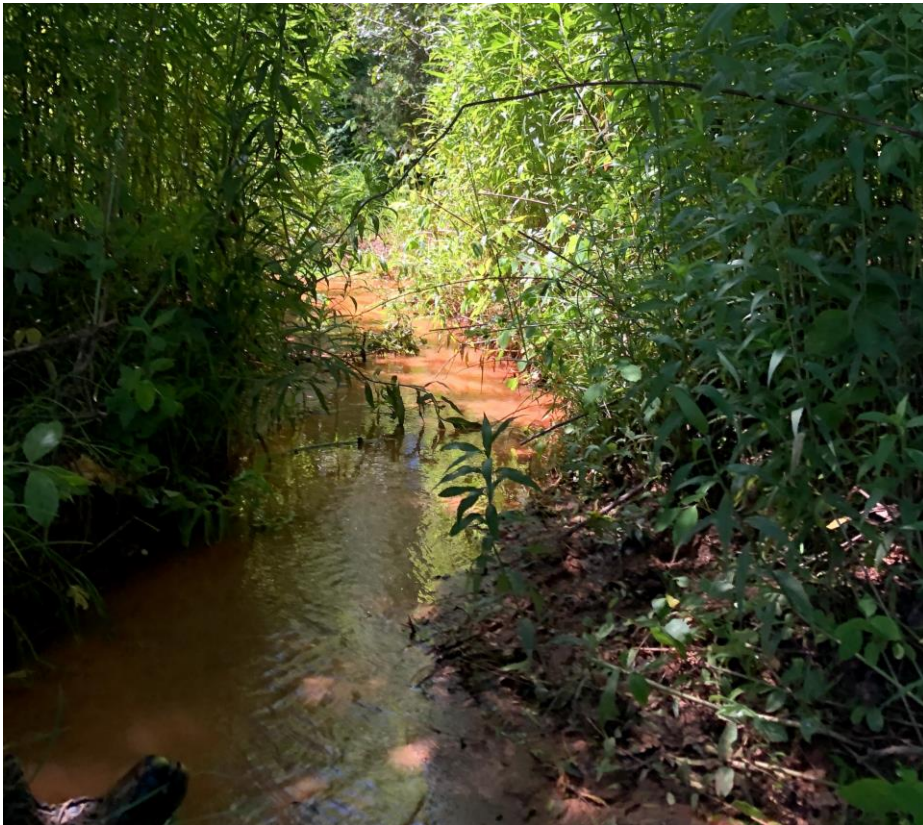
Photo 4. Upstream facing view of Site 2.

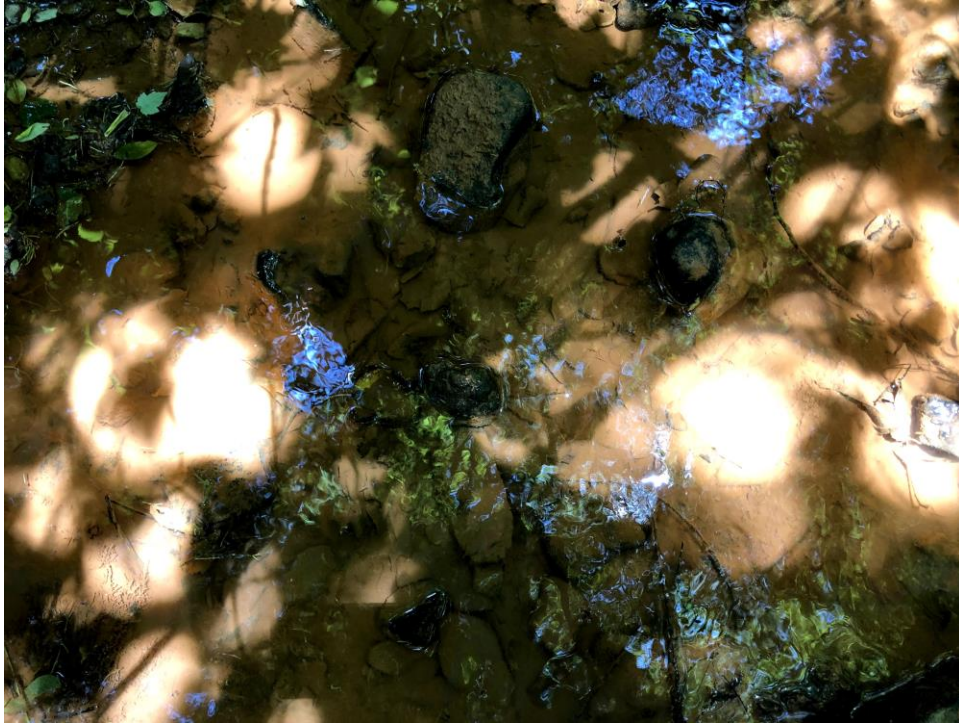
Photo 5. Silt layering bottom substrate observed at Site 2.

Remarks: Significant red clay silt is observed in channel
this is a new development from previous years

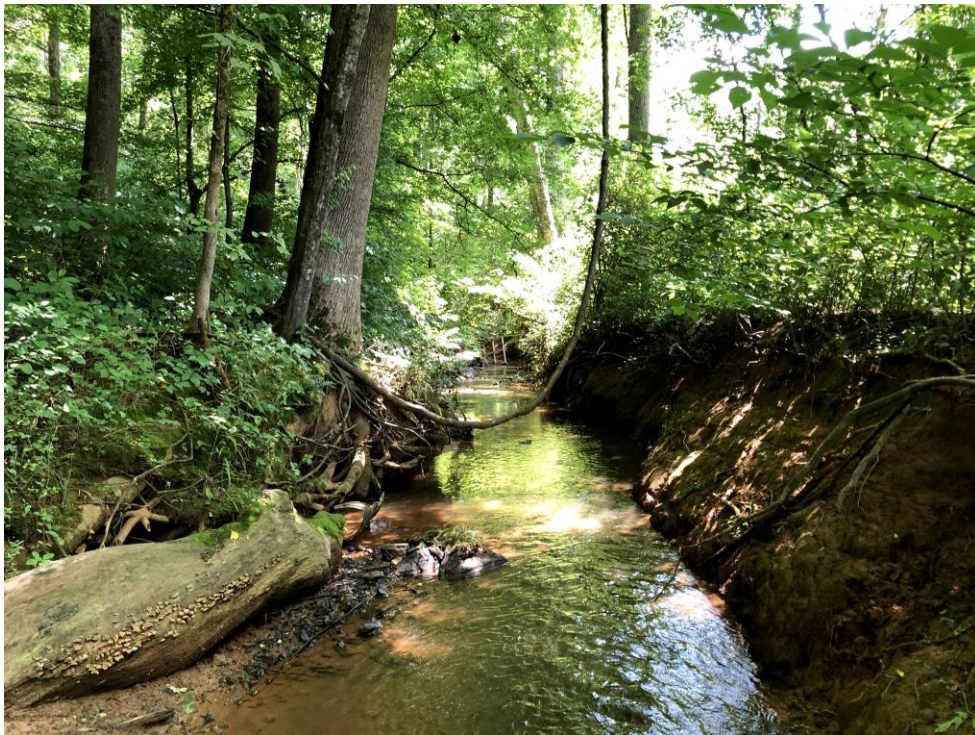
Site 3. Site 3 is the most downstream sampling site, approximately 600 m downstream of Site 2 and just downstream of Interstate 40. The top of bank width was approximately 4 m and stream wetted width ranged from 2 to 3 m. Bank height from the deepest part of the channel to the top of bank was approximately 3 m and stream depth ranged from 0.25 to 0.75 m. The stream banks exhibited severe erosion over much of the survey reach. Flow conditions were normal; the channel was wetted with little to no substrate exposed. Substrate was made up primarily of boulder, cobble, gravel, and sand with some silt present. Instream habitat consisted of a riffle/pool/run sequence (Appendix C, Photos 5 and 6). The riparian buffer was more mature than at the other sites and provided shade throughout the reach, however recent clearing has reduced the width of the riparian buffer on the right descending bank.

Total taxa values ranged between 27 and 36 and EPT Taxa Richness between 6 and 9 at all three sites. Habitat assessment scores in 2021 were similar to scores in 2019. Prior to 2019, there had been overall improvement in habitat assessment scores with the biggest improvement seen from the baseline surveys in 2014 to MY-01 surveys in 2015. During sampling in 2021, both Sites 1 and 2 exhibited moderate to significant siltation within the stream channel. Red silt, most likely erosion from nearby construction, was evident in both reaches. The siltation was not observed or noted in previous years. In fall 2018, the region was hit by damaging flooding associated with Hurricanes Florence and Michael. Sites 2 and 3 exhibited moderate to severe bank erosion first noted in 2019 sampling; the erosion is still present and worsening in portions of Site 3.

Photo 6. Downstream facing view of site 3.

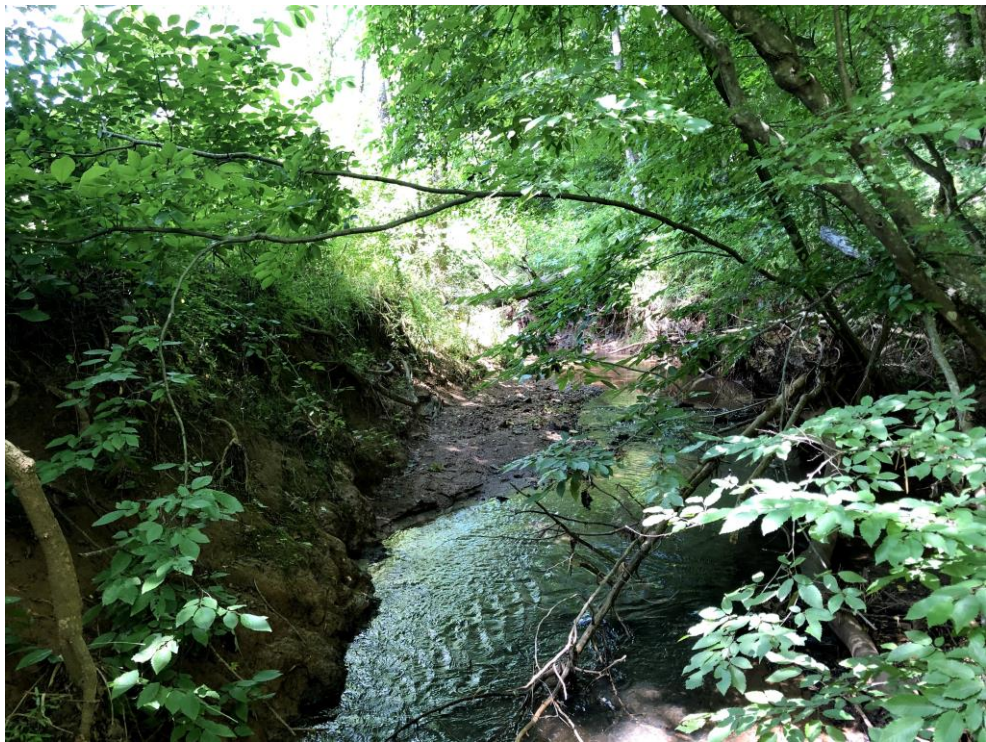
Photo 7. Upstream facing view of Site 3.
