ANNUAL REPORT FOR 2021

Fox Hollow Creek Site #25 Mitigation Site

TIP No. R-2519B

Prepared By:
Roadside Environmental Unit and Environmental Analysis Unit
North Carolina Department of Transportation
September 2021

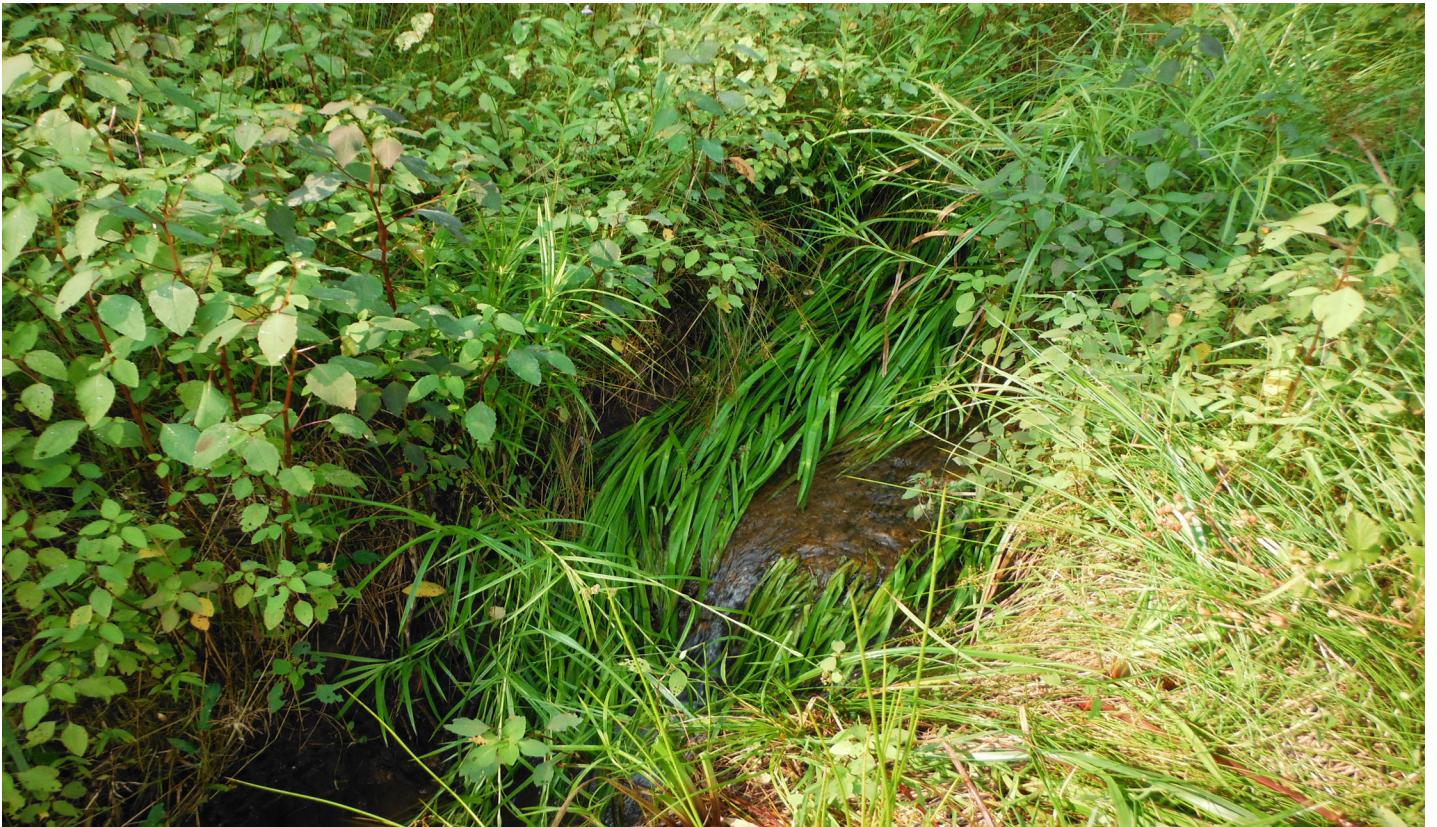
The visual assessment of the stream noted that the channel appears stable with little or no active bank erosion. A headcut was noted approximately 30 feet upstream from the culvert. The headcut had moved approximately 5 feet upstream from the 2020 marked location but this area continues to remain highly vegetated and stable at this time. NCDOT proposes to continue monitoring the channel stability at Site #25 in 2022.

Headcut
