ANNUAL REPORT FOR 2023

Fox Hollow Creek Site #25 Mitigation Site

TIP No. R-2519B

Prepared By:
Roadside Environmental Unit and Environmental Analysis Unit
North Carolina Department of Transportation
October 2023

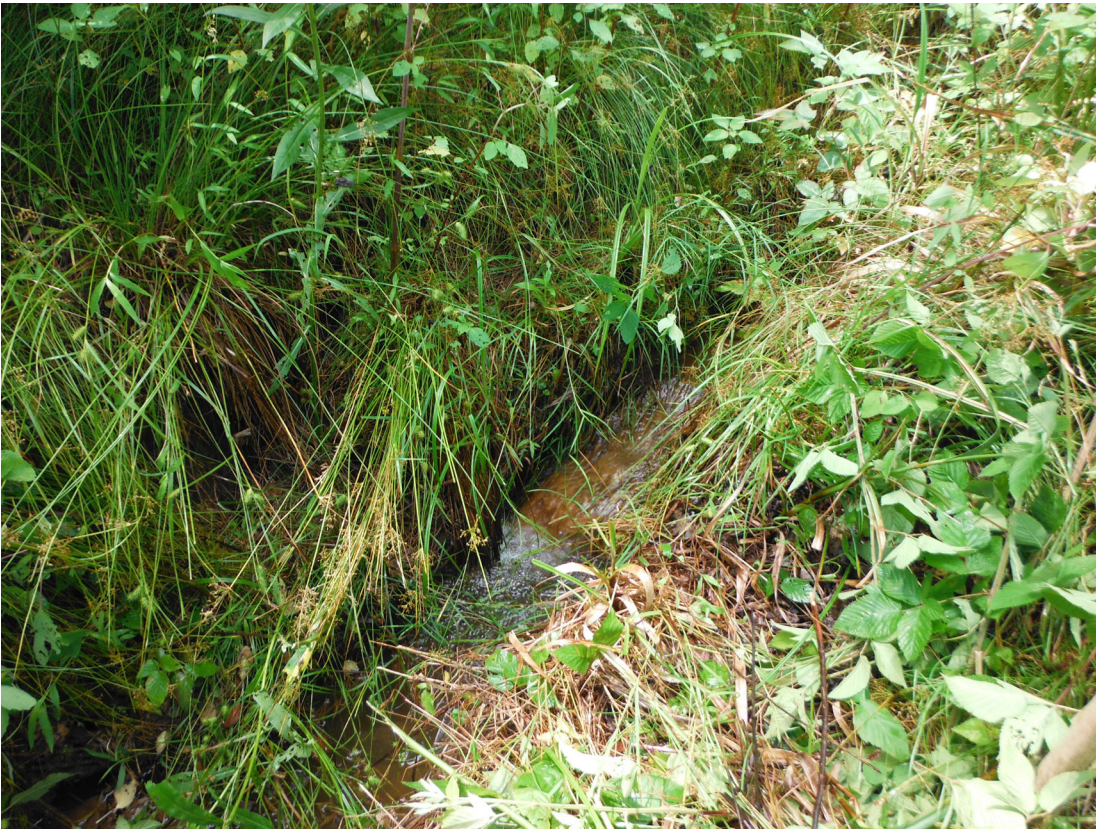
The visual assessment of the stream noted that the channel appears stable with little or no active bank erosion. A headcut previously noted approximately 30 feet upstream from the culvert remains stable at this time with little or no change since last year. The headcut has stabilized at the bedrock within channel. This area continues to remain highly vegetated and stable at this time. NCDOT proposes to continue monitoring the channel stability at Site #25 in 2024.

Headcut
