# ANNUAL REPORT FOR 2023

**Parsnip Branch Site #18 Mitigation Site**

**TIP No. R-2519B**

Prepared By:  
Roadside Environmental Unit and Environmental Analysis Unit  
North Carolina Department of Transportation  
October 2023

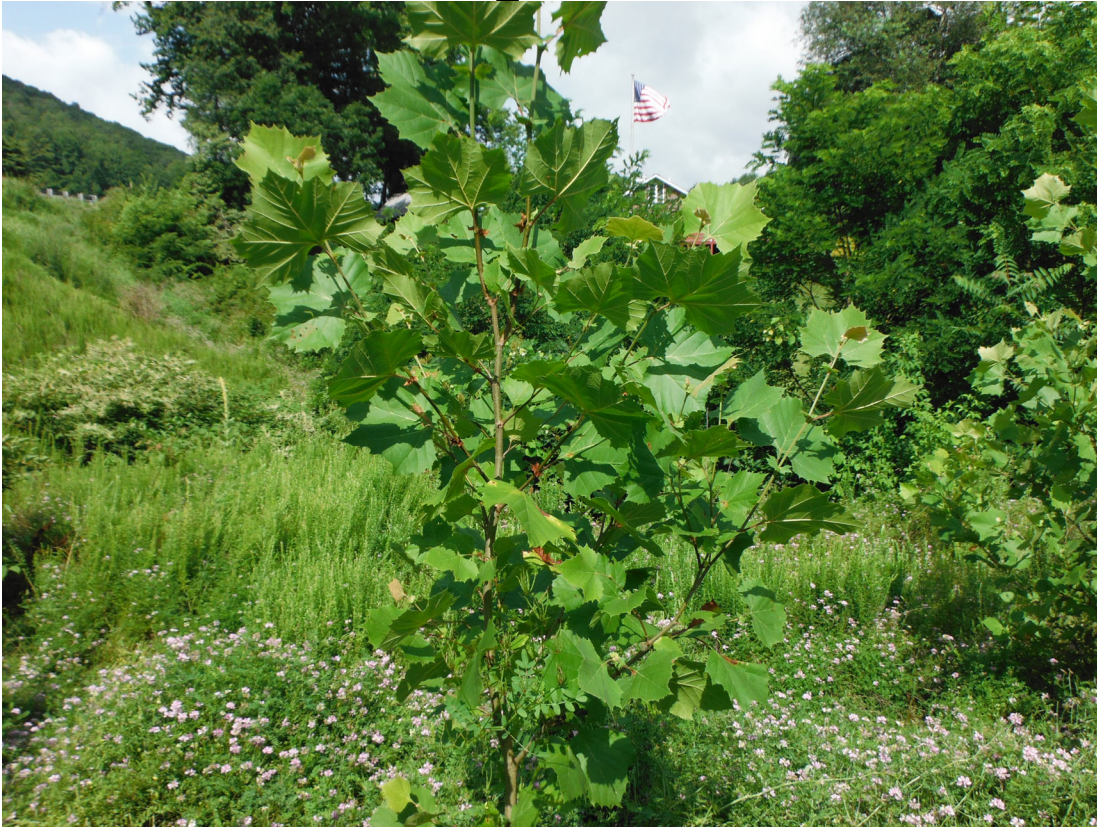
Photo Point #1 looking to the West

The visual assessment of the stream noted that the channel appears stable with little or no active bank erosion. NCDOT will continue to monitor the channel stability at Site #18 in 2024.

**Streambank & Buffer Vegetation:** Visual planted vegetation assessment noted the planted vegetation is surviving at this time. Planted vegetation noted onsite included Yellow Poplar, Sycamore, and River Birch. Japanese Knotweed was noted onsite along the fill slope at the culvert outlet.

NCDOT proposes to continue monitoring the planted vegetation and to spray invasive species at Site #18 in 2024.
