ANNUAL REPORT FOR 2023

UT to Brushy Creek Site #33 Mitigation Site

Mitchell County

Prepared By:
Roadside Environmental Unit and Environmental Analysis Unit
North Carolina Department of Transportation
October 2023

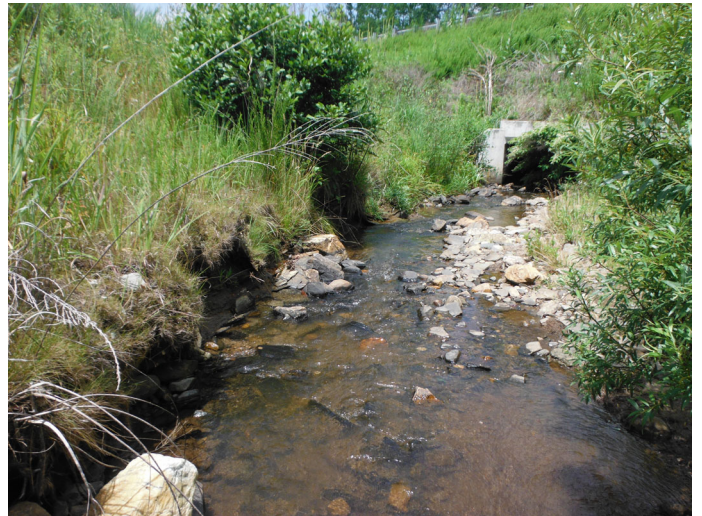
Photo Point #2 (Downstream)

The visual assessment of the stream noted that the channel appears stable with little or no active bank erosion. Minor bank scouring previously noted along the left bank downstream of Photo Point #2 showed little to no change since last year. NCDOT will continue to monitor the channel stability at Site #33 in 2024.
