ANNUAL REPORT FOR 2021

UT to Brushy Creek Site #35 Mitigation Site

Mitchell County

TIP No. R-2519B

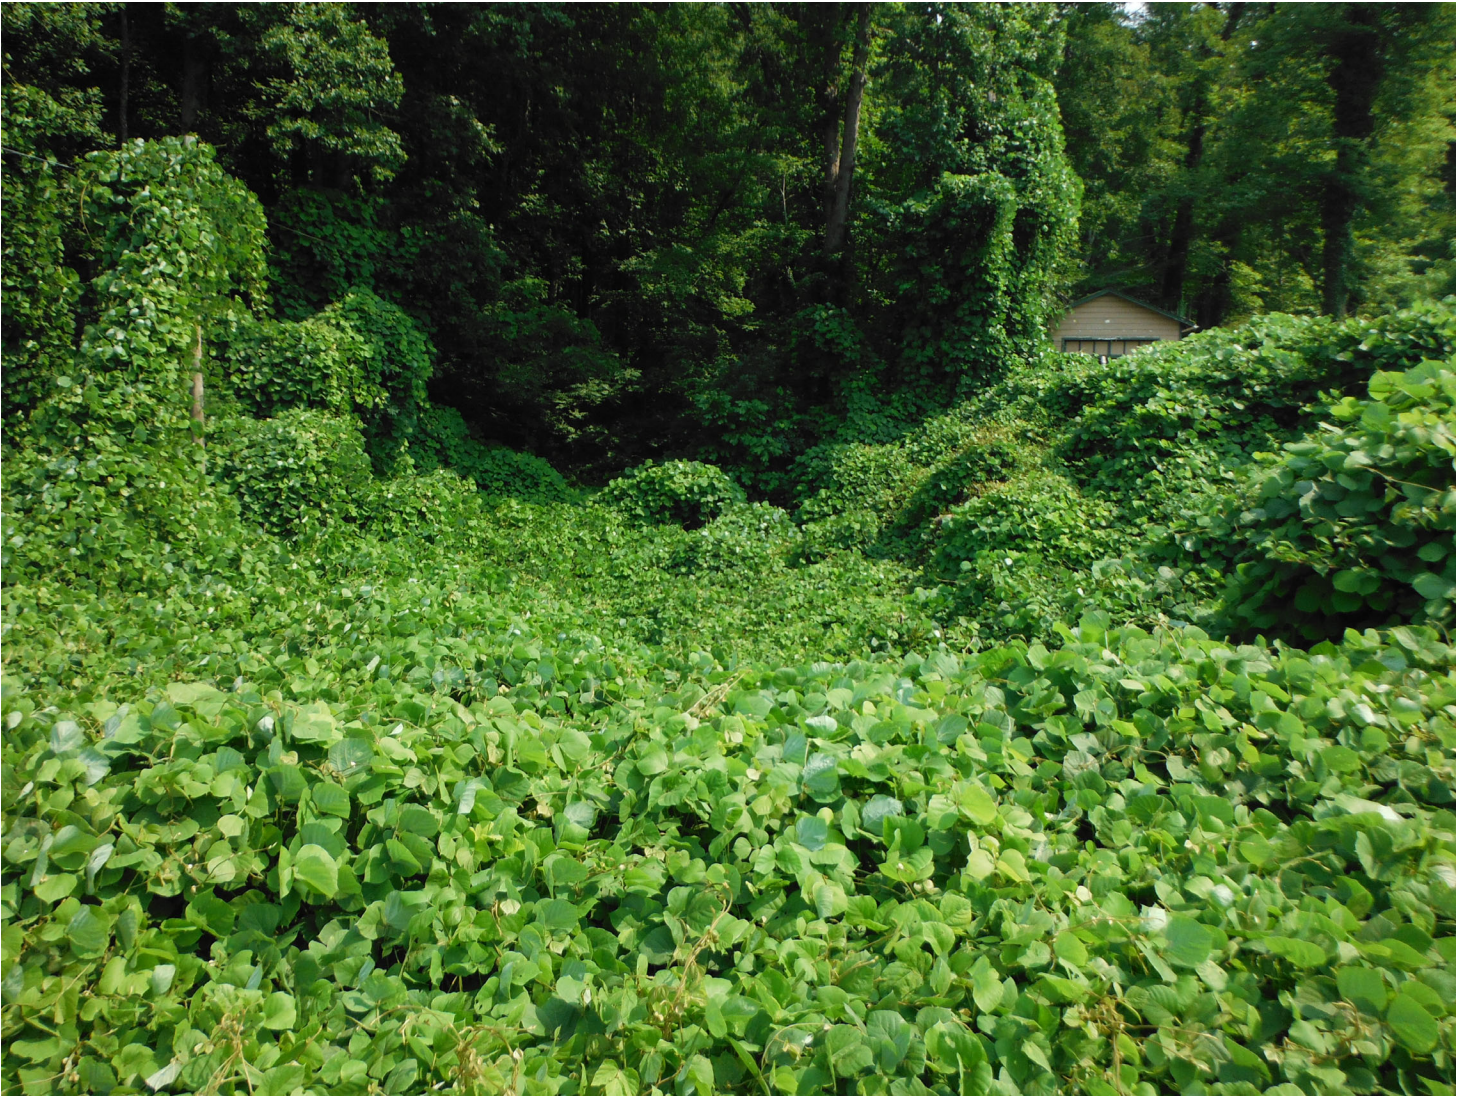
Photo Point #1 (Upstream)

Streambank & Buffer Vegetation: Visual planted vegetation assessment noted no planted vegetation is surviving at this time. The site is covered in kudzu and the surrounding area outside of NCDOT's right-of-way is also covered in kudzu.

The UT to Brushy Creek Site #35 Mitigation Site has not met the required monitoring protocols for the second formal year of monitoring. The channel throughout the stream site is covered in kudzu.

NCDOT proposes to abandon this site due to the kudzu infestation. NCDOT plans to do a permit modification for the UT to Brushy Creek Site #35 Mitigation Site at the end of the five-year monitoring period.
