ANNUAL REPORT FOR 2020

Turner Street Marsh Mitigation Site

TIP #: R-3307

Prepared By:
Roadside Environmental Unit & Environmental Analysis Unit
North Carolina Department of Transportation
September 2020

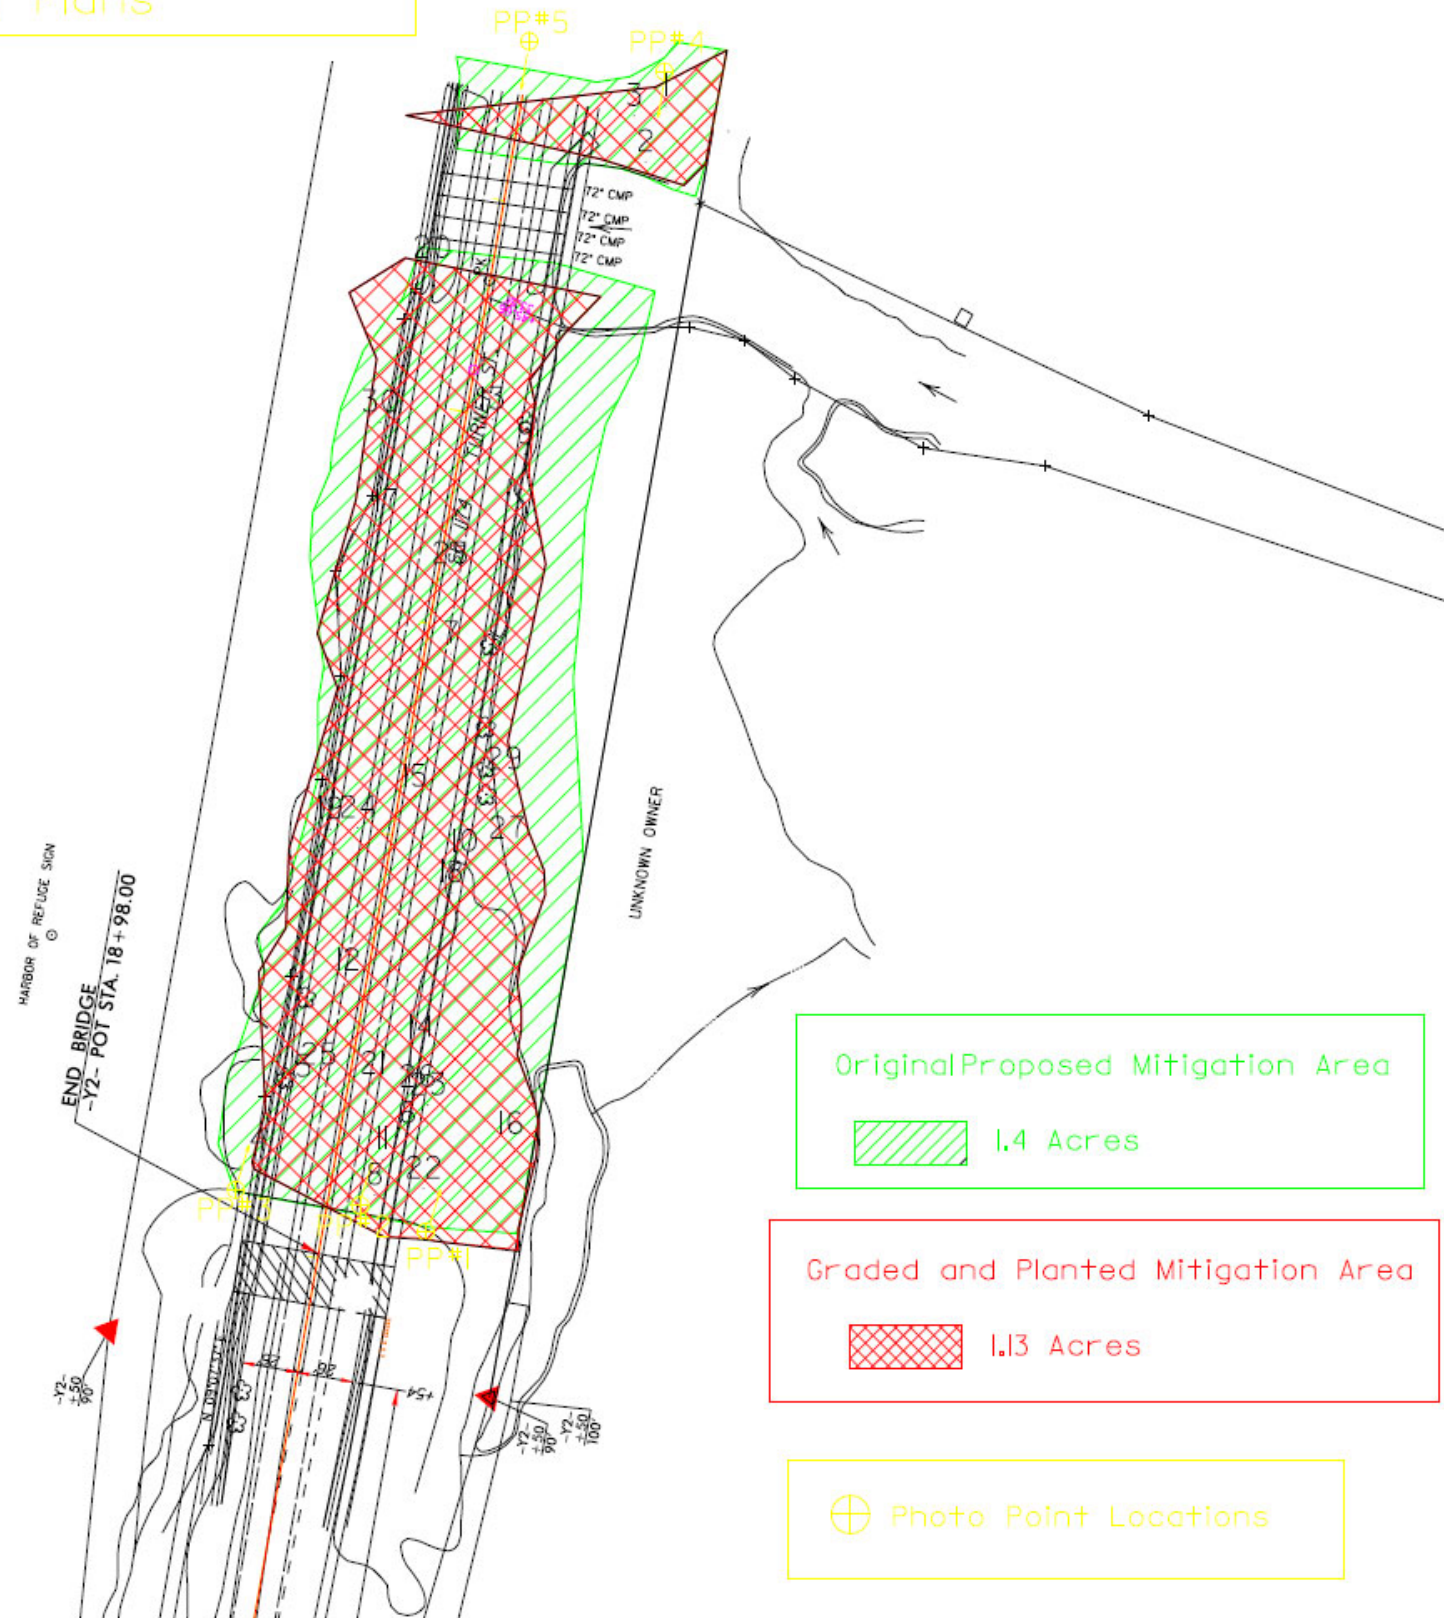
R-3307 Turner Street Mitigation
As-Built Plans

Original Proposed Mitigation Area
1.4 Acres

Graded and Planted Mitigation Area
1.3 Acres

⊕ Photo Point Locations
