# ANNUAL REPORT FOR 2023

**U-2579BA Smith Creek**  
**Forsyth County**  
**TIP No. U-2579BA&B**  
**USACE Action ID: SAW-2008-03183**  
**DWR Project #: 20140090 v7**

Prepared By:  
Environmental Analysis Unit & Roadside Environmental Unit  
North Carolina Department of Transportation  
December 2023

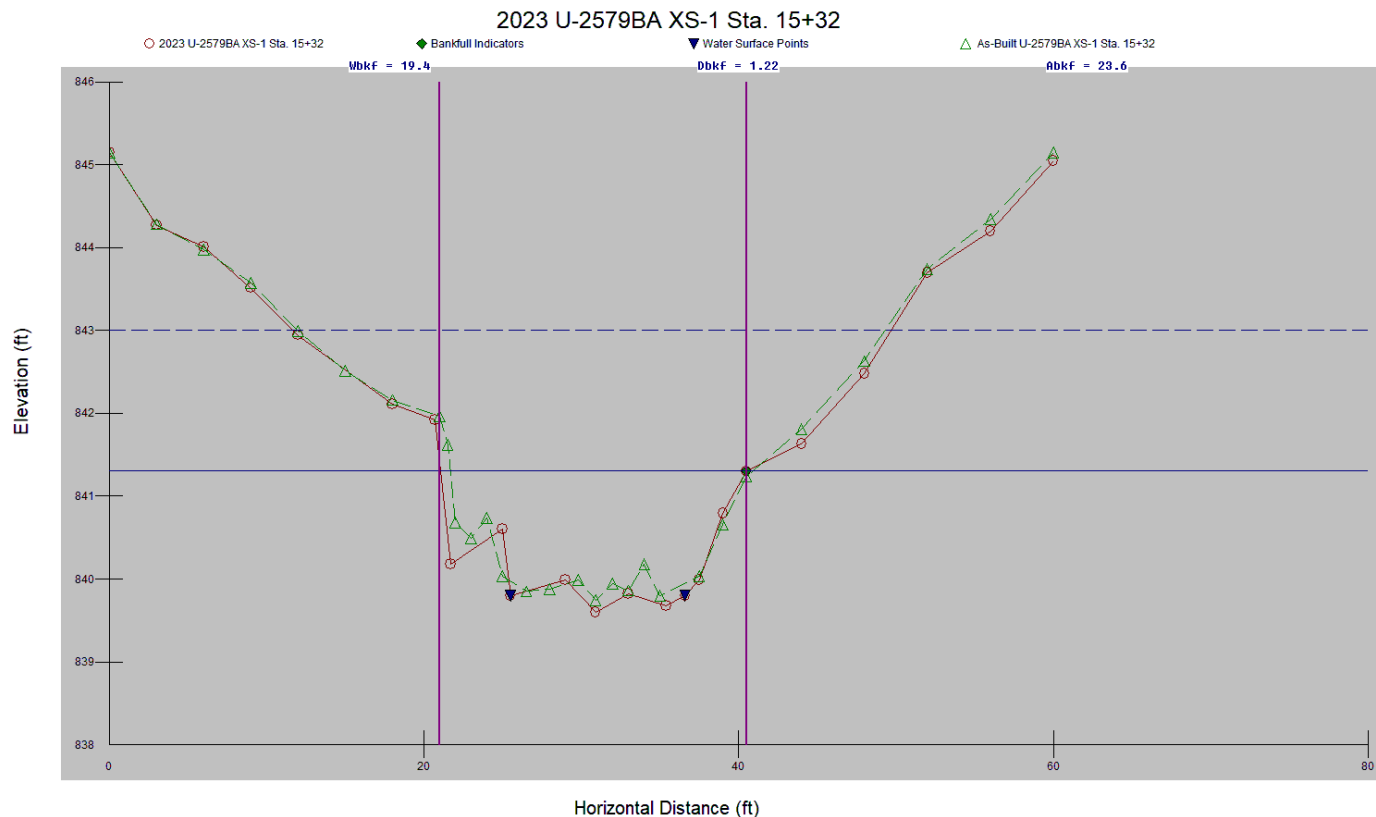
Based on visual assessment and comparisons of the as-built, MY1 (2023), the riffle cross sections are all stable and within expected thresholds for a C5 type stream. Sediment level in the pools is fluctuating as the stream is actively conveying sediment through the system. Pebble counts were not required per the permit conditions and therefore were not completed. The longitudinal profile survey was conducted from Sta. 09+25 through 30+25, stopping at the approximate limits of DOT ROW.

U-2579BA Smith Creek (Fishponds): Cross-Section #1 (Riffle) Abbreviated Morphological Summary						
Variable	As-built	MY1 (2023)	MY2 (2024)	MY3 (2025)	MY4 (2026)	MY5 (2027)
Width of the Floodprone Area (ft)	34.83	38.0				
Bankfull Width (ft)	18.8	19.4				
Entrenchment Ratio	1.85	2.0				
Bankfull Mean Depth (ft)	1.09	1.2				
Maximum Bankfull Depth (ft)	1.5	1.7				
Width/Depth Ratio	17.25	15.9				
Bankfull Cross Sectional Area (ft <sup>2</sup> )	20.53	23.6

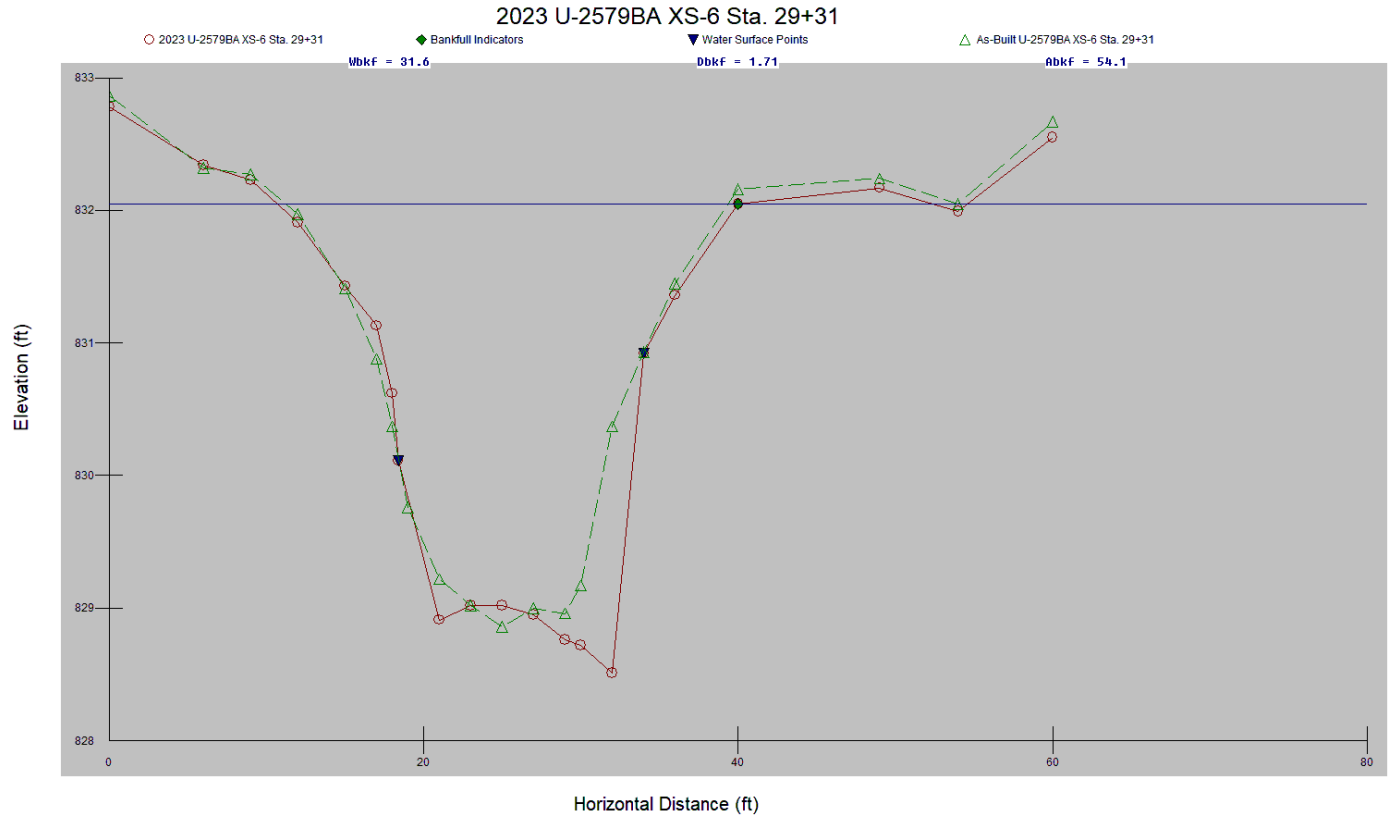
U-2579BA Smith Creek (Fishponds): Cross-Section #6 (Pool) Abbreviated Morphological Summary						
Variable	As-Built	MY1 (2023)	MY2 (2024)	MY3 (2025)	MY4 (2026)	MY5 (2027)
Bankfull Width (ft)	33.9	31.6				
Bankfull Mean Depth (ft)	1.6	1.7				
Maximum Bankfull Depth (ft)	3.3	3.5				
Bankfull Cross Sectional Area (ft <sup>2</sup> )	52.4	18.5

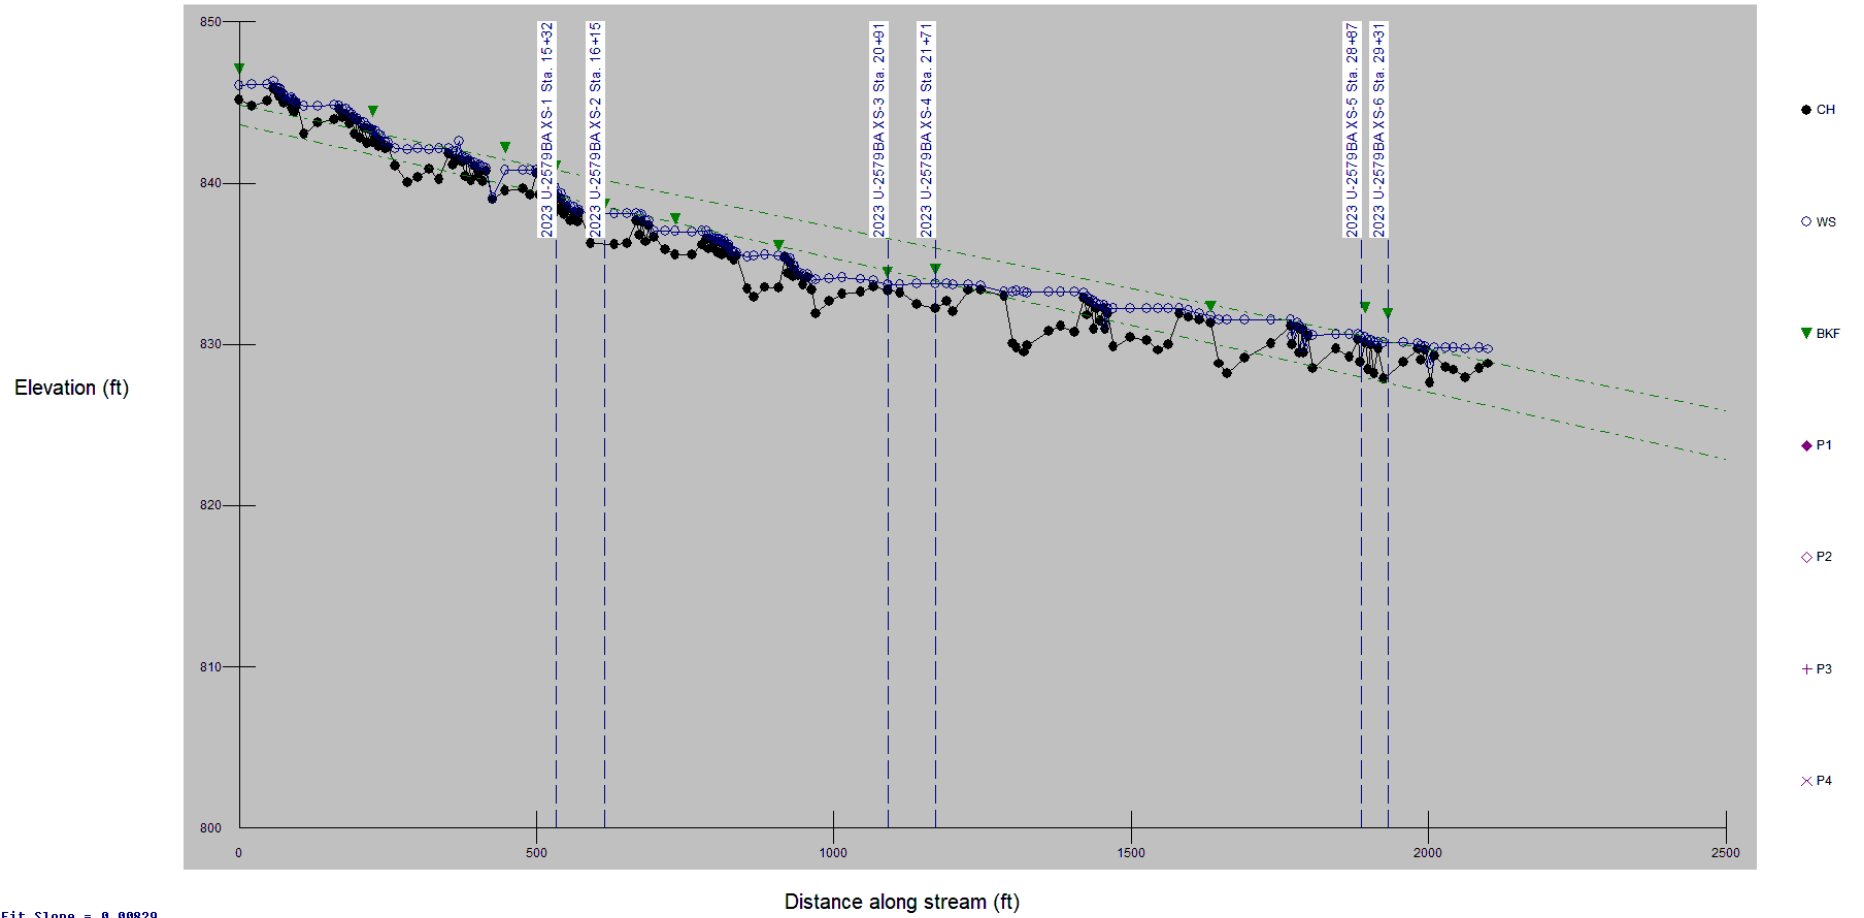
# Longitudinal Profile 2023 - U-2579BA (Fishponds)

CH Best Fit Slope = 0.00829  
BKF Best Fit Slope = 0.00758

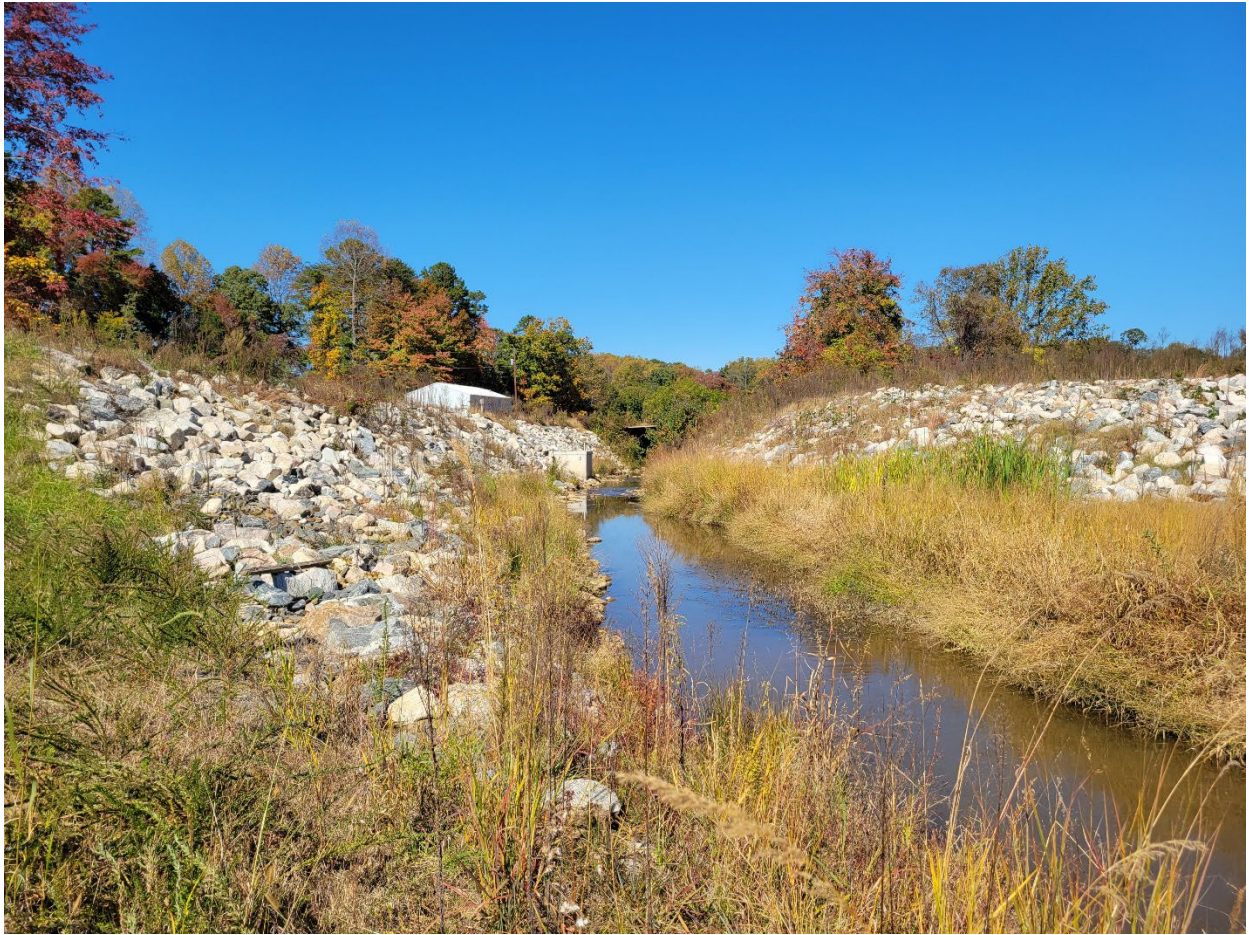
Overview of Main Channel end with Pump Basin

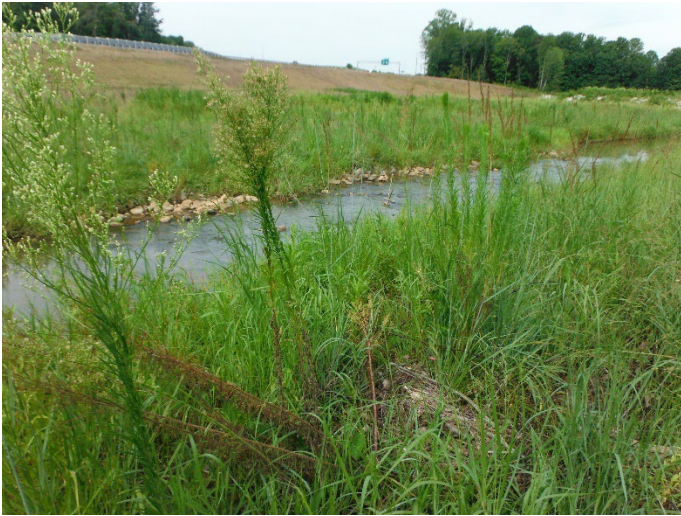
There was evidence of at least one bankfull event having occurred during the 2023 monitoring year by presence of matted vegetation and wrack lines. NCDOT will continue stream monitoring in 2024.

Wrack line upstream of PP#4

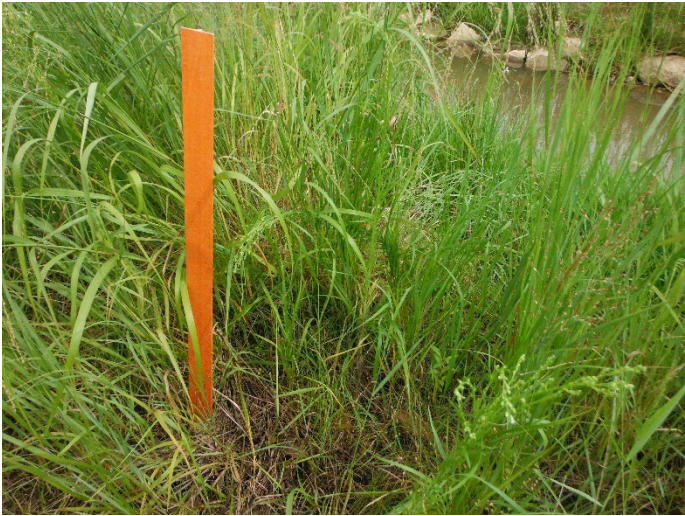
Wrack line at PP#5
