North Carolina Department of Transportation &  
North Carolina Wildlife Resources Commission  
**Wildlife Passage Guidance**

*I-140 Brunswick County*

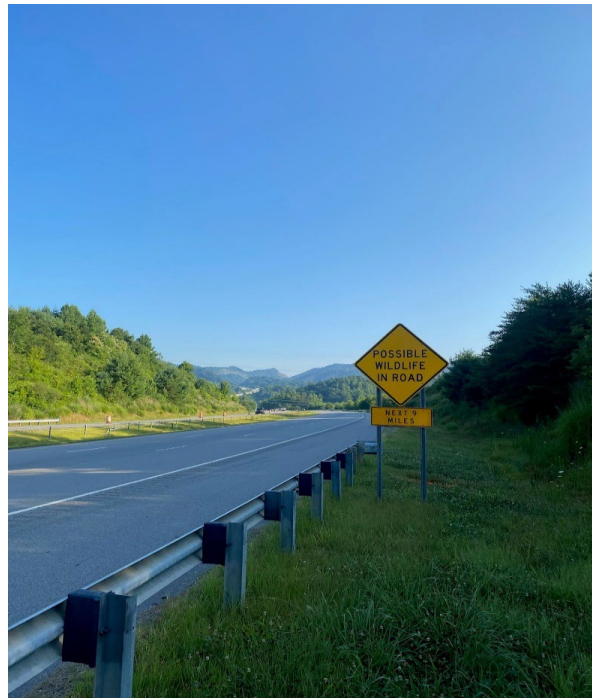
Figure 1 Wildlife warning on I-26 West, Madison County.

NCDOT and NCWRC are continually improving the collection of wildlife-vehicle mortality data to help assess the need for warning signs, crossing structures, fencing, and other mitigative efforts (Figure 1). Reported animal-vehicle collision (AVC) data are available and may support mitigation measures for some projects<sup>1</sup>. North Carolina had over 20,000 reportable AVCs including four fatalities in 2022, (NCDOT 2020-2022). The estimated comprehensive crash costs for all of North Carolina's 2022 AVC is \$486,000,000 (based on NC Standardized Crash Cost 2022). Carcass removal data from other states has documented actual AVC occurrences more than five times greater (in Utah study) and nine times greater (in Virginia study) than the accident-reported AVC numbers (Olson, 2013; Donaldson & Lafon, 2008). Applying the most conservative correction factor to reportable AVC suggests there are closer to 100,000 large AVC occurring annually in North Carolina.

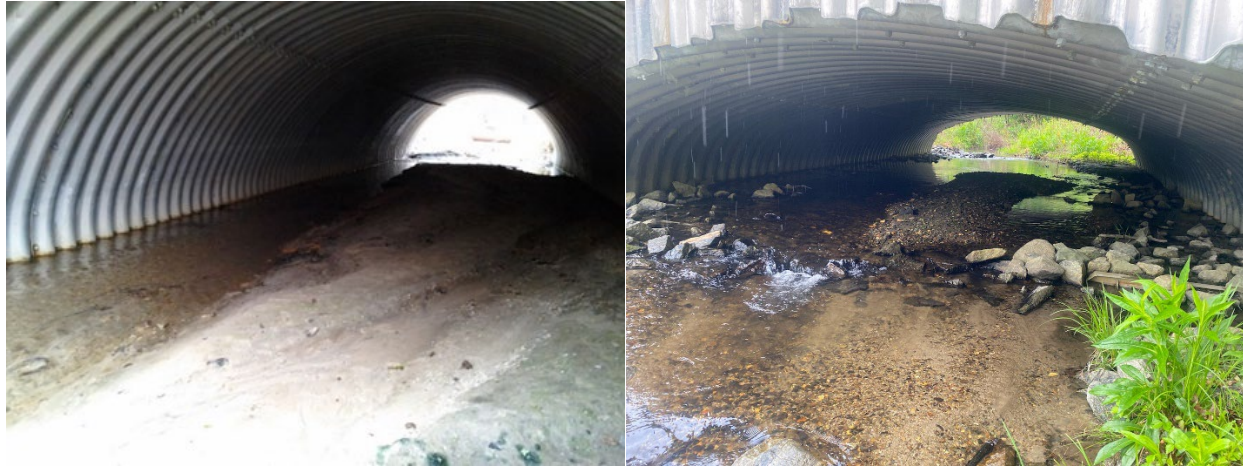
*Figures 2 and 3. Wide corrugated metal pipe (Wayne County, SR 1300, Unnamed Tributary) retaining bedload (left) and aluminum box culvert (Transylvania County, #870163, North Prong Glade Creek) with notched sills and baffles buried by bedload (right, note partially exposed sill in photo right).*

4. Rip rap used for floodplain benching and as backfill inside dry culvert barrels should be topped with native streambed/floodplain material to reduce roughness and rip rap voids that can deter wildlife use. (Figures 3 and 14). This is consistent with current NCDOT Guidelines for Drainage Studies and Hydraulic Design. Exceptions may include stream systems with heavy sediment loads, such as urban streams, that will fill in rip rap voids quickly during flood events. The construction engineer and environmental staff should approve all materials used.

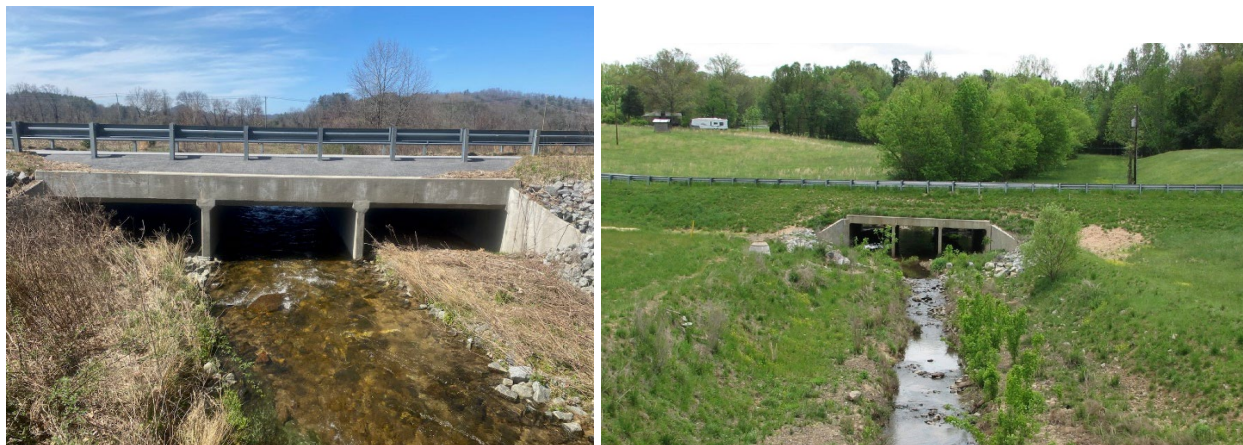
*Figures 4 and 5. Benching into box culvert (left, Transylvania County, #870012, Hogsed Creek) and benching with bank sloping (right, Mecklenburg, I-485 vicinity, unnamed tributary).*

for terrestrial wildlife; these would supplement the hydraulic design capacity and help to maintain the stream's baseflow channel dimensions for aquatic passage through the primary barrel(s) (Figures 4 and 5).

Floodplain or approach benches must be constructed to transition high-flow culvert barrels or dry benching in or under single pipes, boxes, or bridges, into the stream banks upstream and downstream of the structure (Figures 4 and 5). This will encourage wildlife use by creating unobstructed habitat connectivity under the roadway. Bank sloping may be required on incised stream channels to transition the floodplain or lower dry ground elevation down to the bench elevations (Figure 4).

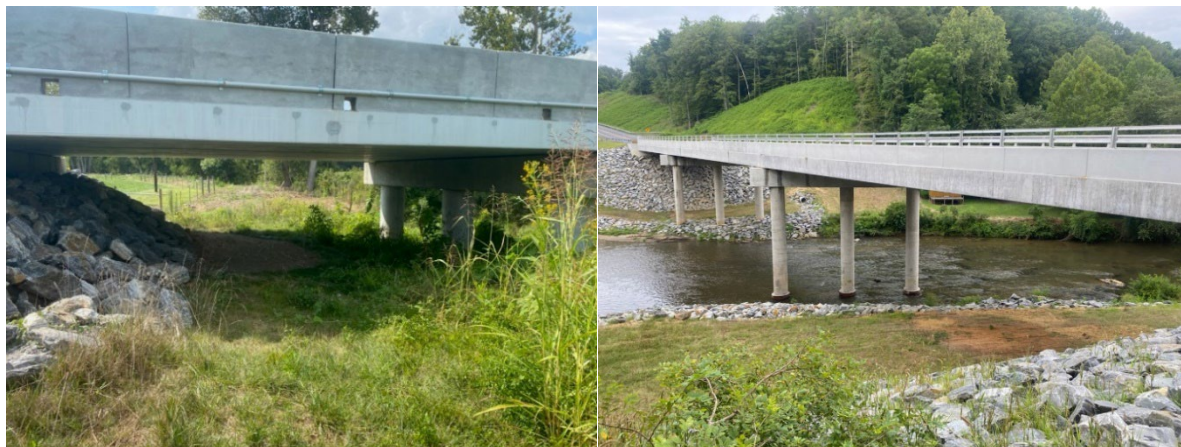
Figures 7 and 8. Unarmored floodplains under bridge in Iredell County (left, #480212, Patterson Creek) and large bridge in Stokes County (right, #840008, Dan River).

1. Avoid the use of rip rap under new bridges if not needed for scour protection or slope stabilization (Figures 6-8). Unarmored stream banks under bridges often remain stable without matting or any stabilizing treatments (observations by NCWRC and NCDOT staff). Some situations such as a sharp channel meander may warrant armoring the outside of the meander while leaving the opposing bank unarmored to allow unobstructed wildlife passage.

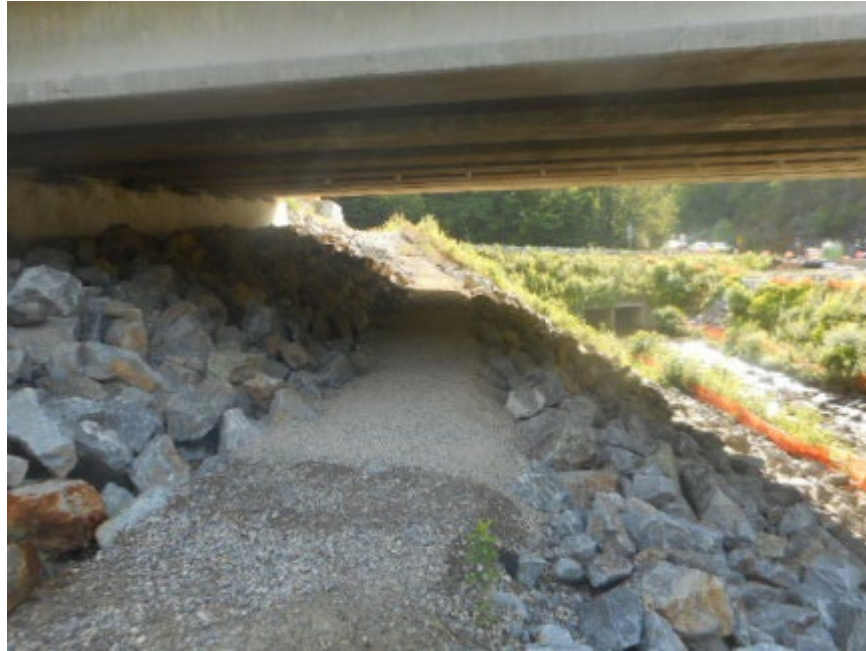
Figure 10. Wildlife pathway or "bench" as built from Figure 9.

2. Where plating is used, incorporate a rip rap-free area in the excavated slopes, or construct a path over the rip rap using aggregate, coarse stone, or floodplain material that eliminates voids and creates a flat surface (Figures 9, 10, and 11). (Note, topping treatments are not expected to be maintained post-construction due to access limitations. The fine materials will often accumulate over time naturally due to sediment deposition during floods.)

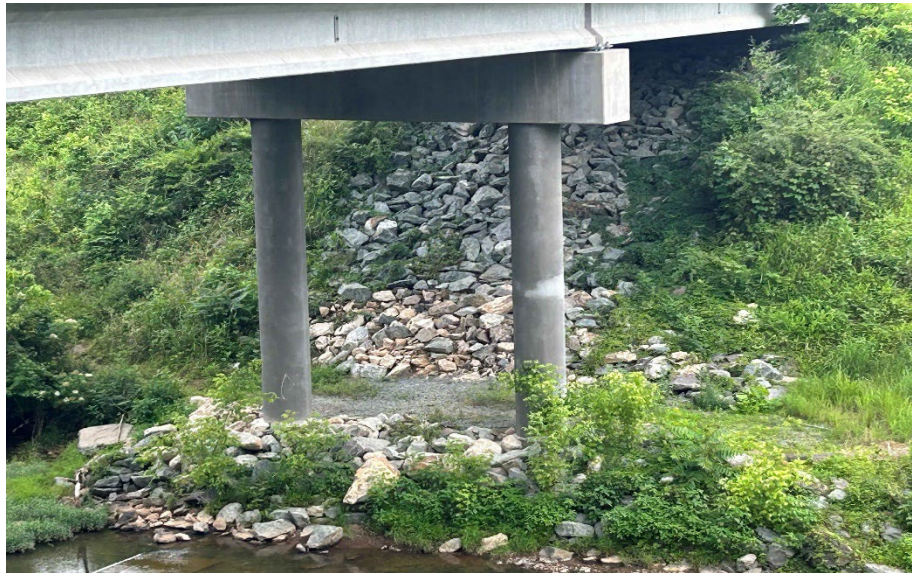
Figure 11 Eno River bench, Orange County, NC.

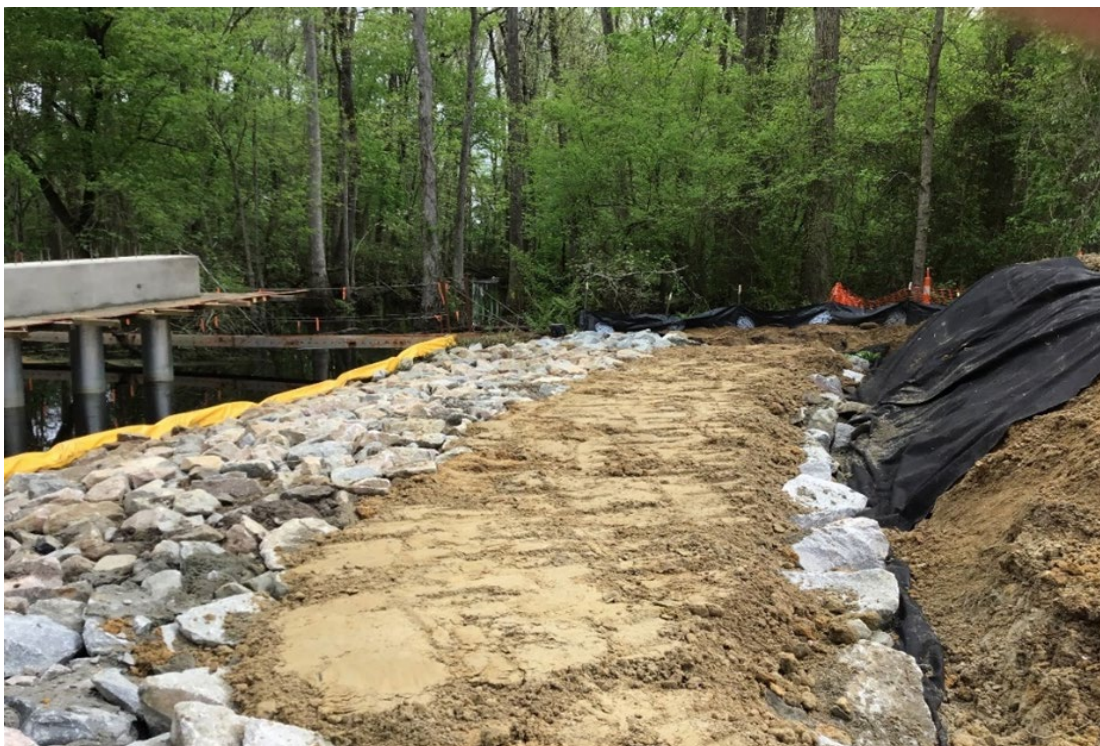
Figure 13. Construction of bench over embedded rip rap (Edgecombe County, # 320113, Otter Creek).

3. Where possible, rip rap should be keyed-in or embedded below grade before overfilling with native material or aggregate, as approved (Figures 12 and 13).

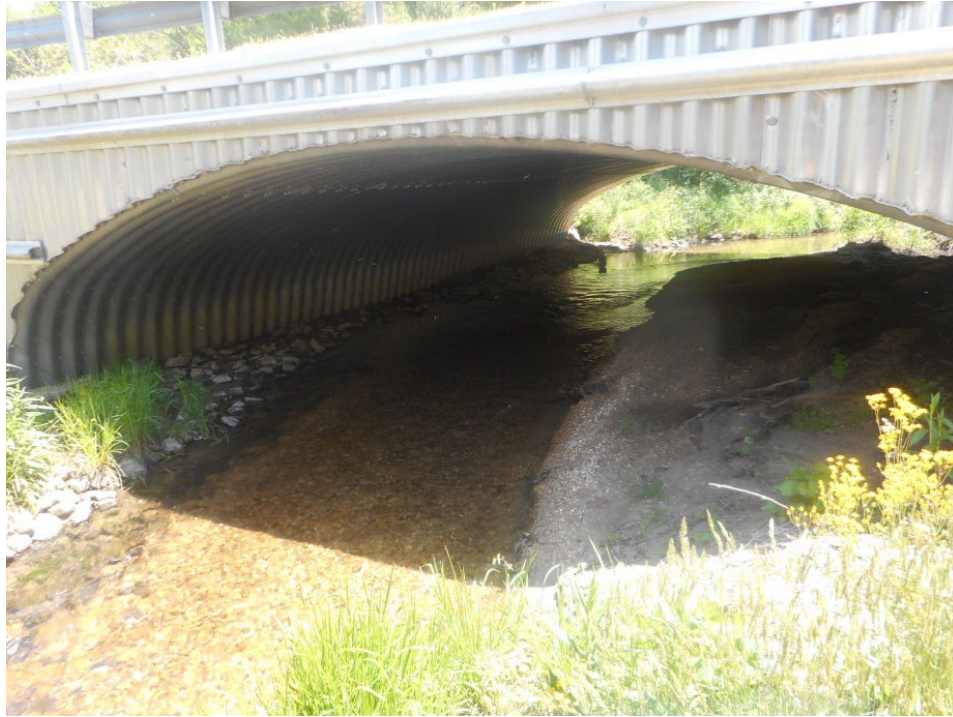
Figure 14. Native material backfilled over rip rap in aluminum box culvert (Henderson County, #440073, Greer Creek).

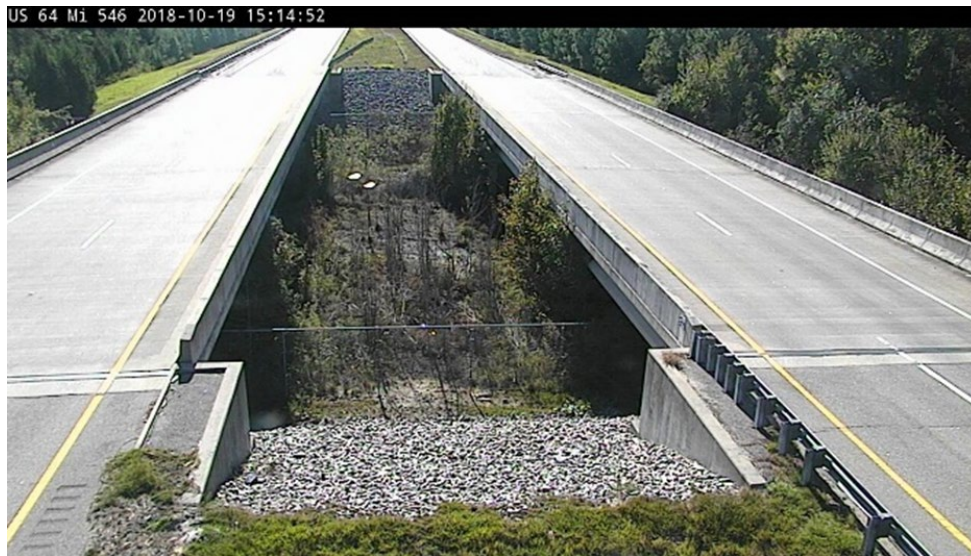
Figure 15. Wildlife underpass on US 64 in Washington County.

There are several dedicated wildlife crossing structures in North Carolina with different designs and objectives. Large wildlife crossing structures can be overpasses or underpasses that allow wildlife to travel over/under the roadway using a grade-separated bridge or culvert (Figures 15 and 16). North Carolina has constructed several successful wildlife underpasses that provide habitat connectivity for a full range of wildlife species. By contrast, site-specific or species-specific crossings will typically cover a much smaller area and may only utilize small crossing structures (Figure 17). Structures intended to promote ecological connectivity should provide both the ability to pass large mammals as well as small mammals, reptiles, and amphibians. Connectivity projects will often include multiple structures providing better habitat connectivity and conservation value, particularly for small and/or range-limited species.

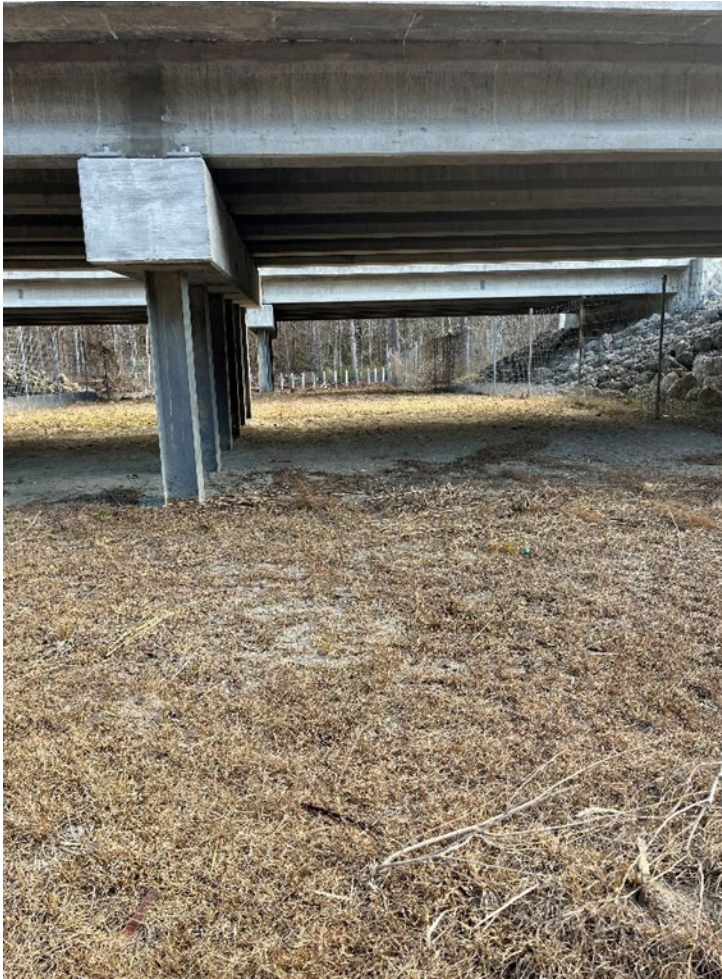
*Figure 16. Wildlife underpass on US 17 in Jones County for connecting habitat for a range of species.*

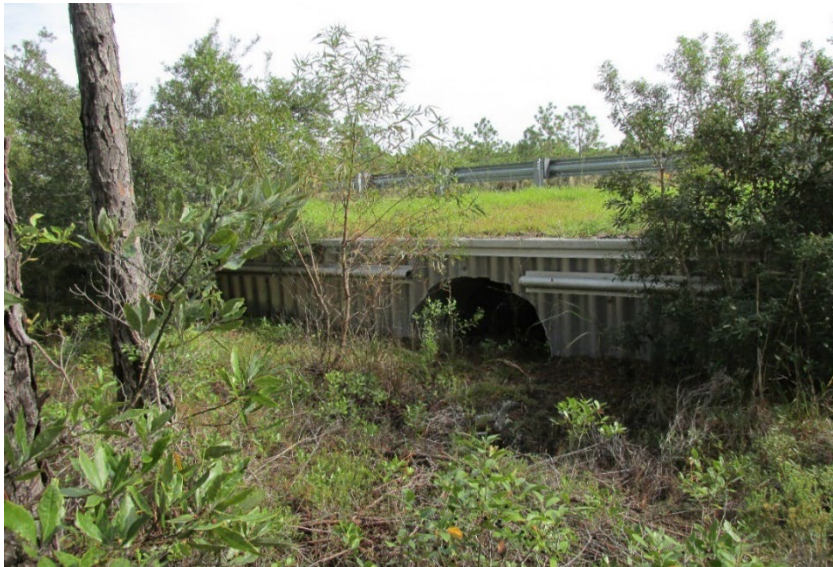
*Figure 17. Culvert designed for small and medium animal passage on EF Middleton Blvd. Brunswick County.*

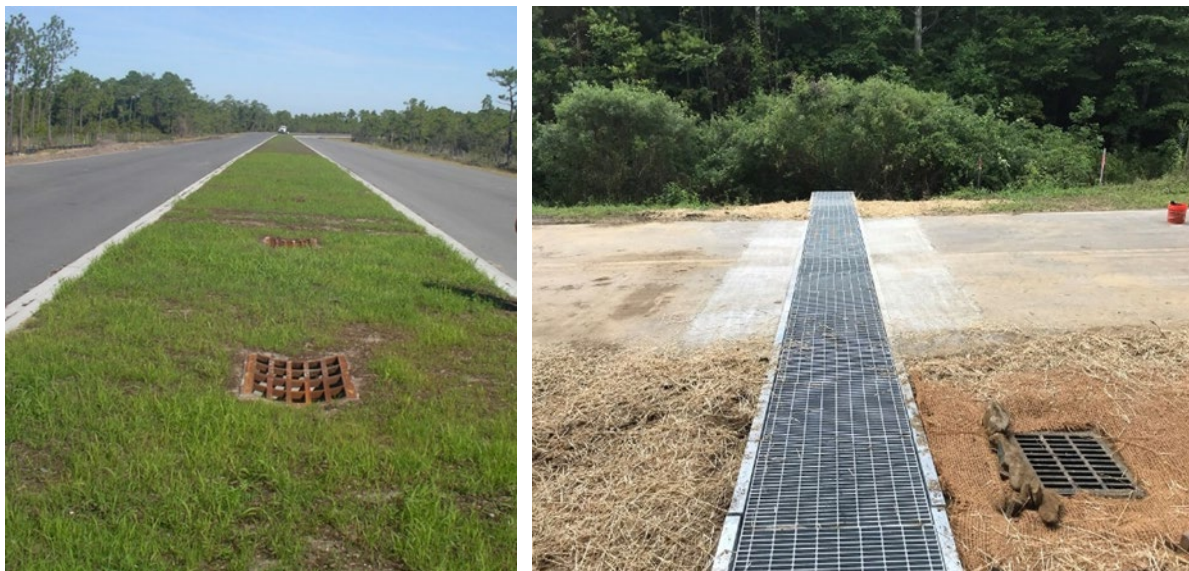
Figures 20 and 21. Grate in median of wildlife culvert, EF Middleton Blvd Brunswick County (left) and open grate crossing Ashe County.

1. Align culverts to provide a clear line of sight through the structure (Figure 19)
2. Backfill culverts with a natural substrate.
3. Incorporate grates in the culvert to allow light and acclimatization to outside conditions (Figure 20)
4. Elevate grates and properly grade culvert approaches to prevent concentrated stormwater from entering the crossing structure. In some cases, specialized crossing structures such as full open grate structures may be necessary to effectively provide wildlife passage (Figure 21).

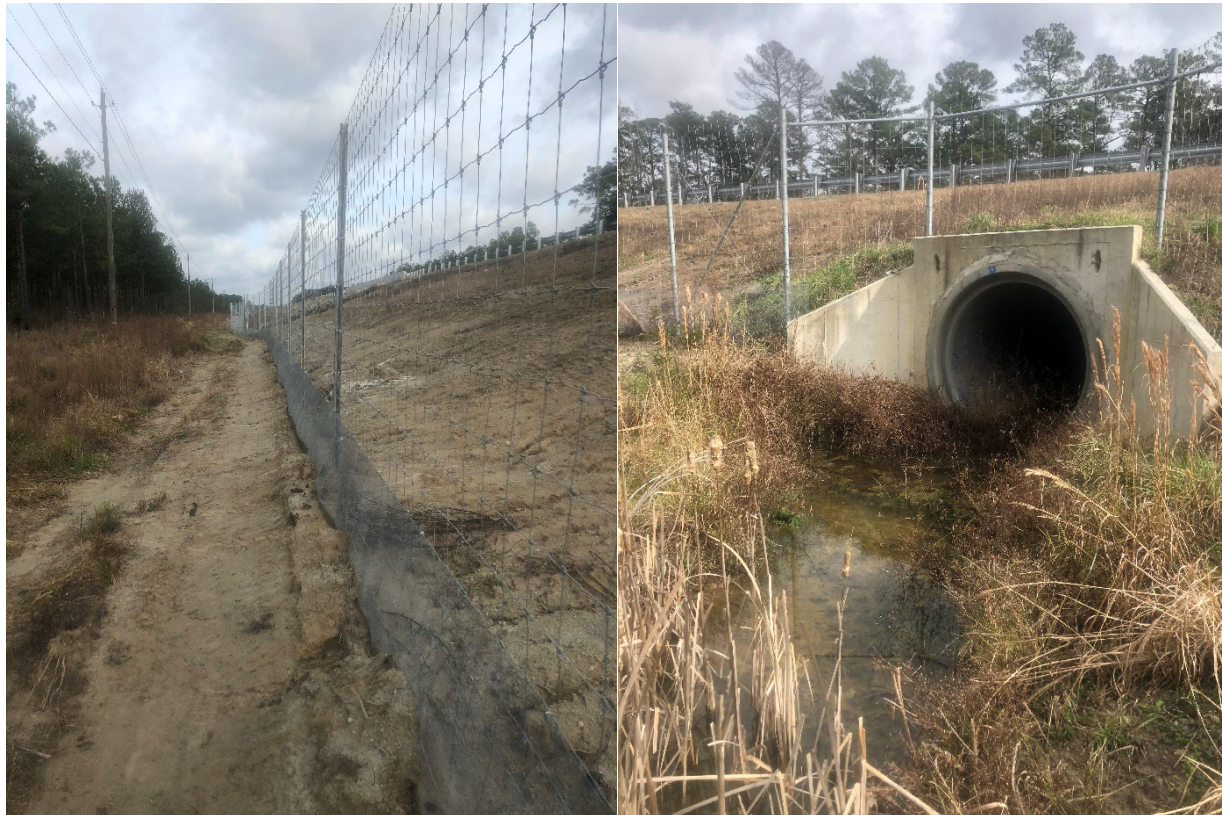
Figures 23 and 24. Woven-wire wildlife fence run (left) and tie into crossing structure (right). US 17 Jones County
