Figure 2. Hydrological gauge transects and vegetation plot locations.

Land Management Group, Inc.
 Environmental Consultants
 Wilmington, N.C.
 December 2004

The Eagle Brunswick Tract
 Wilmington Bypass Project
 Brunswick County, NC
 Year Four Monitoring Report

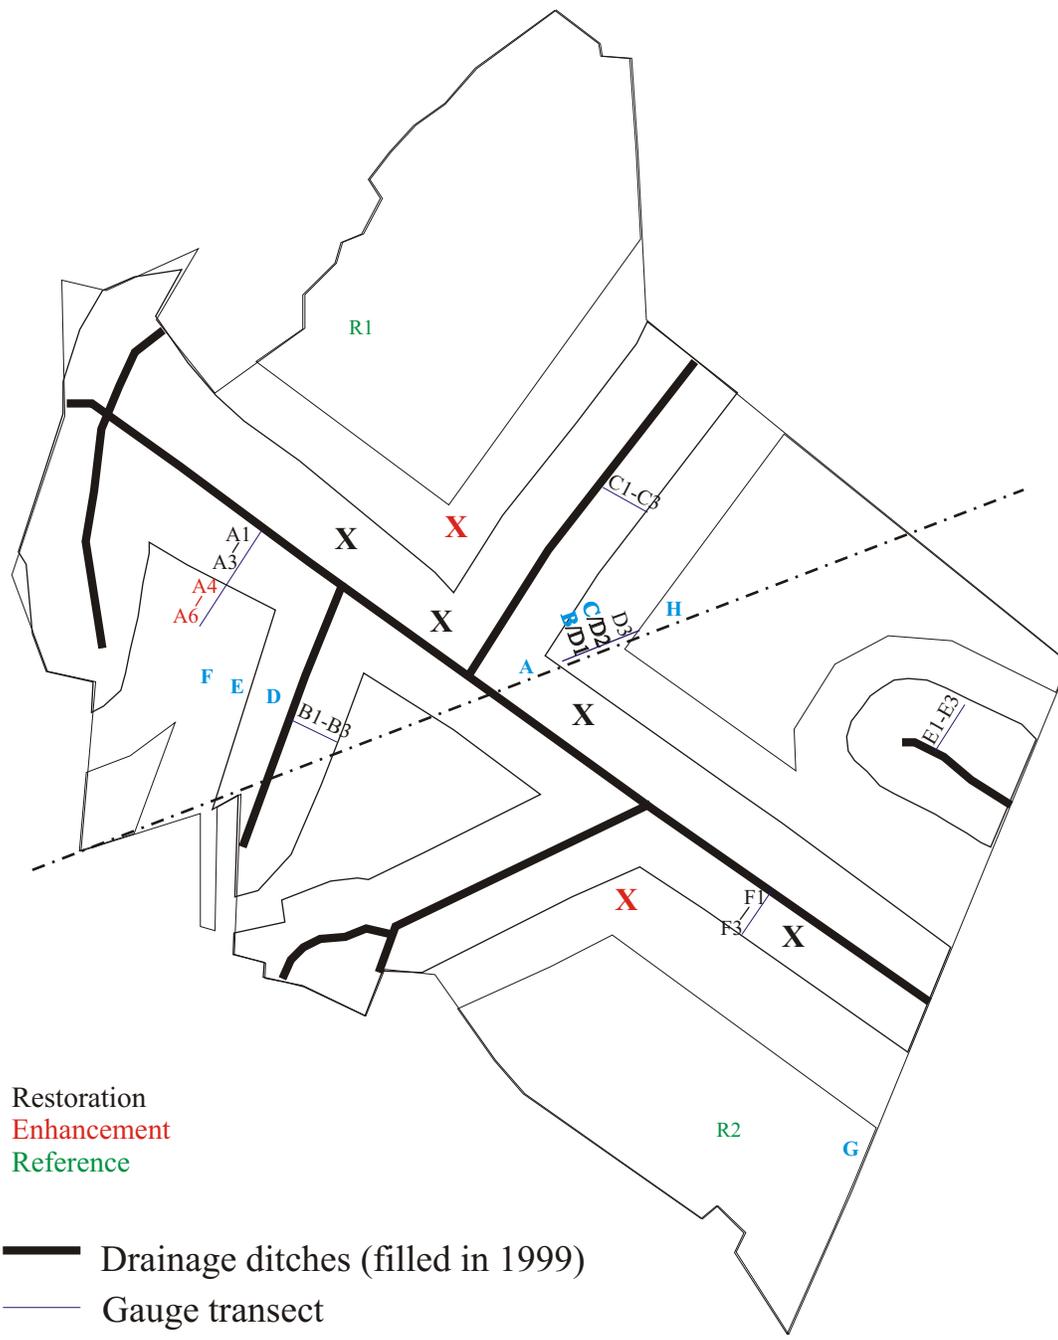
- Restoration
- Enhancement
- Reference
- Drainage ditches (filled in 1999)
- Gauge transect
- - - - Power line corridor
- X Vegetation monitoring plot
- A Pre-project monitoring gauges

Note: Gauges D1 and D2 are in the same location as pre-project gauges B and C.
