ANNUAL REPORT FOR 2006

**Stella Bridge Mitigation Site
Onslow County
TIP No. B-2938**

Natural Environment Unit & Roadside Environmental Unit
North Carolina Department of Transportation
December 2006

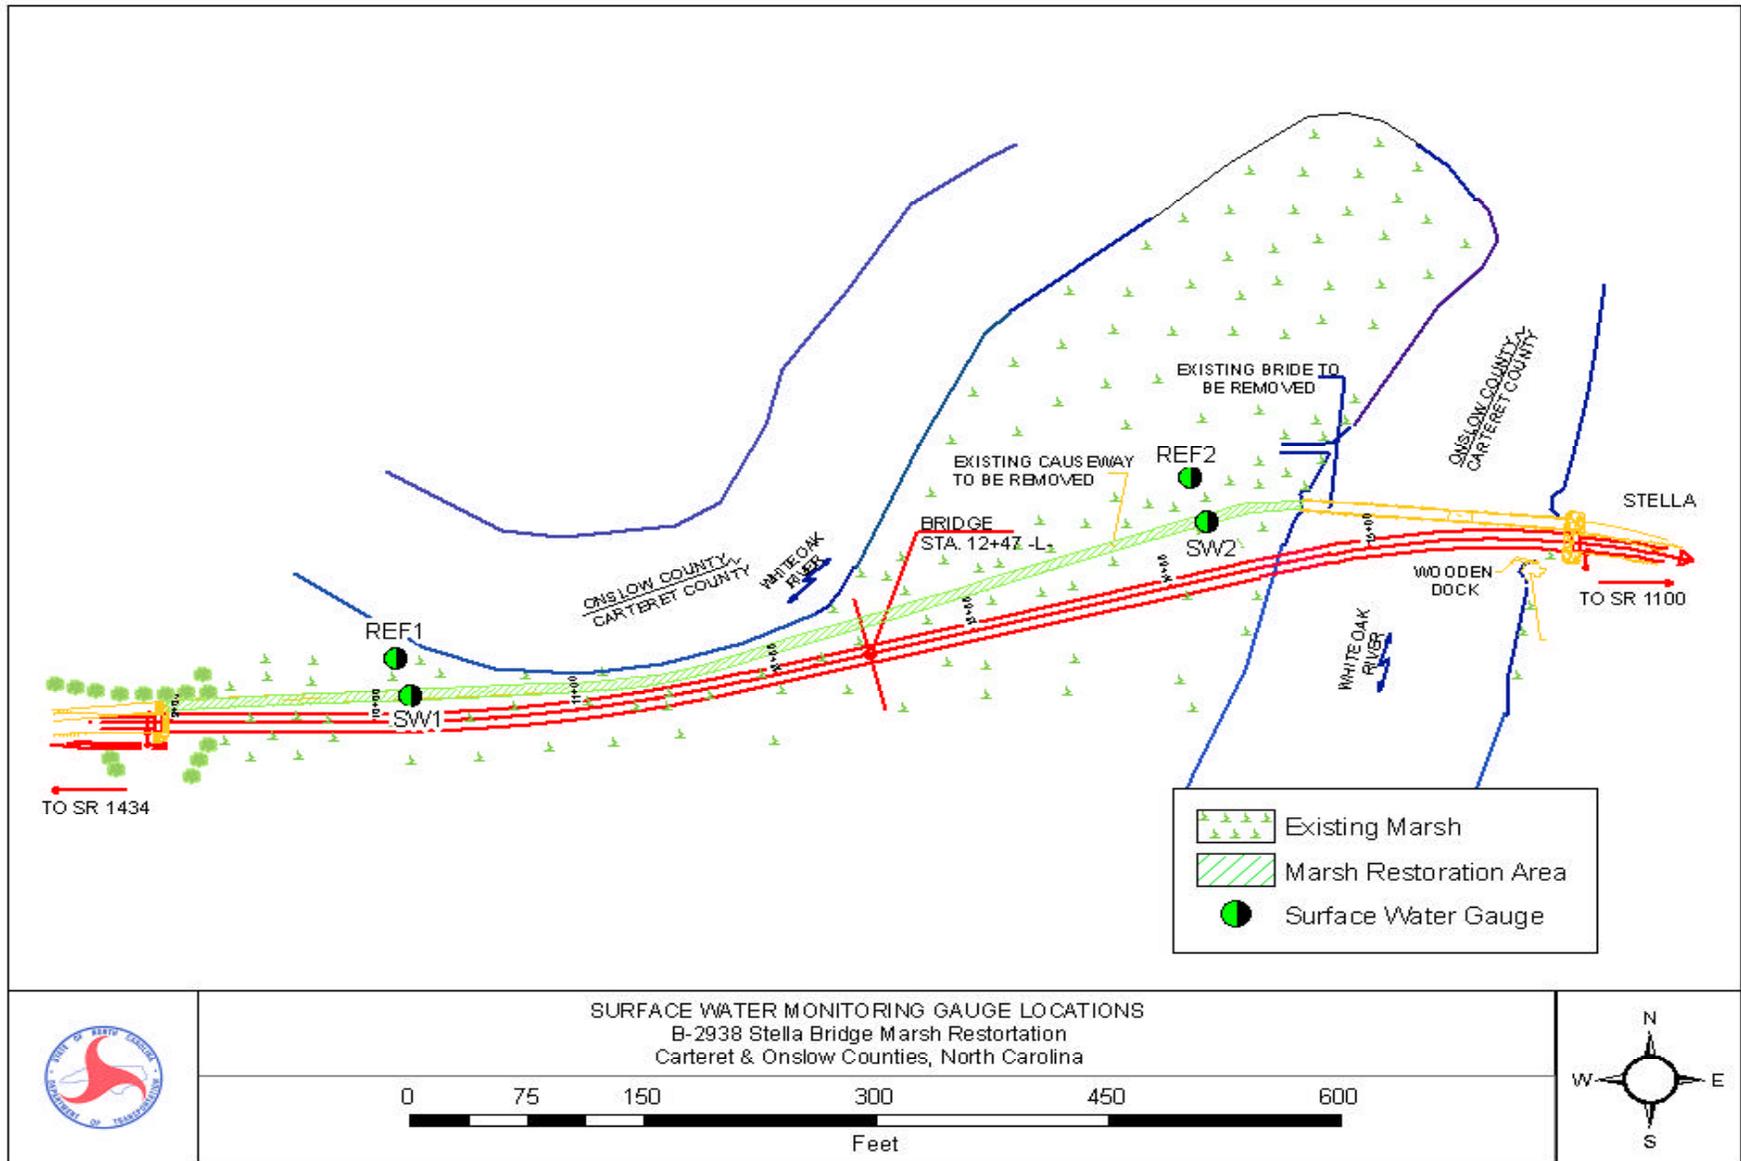
Figure 2. Monitoring Gauge Location Map

Hydrologic monitoring occur throughout the growing season in the restoration area by using surface water gauges. Two surface water gauges were placed in the restored Brackish Marsh area. Two surface water gauges were placed in the reference Brackish Marsh area located within the project area. Hydrologic success criteria was base on the establishment of hydrologic conditions comparable in hydrologic frequency and duration to those of the existing reference wetlands. The surface water gauges record surface water levels every three hours. Monitoring data for 2006 represents the first year of hydrologic monitoring for the site.
