ANNUAL REPORT FOR 2005

**Rocky Hock Creek Bridge
Chowan County
TIP No. B-3435
CAMA permit No. 105-02**

Prepared By:
Natural Environment Unit & Roadside Environmental Unit
North Carolina Department of Transportation
December 2005

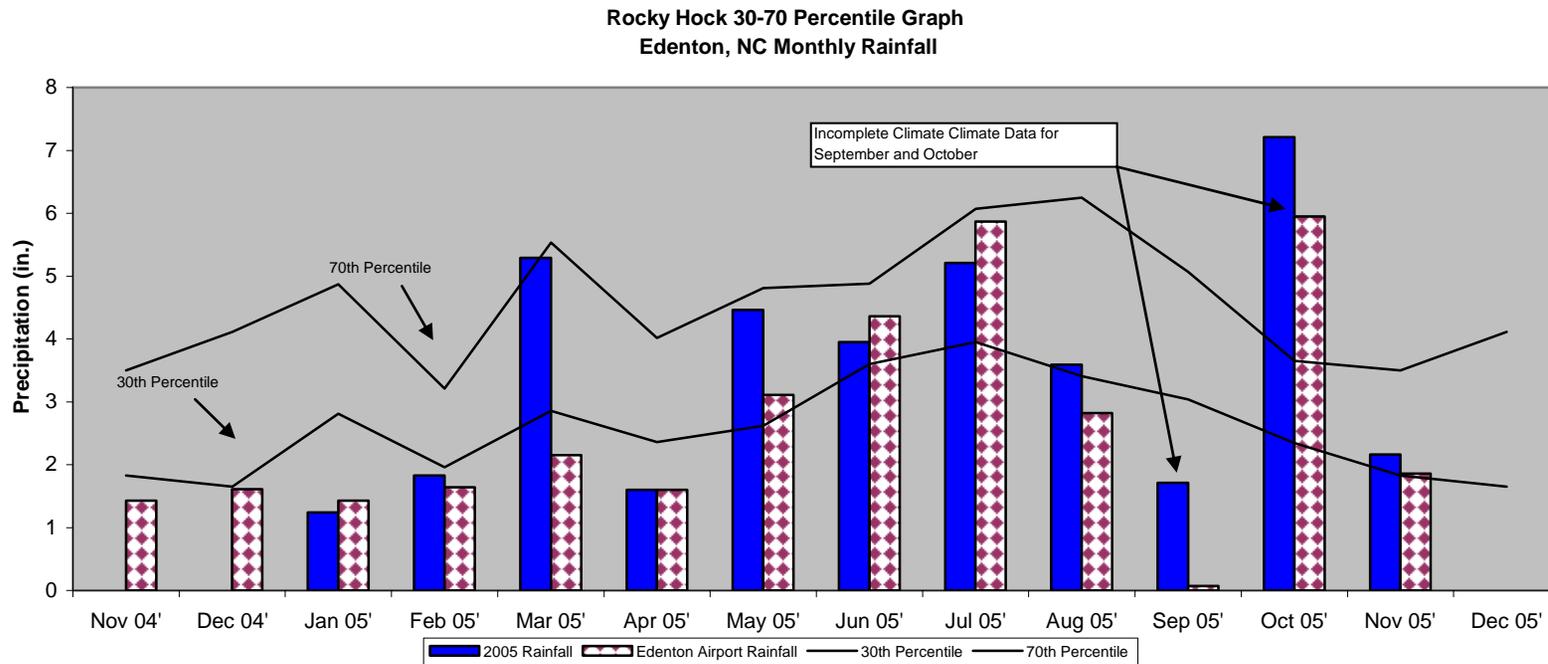
Figure 2. 30-70 Percentile Graph.

Figure 2 represents an examination of the local climate in comparison with historical data in order to determine whether 2005 was “normal” in terms of climate conditions. The two lines represent the 30th and 70th percentiles of monthly precipitation for Edenton, NC. The bars are monthly rainfall totals for 2005.

Overall, the on-site rainfall for 2005 was normal. The rainfall for January, February, April and September was below normal. The rainfall for March, May, June, July, August, and November was normal and October was above normal.

The historical data was collected from the State Climate Office of North Carolina. The rainfall data from the Edenton Station is incomplete for September and October. On-site rainfall was collected from the middle of January through December.
