ANNUAL REPORT FOR 2015

Aberdeen Creek Wetland Mitigation Site
Moore County
TIP No. B-3680
COE Action ID: SAW 2001-01373
NCDWR Project #: 12-0040

Prepared By:
Natural Environment Section & Roadside Environmental Unit
North Carolina Department of Transportation
January 2016

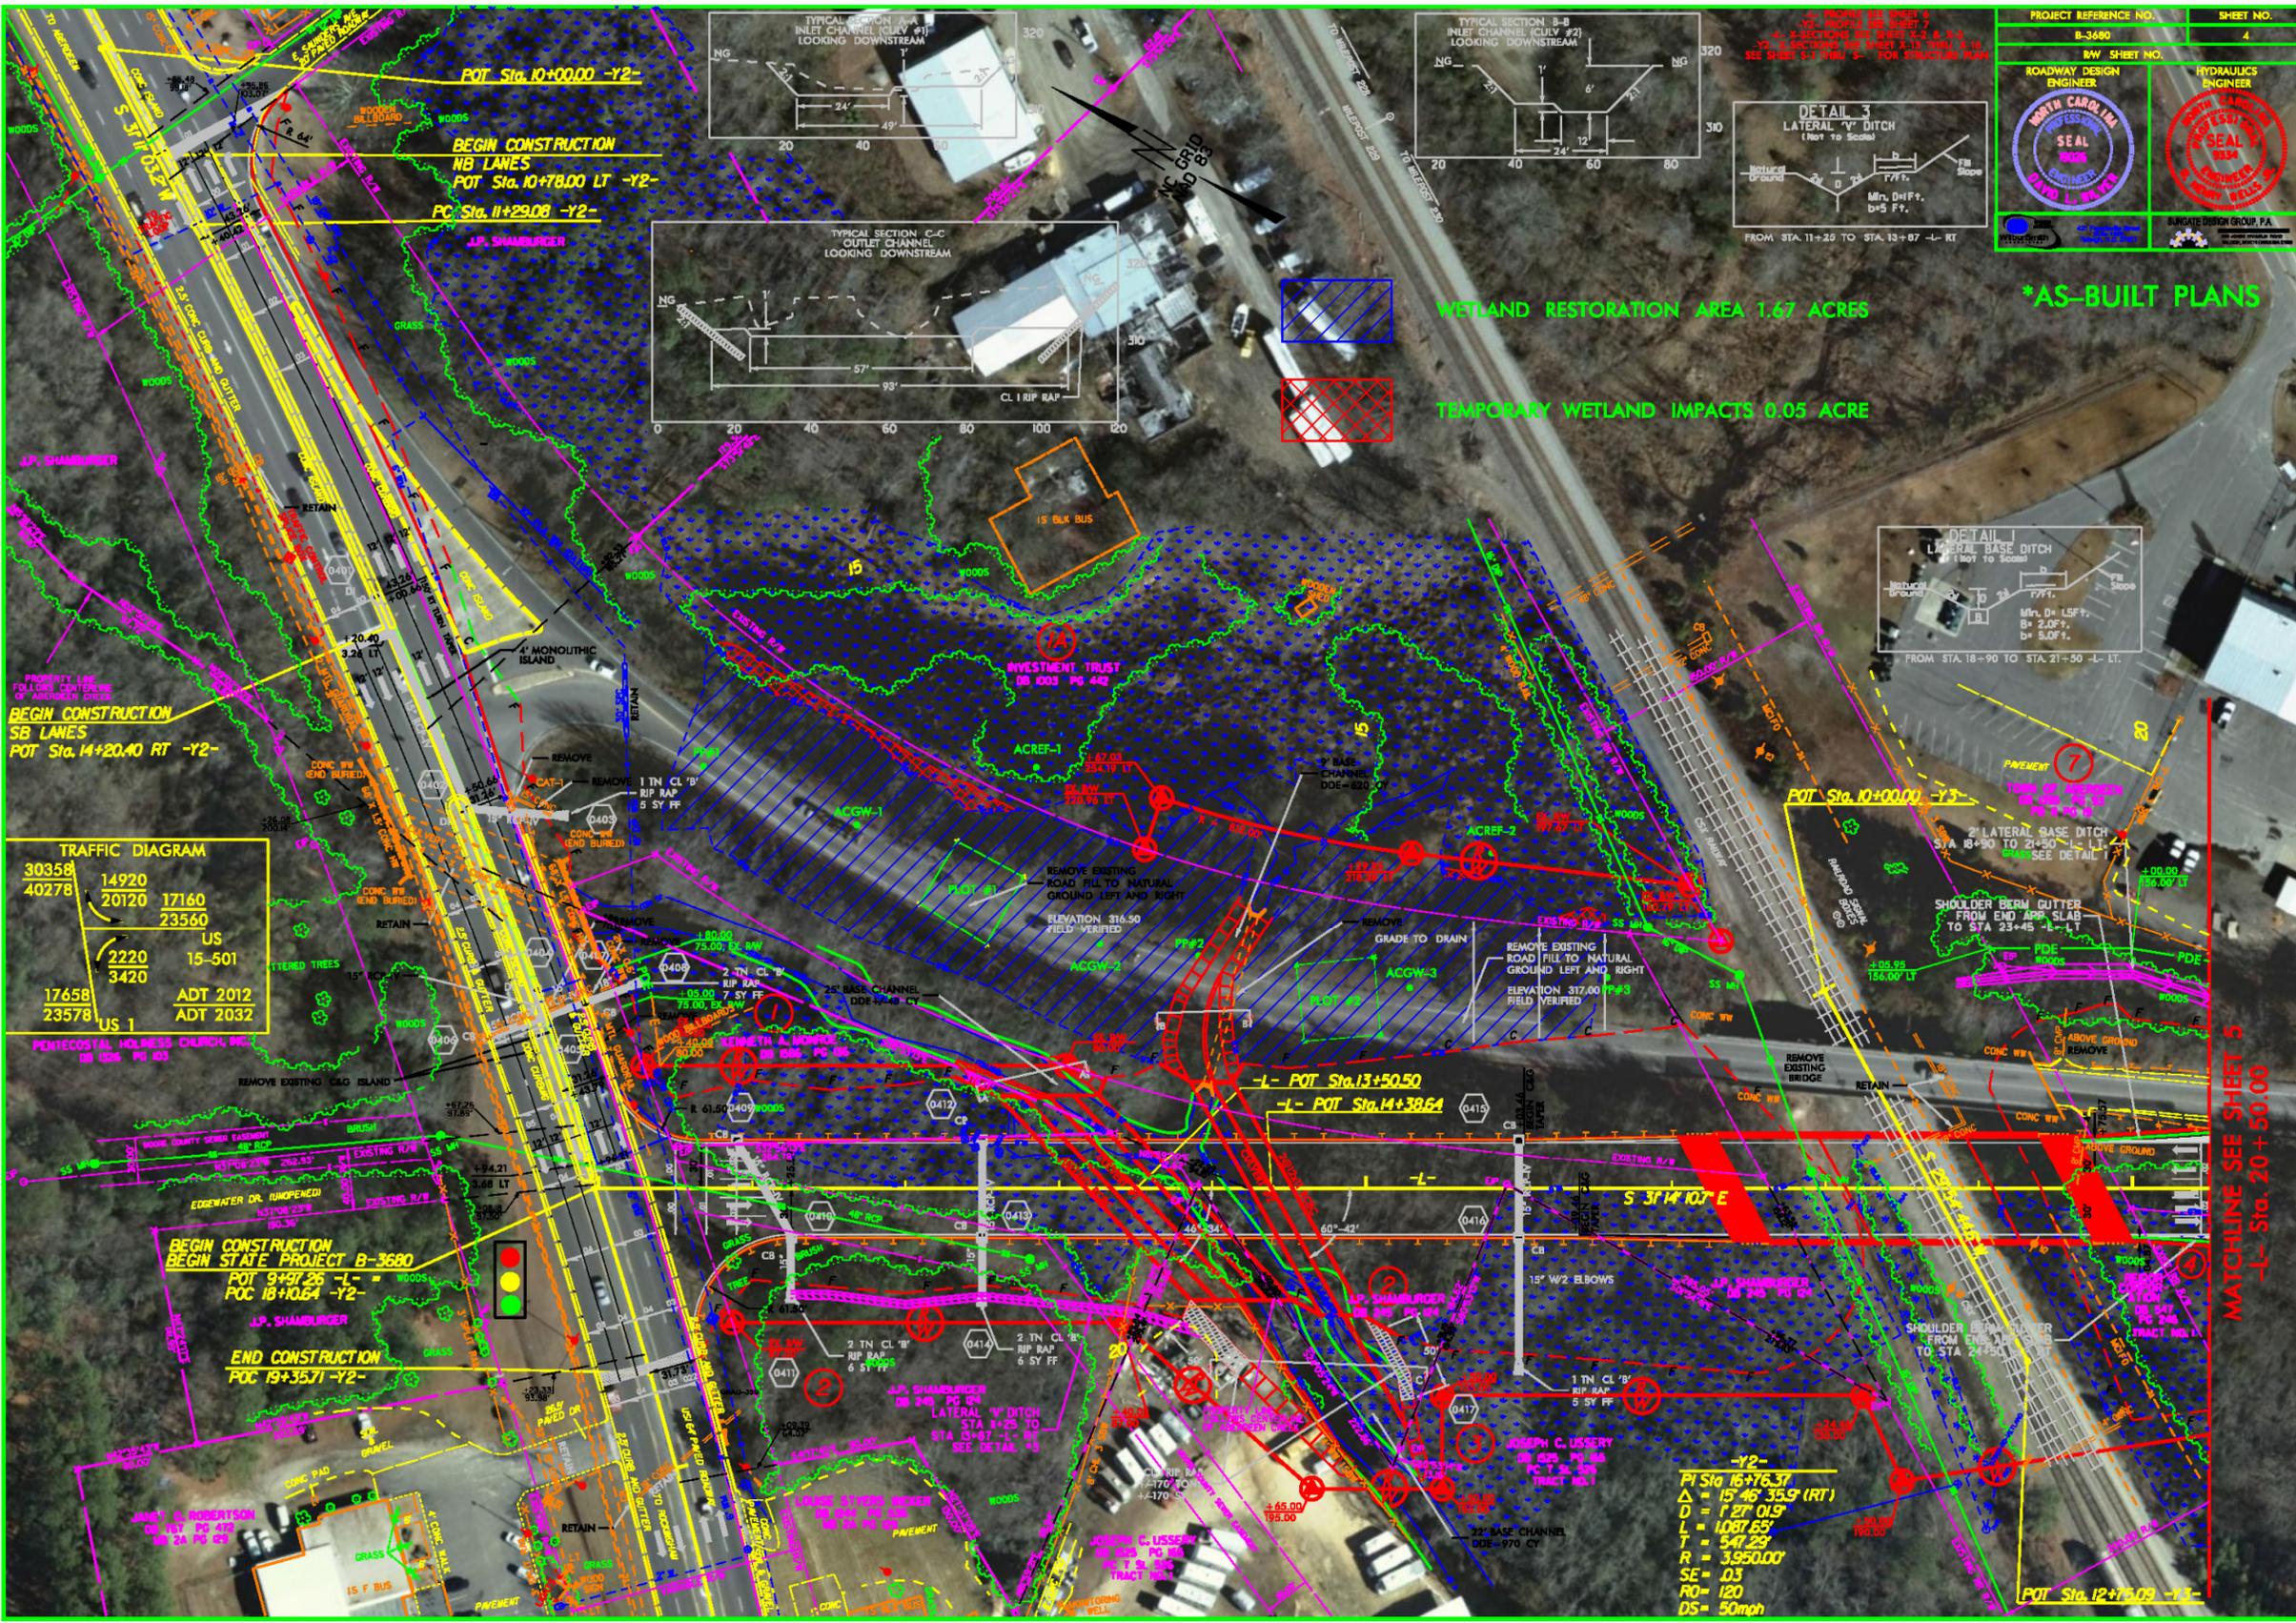
*AS-BUILT PLANS

WETLAND RESTORATION AREA 1.67 ACRES

TEMPORARY WETLAND IMPACTS 0.05 ACRE
