ANNUAL REPORT FOR 2013

Pig Basket Creek Mitigation Site
Nash County
TIP No. B-3876
COE Action ID: SAW-2007-1026-164
DWQ #: 20070366

Prepared By:
Natural Environment Section & Roadside Environmental Unit
North Carolina Department of Transportation
June 2013

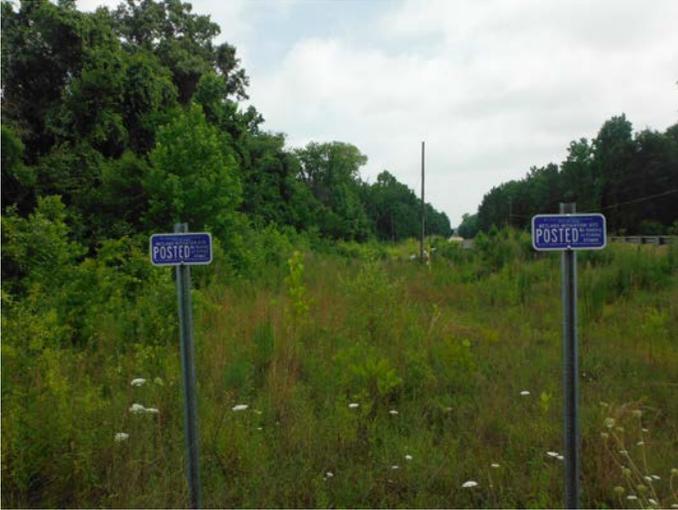
Photo 1 (Wetland Restoration-Site 4)

The impacted area where the old bridge and causeway was removed is re-attaining wetland jurisdictional status and the planted species are surviving. Planted species noted surviving included sycamore, water oak, tulip poplar, green ash, and willow oak. Other species noted within the planted area included river birch, sedge, fennel, sweetgum, baccharis, soft rush, red maple, alder, and various grasses. A bankfull event had recently occurred along Pig Basket Creek.

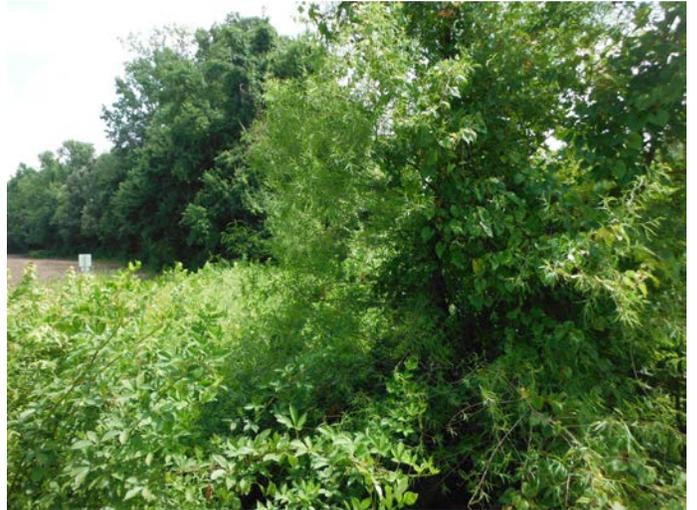
Photo 4 (Stream Enhancement-Site 3)

Vegetation noted within the stream enhancement area included black willow, red maple, black berry, pokeweed, tag alder, briars, and various herbaceous species.
