ANNUAL REPORT FOR 2012

Pig Basket Creek Mitigation Site
Nash County
TIP No. B-3876
COE Action ID: SAW-2007-1026-164
DWQ #: 20070366

Prepared By:
Natural Environment Section & Roadside Environmental Unit
North Carolina Department of Transportation
July 2012

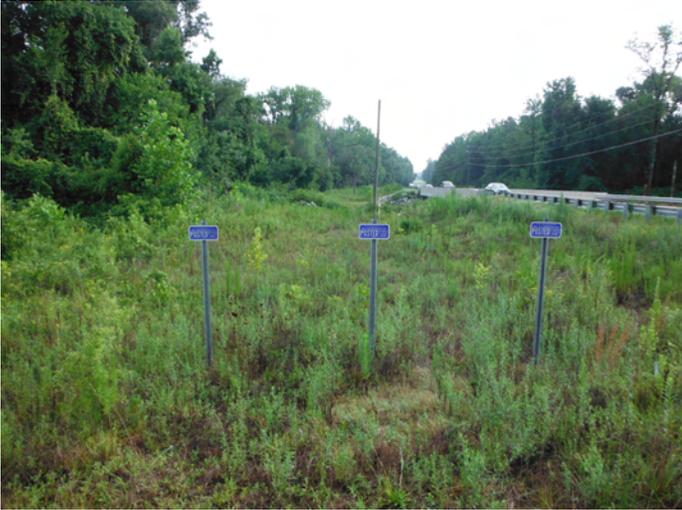
Photo 1 (Wetland Restoration-Site 4)

The impacted area where the old bridge and causeway was removed is re-attaining wetland jurisdictional status and the planted species are surviving. Planted species noted surviving included sycamore, water oak, tulip poplar, green ash, water tupelo, and willow oak. Other species noted within the planted area included river birch, sedge, fennel, sweetgum, baccharis, soft rush, and various grasses.

There were approximately 0.52 acres of wetland restoration and 90 feet of stream enhancement planted on site. There were no plots established on the site. By visual observation, the Pig Basket Creek Mitigation Site shows that the planted species are surviving and the impacted area is re-attaining wetland jurisdictional status.

NCDOT proposes to continue vegetation monitoring at the Pig Basket Creek Mitigation Site in 2013.

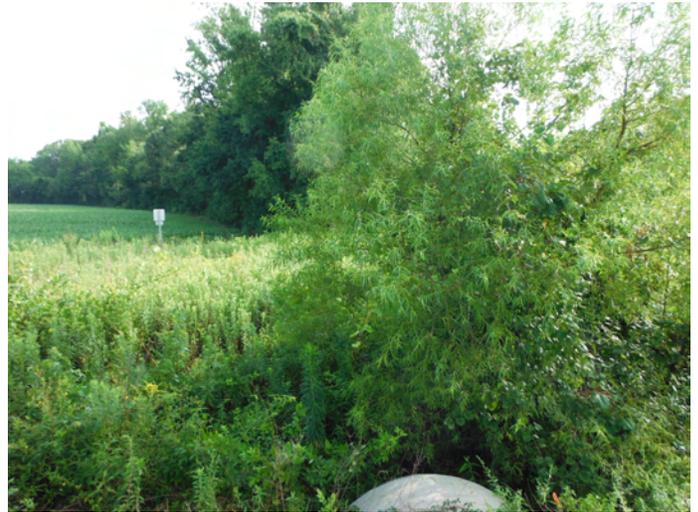
Photo 4 (Stream Enhancement-Site 3)

Vegetation noted within the stream enhancement area included black willow, red maple, black berry, pokeweed, tag alder, and various herbaceous species.
