Monitoring Data Record

Project Title: B-4138 COE Action ID: 2003-00357
 Stream Name: UT to Cape Fear River DWQ Number: 20091321
 City, County and other Location Information: Harnett County, project located at the US 401/NC 210 crossing at the Cape Fear River in Lillington, NC
 Date Construction Completed: planting completed Dec. 18, 2013 Monitoring Year: (1) of 5
 Ecoregion: _____ 8 digit HUC unit 030030004
 USGS Quad Name and Coordinates: 35.408081, -78.813244

Plan Sheet No. EC-08/CONST.05
B-4138 UT to Cape Fear River
Harnett County, North Carolina

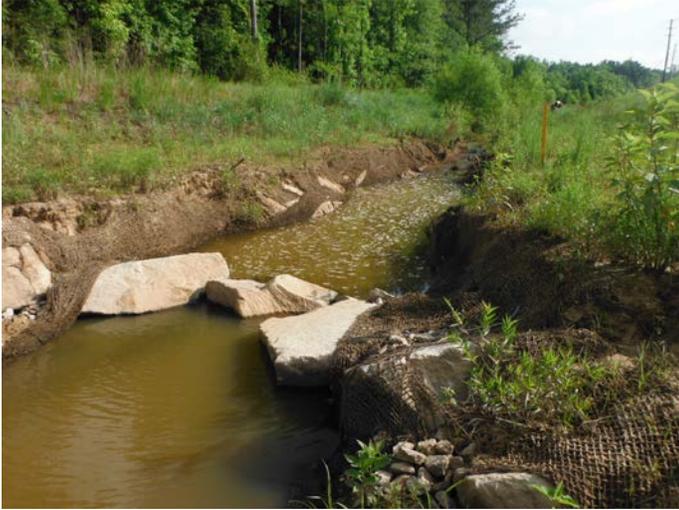
PP #4 (Upstream)

UT to Cape Fear River is stable for the Year 1 monitoring evaluation, except for, the streambanks up and downstream at PP#4 that have sloughed off due to high water within the Cape Fear River encroaching into the site. This has left some areas of raw banks. NCDOT plans to live stake these banks after the herbicide applications on the lespedeza are complete to stabilize this area. A beaver dam was noted upstream of PP#1. USDA has been contacted to trap and remove the beavers. NCDOT will continue to monitor channel stability at the UT to Cape Fear River in 2015.

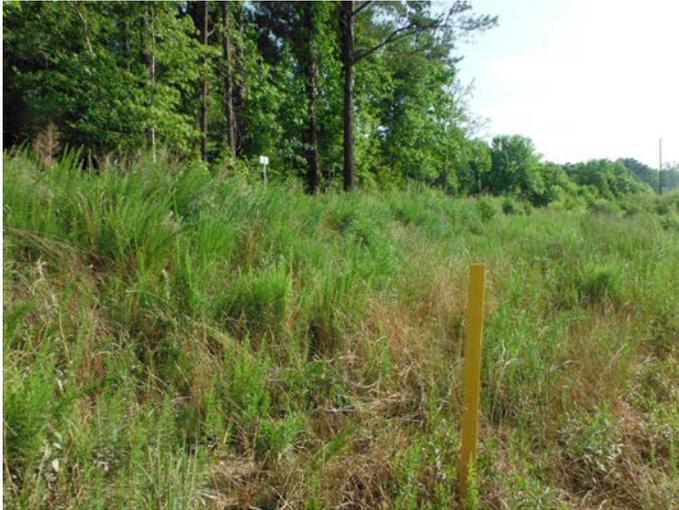
Vegetation Plot #1

There were multiple dead trees noted throughout the site due to high water from the Cape Fear River encroaching into the site and from competition from lespedeza within reforestation area. The lespedeza has encroached into the buffer from the fill slope seeding.

| Plot # | Yellow Poplar | Sycamore | White Oak | River Birch | Green Ash | Total (Year 1) | Total (at planting) | Density (Trees/Acre) |
|--|---|---|---|---|---|---|---|---|
| 1 | 1 | 5 | 1 | 4 | 0 | 11 | 50 | 150 |

Estimated causes, and proposed/required remedial action: NCDOT is currently planning to apply multiple herbicide applications in order to control the lespedeza at the site. The site will then be replanted with water tolerant species and live stakes will be planted on the southern end of the site where high river flows have affected the planted vegetation.

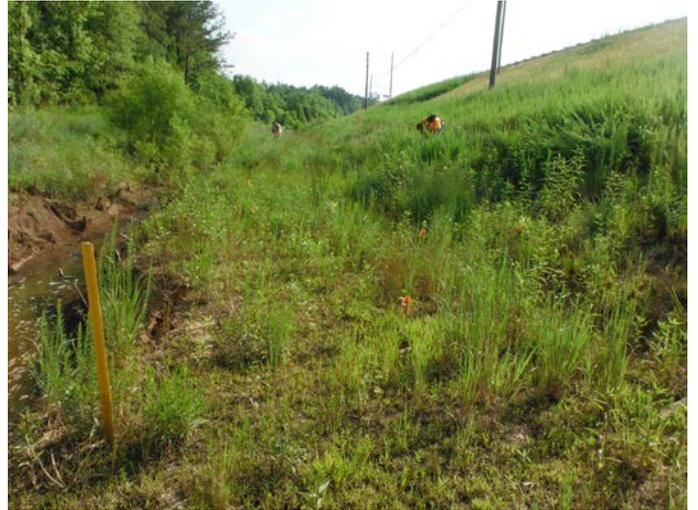
Vegetation Plot #2

| Plot # | Yellow Poplar | Sycamore | White Oak | River Birch | Green Ash | Total (Year 1) | Total (at planting) | Density (Trees/Acre) |
|--|---|---|---|---|---|---|---|---|
| 2 | 0 | 7 | 0 | 11 | 3 | 21 | 38 | 376 |

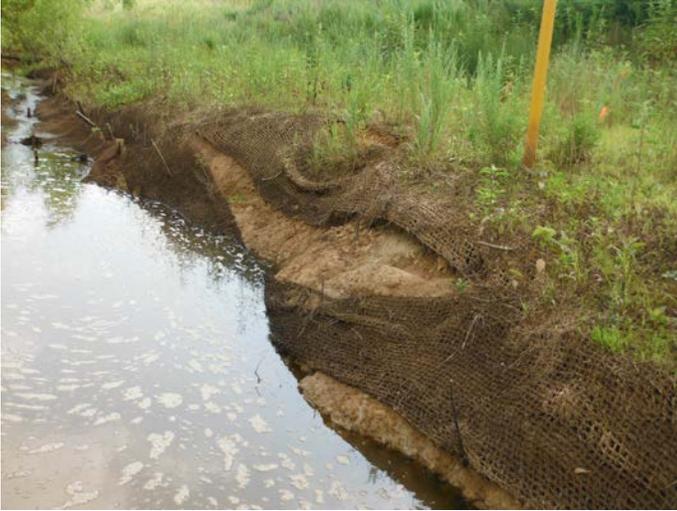
Left Bank at Sta. 34+50

| Other problems noted? | Sloughed off and raw banks | | | | |
