ANNUAL REPORT FOR 2015

**Hardison Mill Creek Wetland Mitigation Site
Martin County
TIP No. B-4185
COE Action ID: SAW-2006-40479
NCDWR Project #: 20121133**

Prepared By:
Natural Environment Section & Roadside Environmental Unit
North Carolina Department of Transportation
June 2015

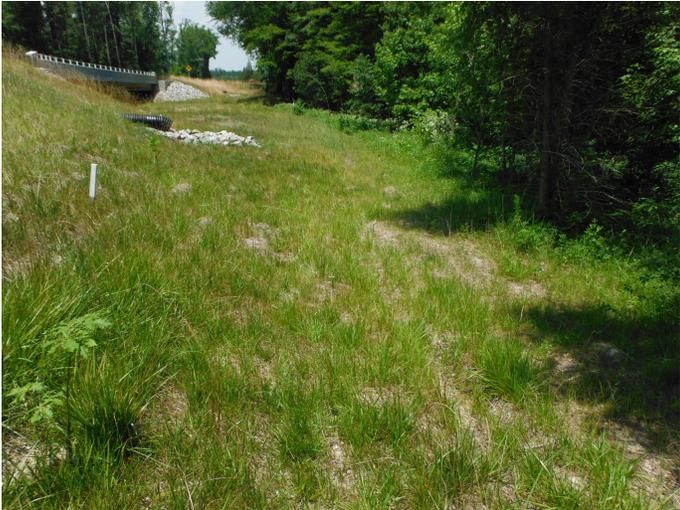
Photo 3

Site Notes: The reforested area located on the south side of the site at Photo Point #3 is lacking the planted tree species. NCDOT plans on completing a supplemental planting of this area by March 2016.

NCDOT will complete a supplemental planting of the south side of the site at Photo Point #3 and will continue vegetation monitoring at the Hardison Mill Creek Mitigation Site in 2016.
