ANNUAL REPORT FOR 2016

**Hardison Mill Creek Wetland Mitigation Site
Martin County
TIP No. B-4185
COE Action ID: SAW-2006-40479
NCDWR Project #: 20121133**

Prepared By:
Natural Environment Section & Roadside Environmental Unit
North Carolina Department of Transportation
August 2016

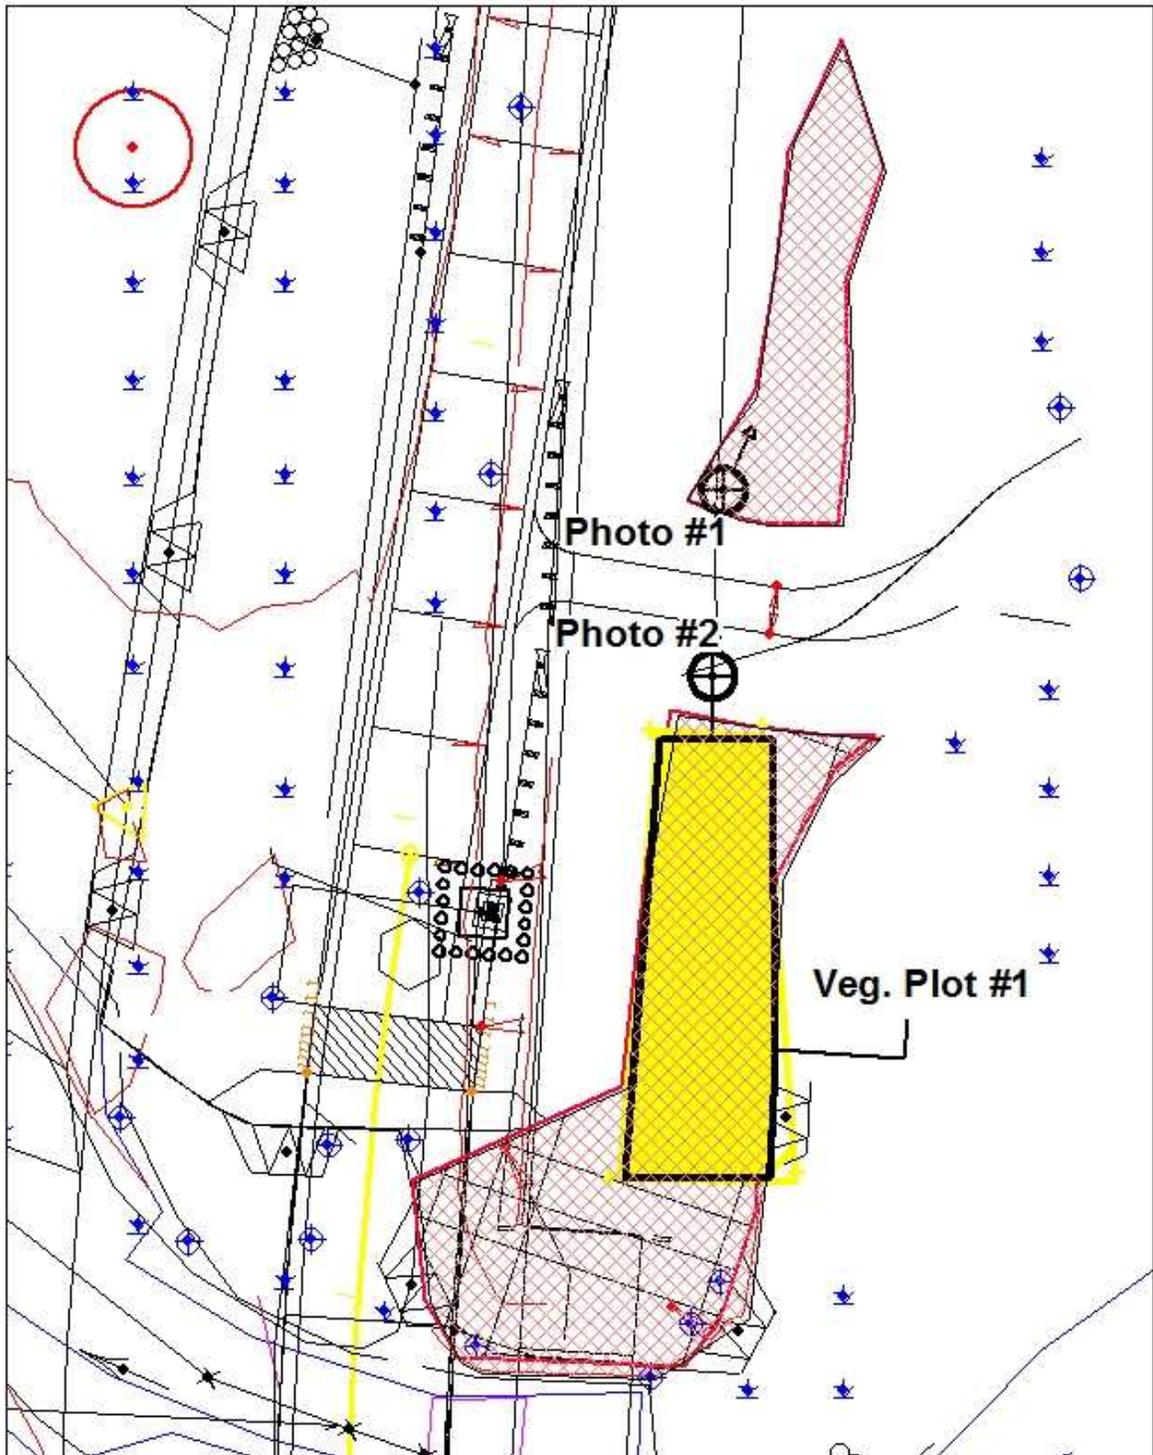
Site Map Wetland Reforestation Area, Vegetation Plot, & Photo Point Locations B-4185 Hardison Mill Creek Martin County, North Carolina

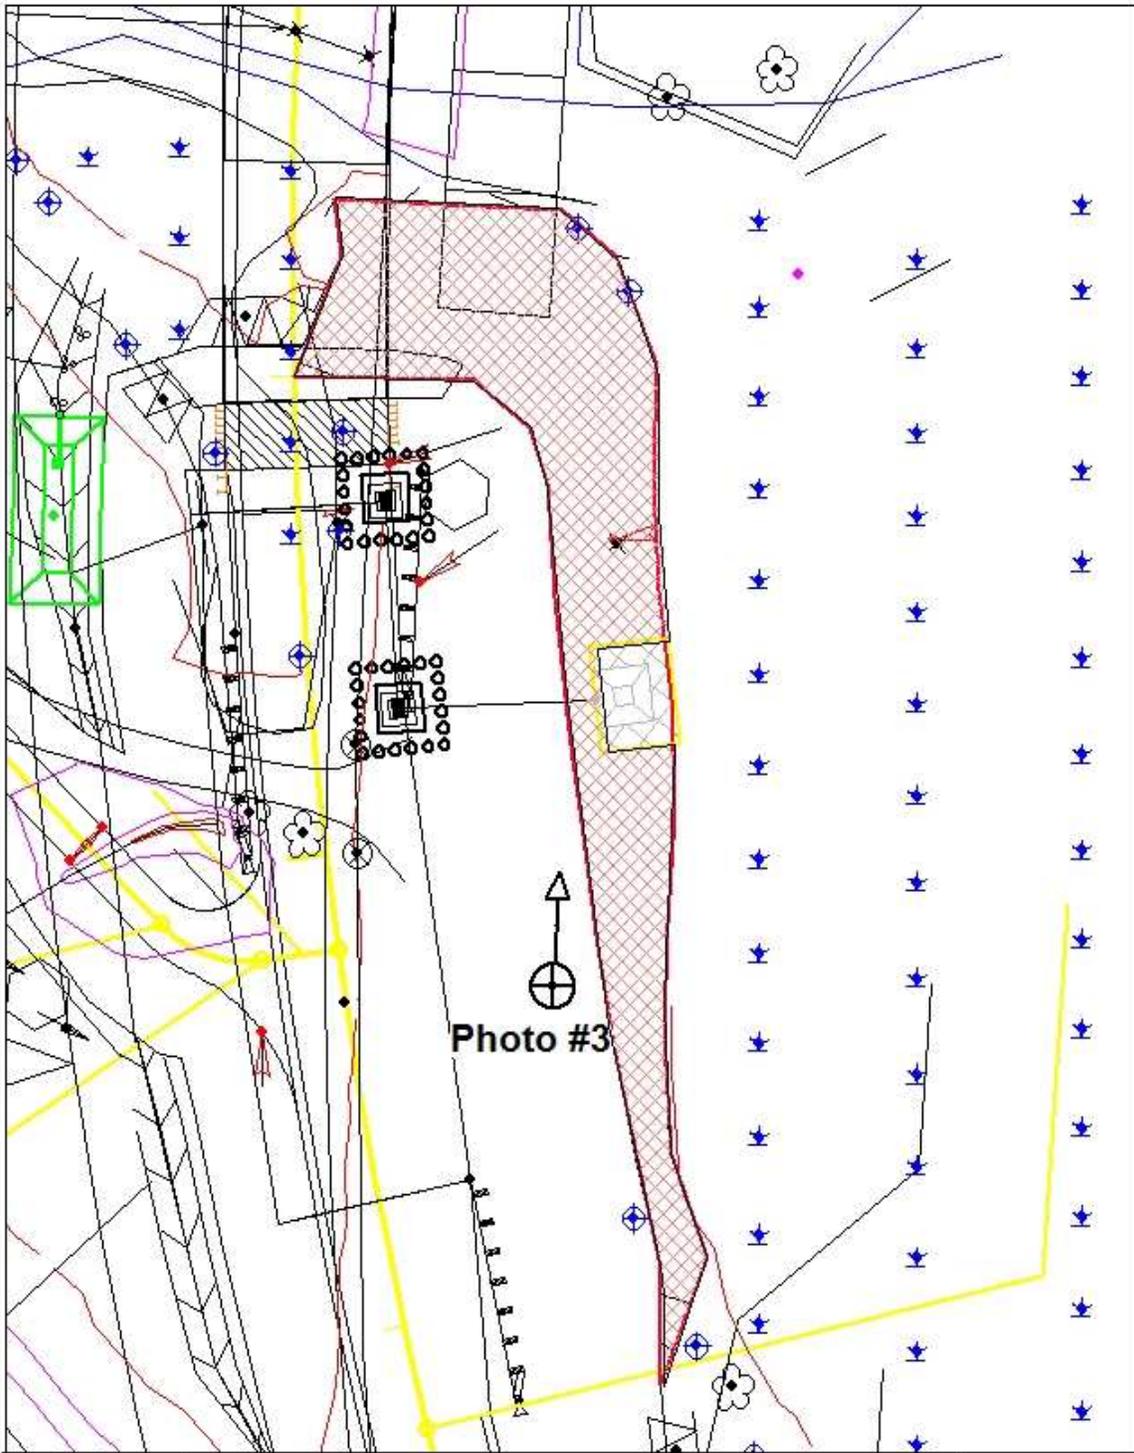
Site Map Wetland Reforestation Area, Vegetation Plot, & Photo Point Locations B-4185 Hardison Mill Creek Martin County, North Carolina
