# ANNUAL REPORT FOR 2013

**Northeast Cape Fear River Wetland Mitigation Site**  
**Pender County**  
**TIP No. B- 4223**  
**COE Action ID: 200101172**  
**DWQ Project #: 060364**  
**CAMA Permit #: 123-06**

Prepared By:  
Natural Environment Section & Roadside Environmental Unit  
North Carolina Department of Transportation  
July 2013

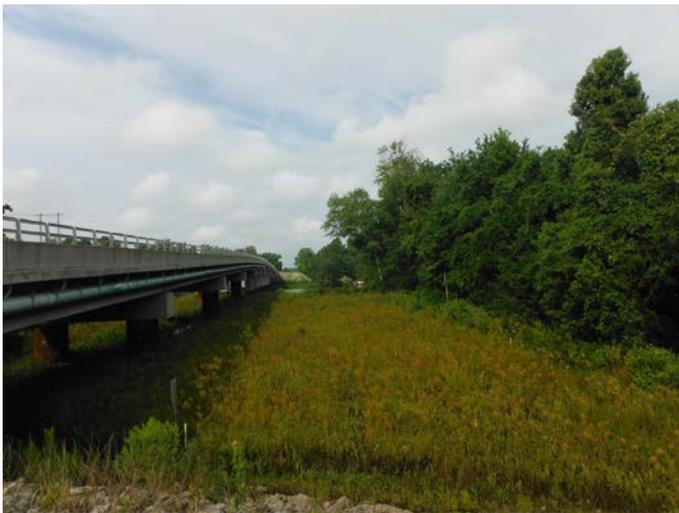
Overview photo of the site

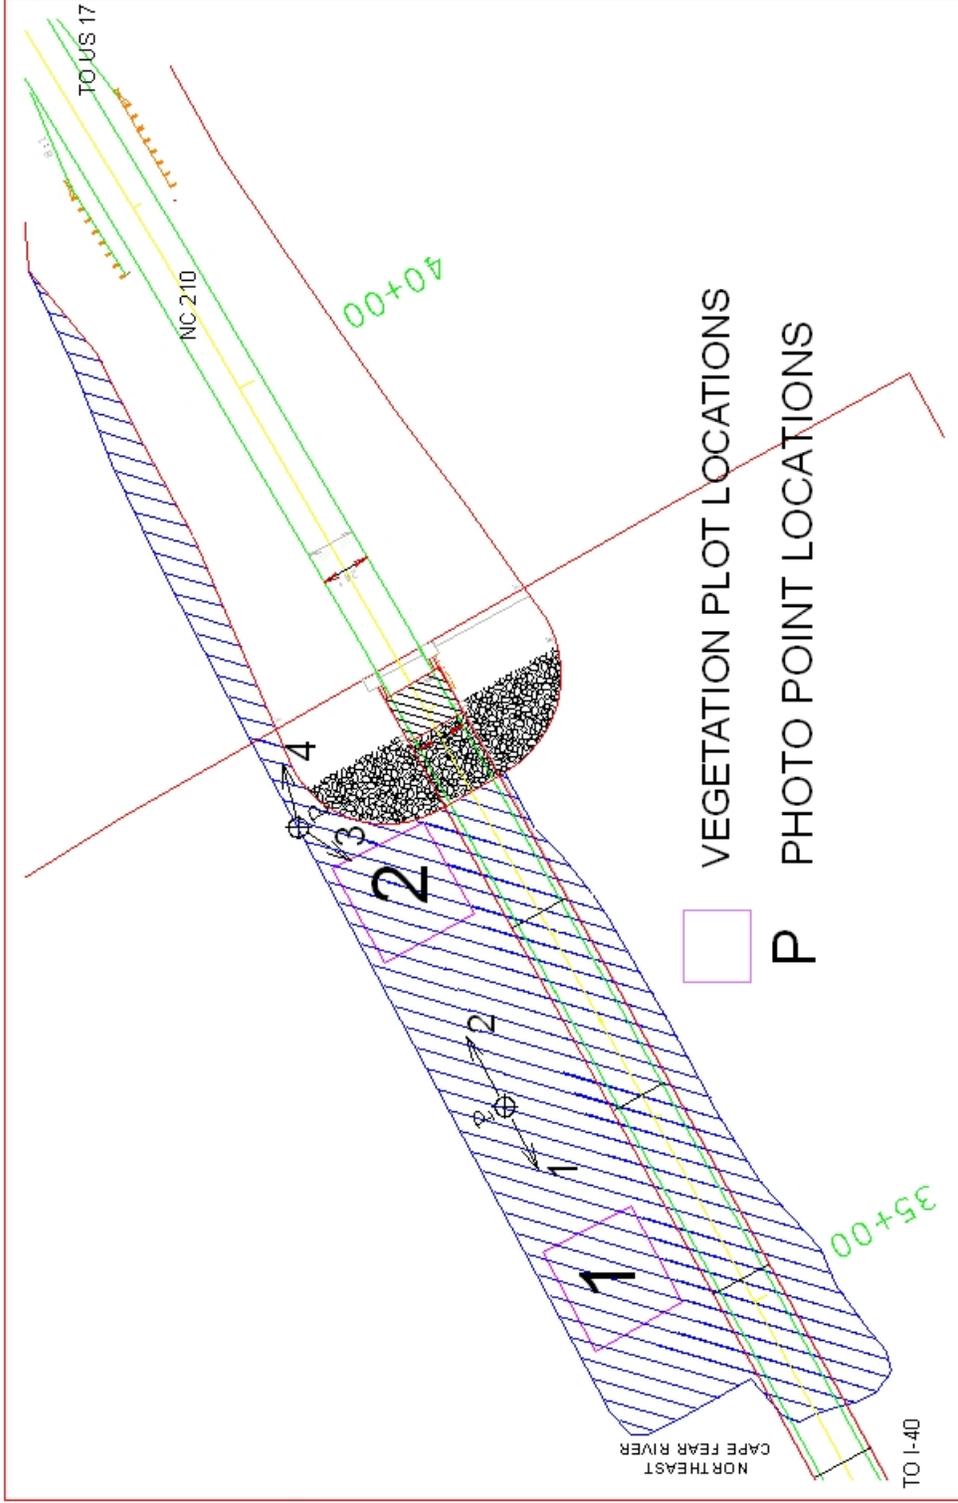
VEGETATION PLOT AND PHOTO POINT LOCATIONS  
 B-4223 Northeast Cape Fear River Wetland Restoration  
 Pender County, North Carolina
