ANNUAL REPORT FOR 2014

Northeast Cape Fear River Wetland Mitigation Site
Pender County
TIP No. B-4223
COE Action ID: 200101172
DWQ Project #: 060364
CAMA Permit #: 123-06

Prepared By:
Natural Environment Section & Roadside Environmental Unit
North Carolina Department of Transportation
September 2014

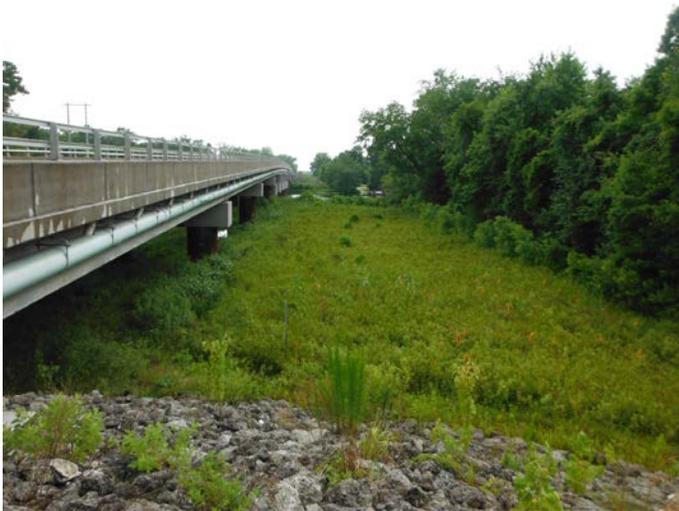
Site Notes: The restoration area is re-attaining wetland jurisdictional status and the planted species are surviving. Other species noted onsite included woolgrass, cattail, black willow, phragmites, tag alder, wax myrtle, *Sagittaria* sp., pennywort, buttonbush, *Juncus* sp., climbing hempvine, baccharis, red maple, sycamore, stinkweed, jewelweed, sedge, and various grasses. The few phragmite stems noted onsite were sprayed with an herbicide application on July 1, 2014. The phragmites noted onsite was not affecting the overall survival of the planted vegetation. An ATV path was still present onsite but no recent ATV activity was noted on it.

Overview photo of the site
June 2014

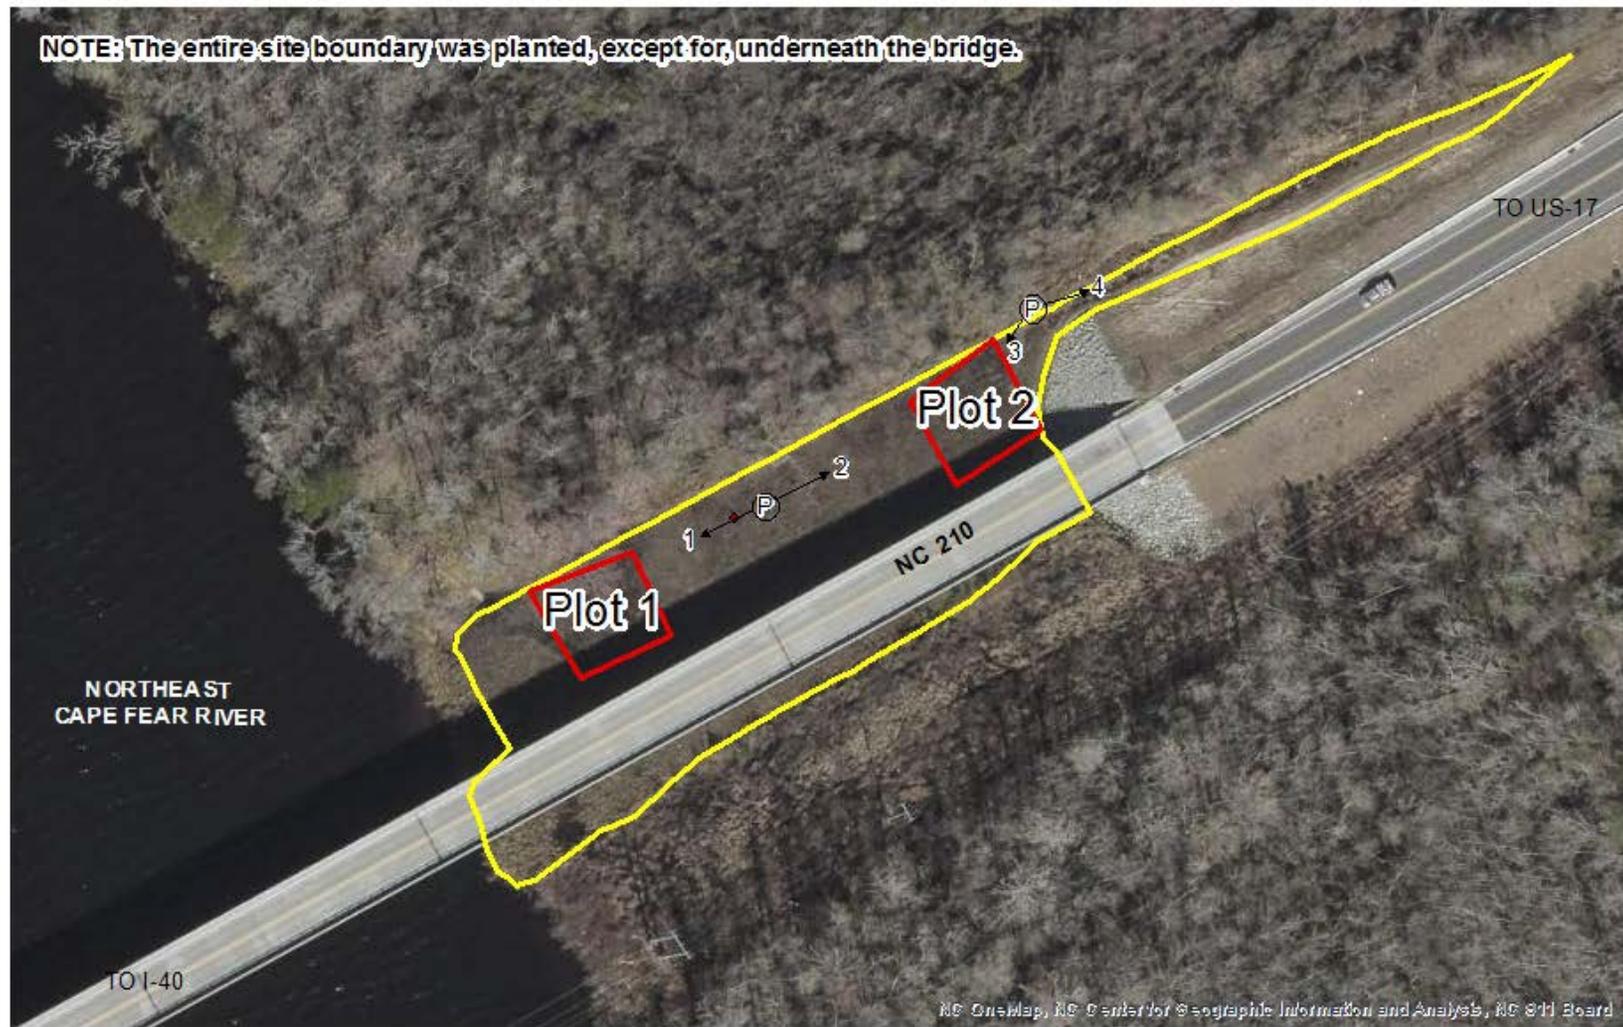
Site Map: Vegetation Plot and Photo Point Locations
B-4223 Northeast Cape Fear River Wetland Restoration
Pender County, North Carolina

NOTE: The entire site boundary was planted, except for, underneath the bridge.
