# ANNUAL REPORT FOR 2010

**Little River Bridge Mitigation Site  
Moore County  
TIP No. R-0210A**

Prepared By:  
Natural Environment Unit & Roadside Environmental Unit  
North Carolina Department of Transportation  
December 2010

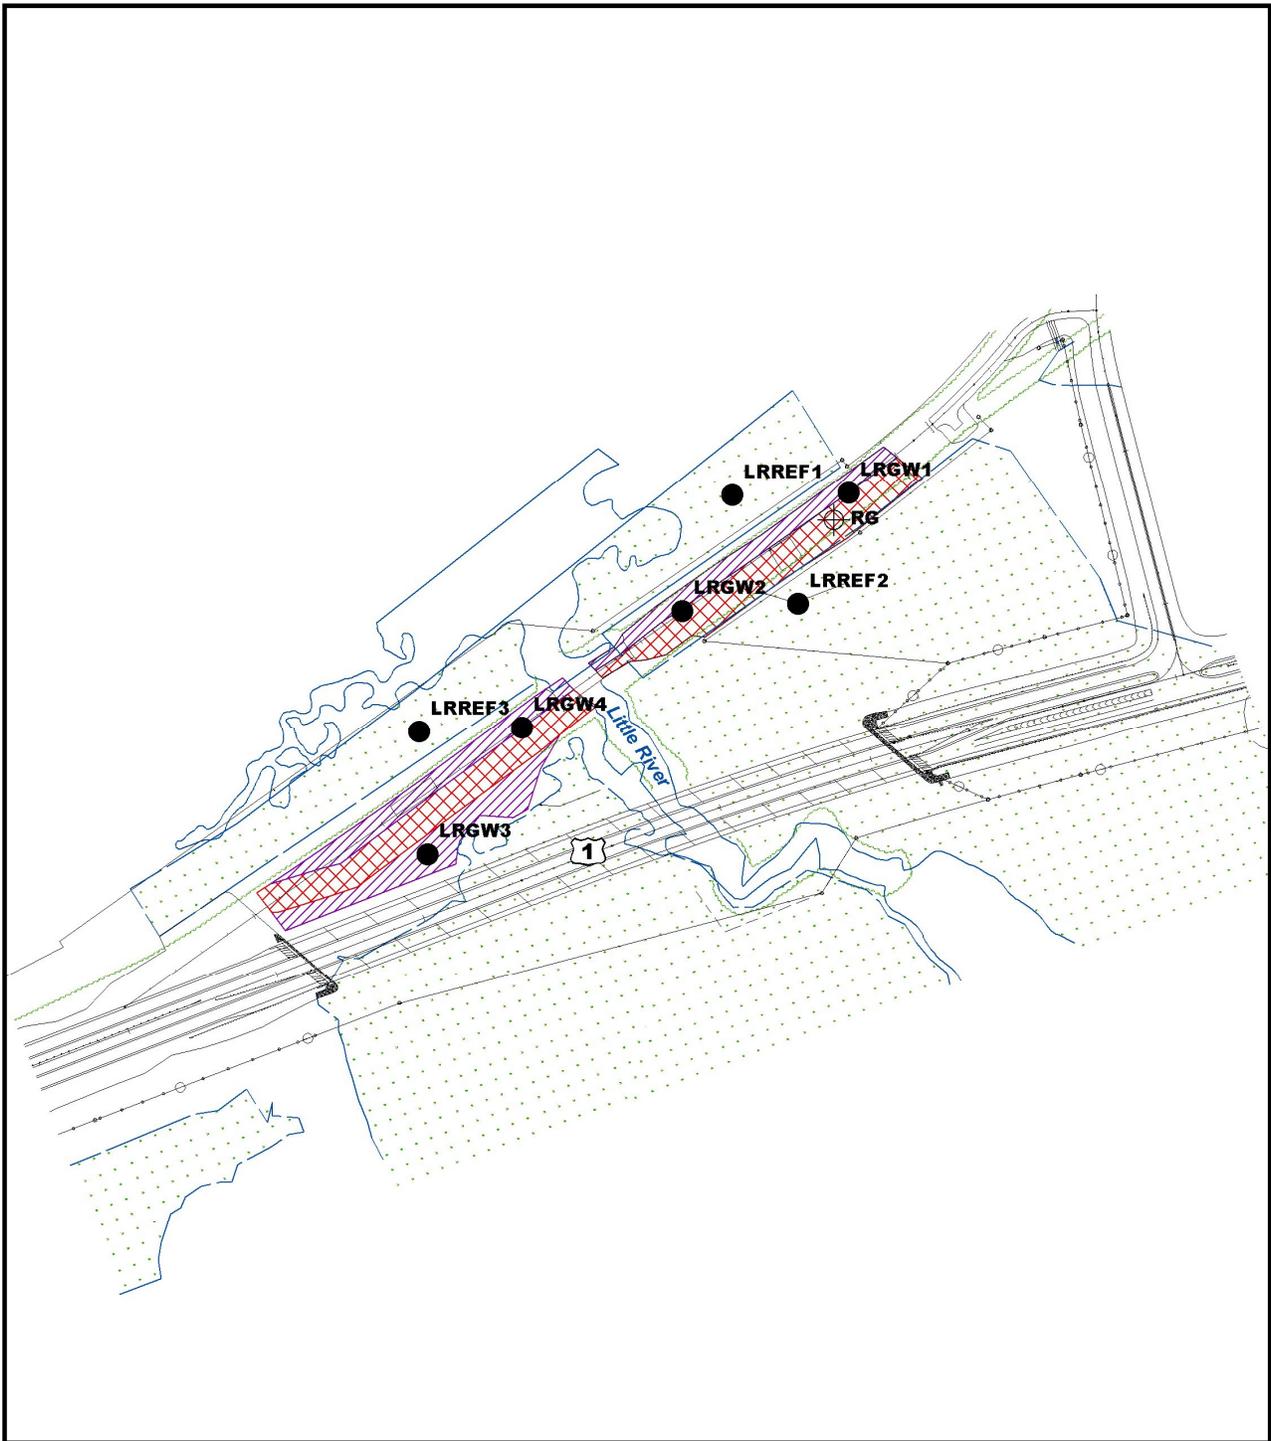
**Figure 2. Monitoring Gauge Location Map**

Four groundwater monitoring gauges were installed within the site's restoration area (Figure 2) in February 2006. There are also three reference gauges that were installed prior to construction in the existing wetlands that are adjacent to the constructed site. A rain gauge is also located on the site to assist in comparison of the rainfall data (supplied by the NC State Climate Office) from an official weather station in Carthage. The groundwater gauges record water levels on a daily basis.

Groundwater monitoring gauge four did not meet the success criterion in 2010. The close proximity to the Little River may be causing a drawdown effect on the gauge. NCDOT may need to delineate this area to determine whether or not wetland hydrology is present in this portion of the site. Hydrologic monitoring results from all five years of monitoring are presented in Table 3 below.

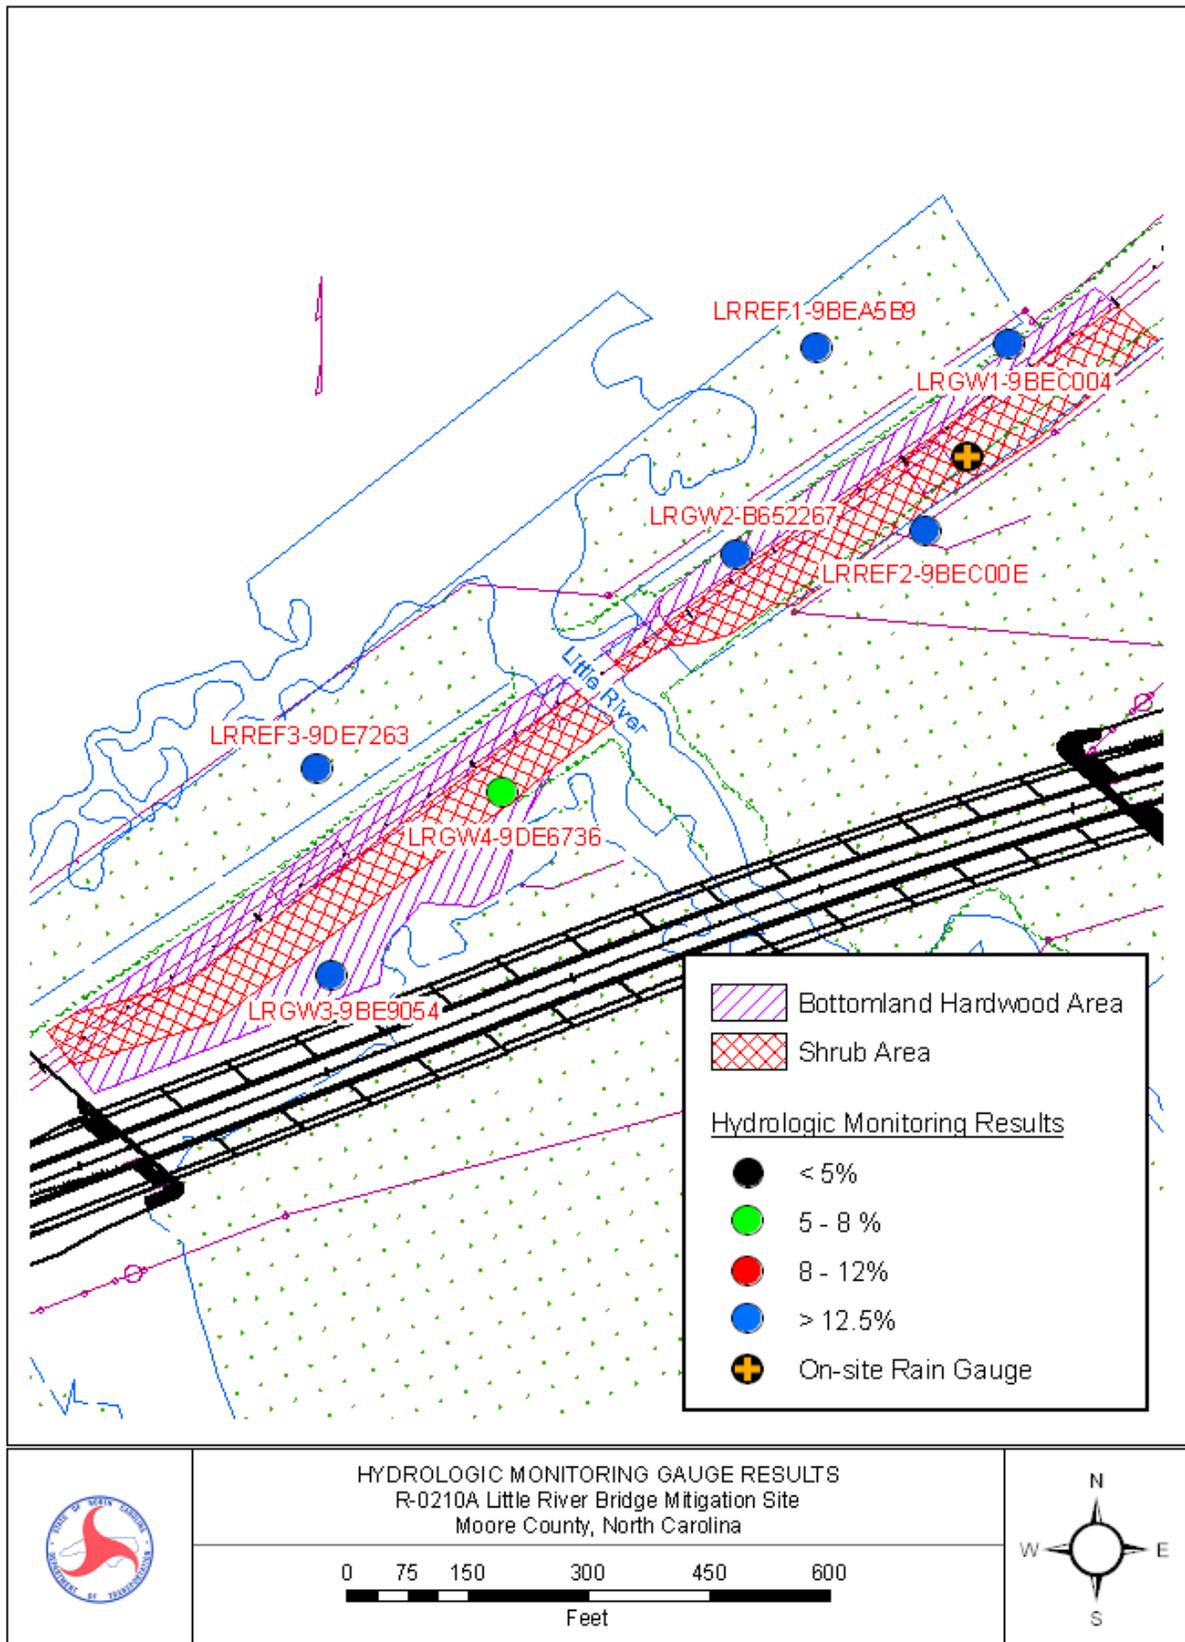
**Figure 3.** Hydrologic Monitoring Results

The maximum number of consecutive days that saturation occurred within 12 inches of the ground surface was determined for each groundwater monitoring gauge. This number was converted into a percentage of the 230-day growing season (March 23 – November 7). Table 1 provides the 2010 hydrologic results; Figure 3 is a graphical representation of these results. Appendix A includes graphs of the data recorded at each groundwater gauge. Daily rainfall events recorded at the onsite rain gauge are included on each of the groundwater gauge plots.

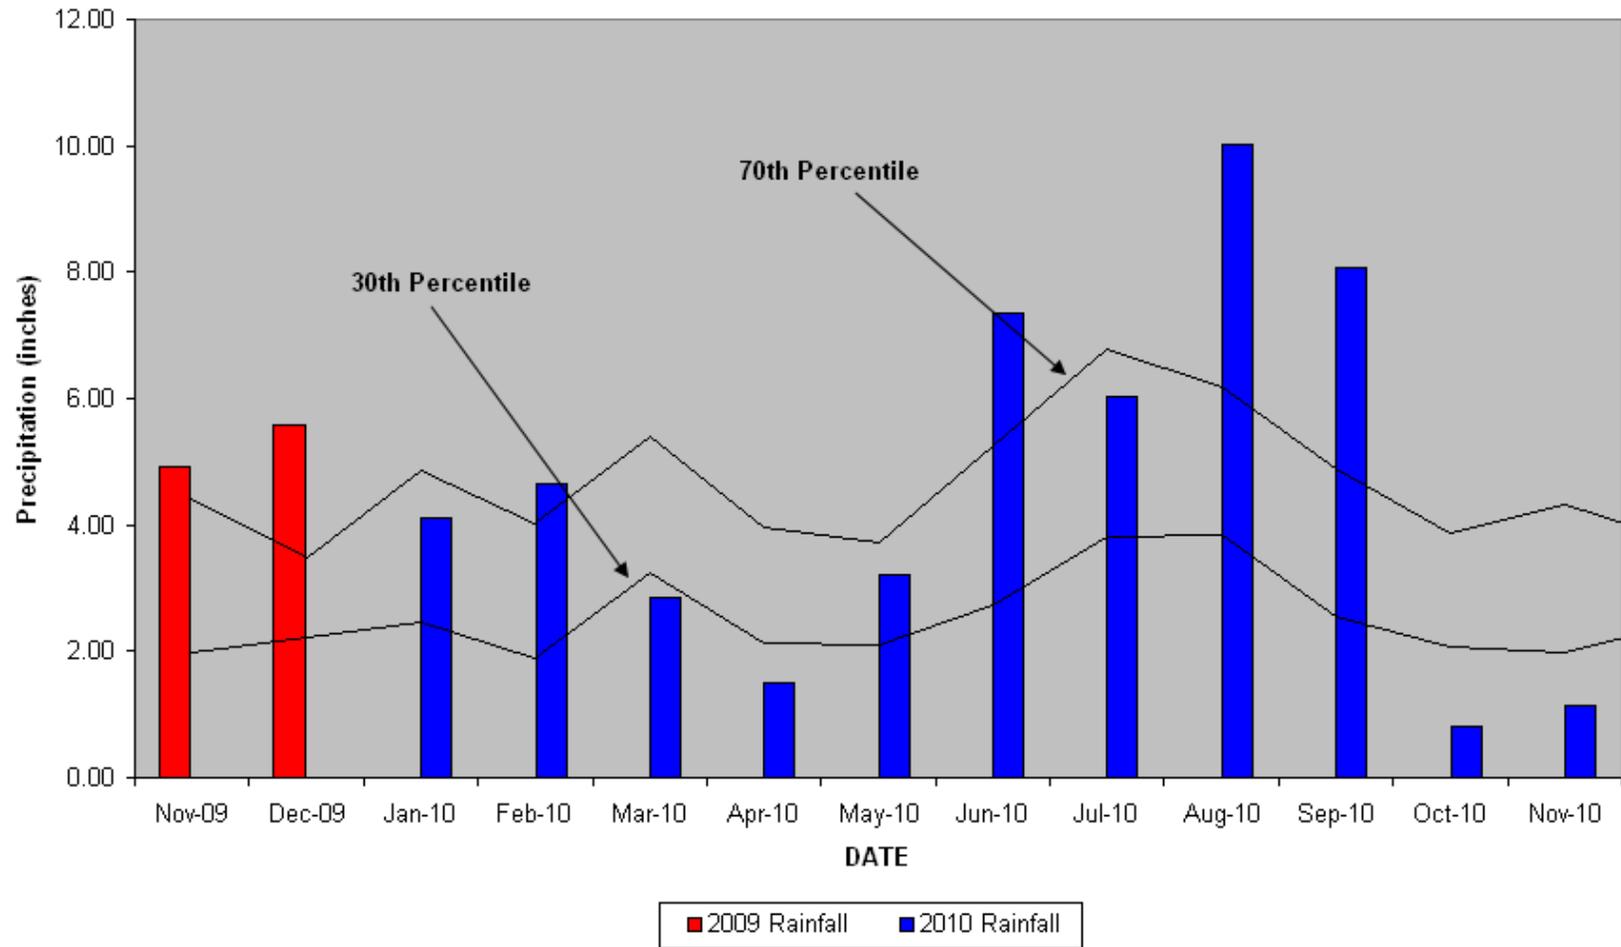
Figure 4. 30-70 Percentile Graph

Figure 4 is a comparison of the 2010 monthly rainfall to the historical precipitation (collected between 1977 and 2009) for Carthage, North Carolina. This comparison gives an indication of how 2010 relates to historical data in terms of climate conditions. The NC State Climate Office provided all historical rainfall information. For 2010, March, April, October and November recorded below average rainfall. The months of January, May and July recorded average rainfall; while February, June, August and September recorded above average rainfall. Overall, 2010 was an average rainfall year.
