# ANNUAL REPORT FOR 2006

**Indian Creek Mitigation Site  
Lincoln County  
TIP No. R-0617BA**

Prepared By:  
Natural Environment Unit & Roadside Environmental Unit  
North Carolina Department of Transportation  
January 2007

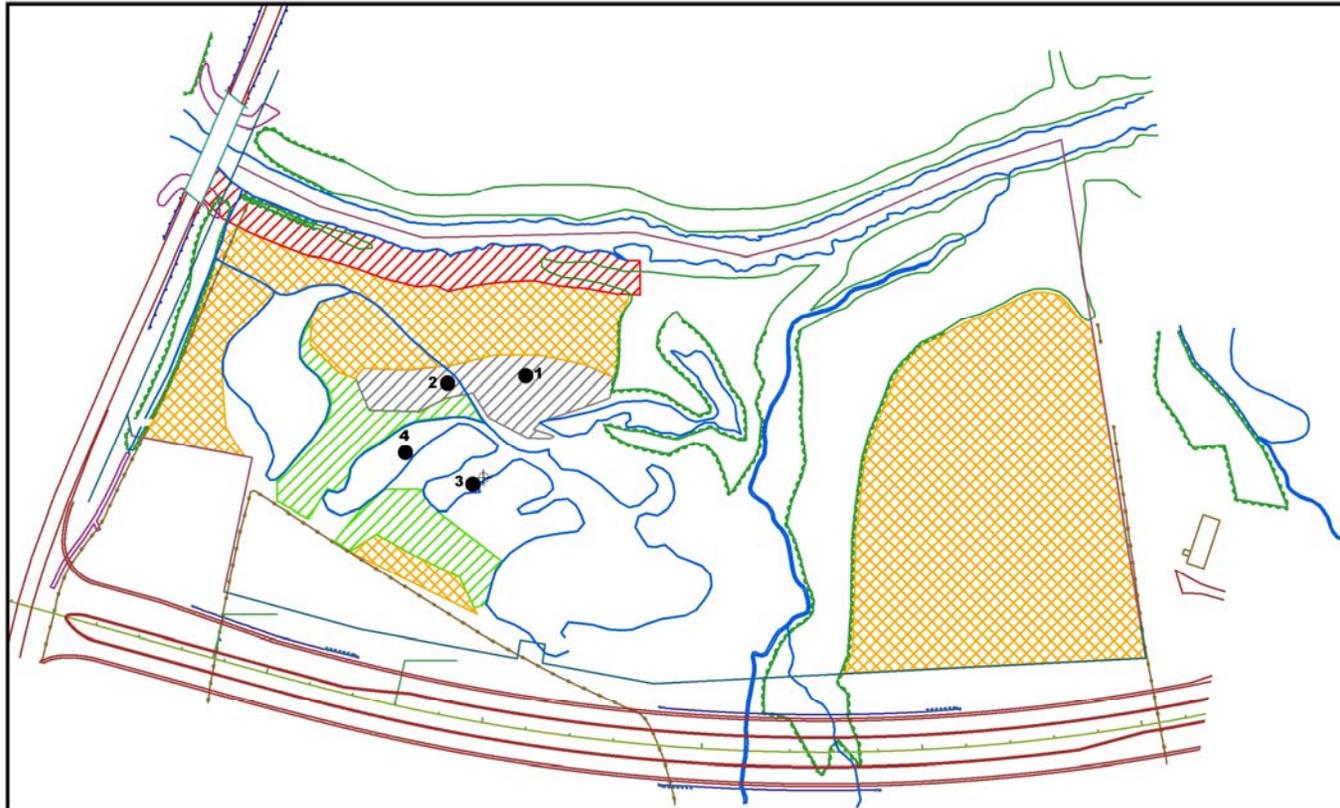
**Figure 2. Gauge Location Map**

In March 2005, four groundwater gauges were installed across the site (Figure 2). The automatic monitoring gauges record daily readings of groundwater depth. The 2006-year represents the second growing season that the monitoring gauges have been in place since construction of the site.

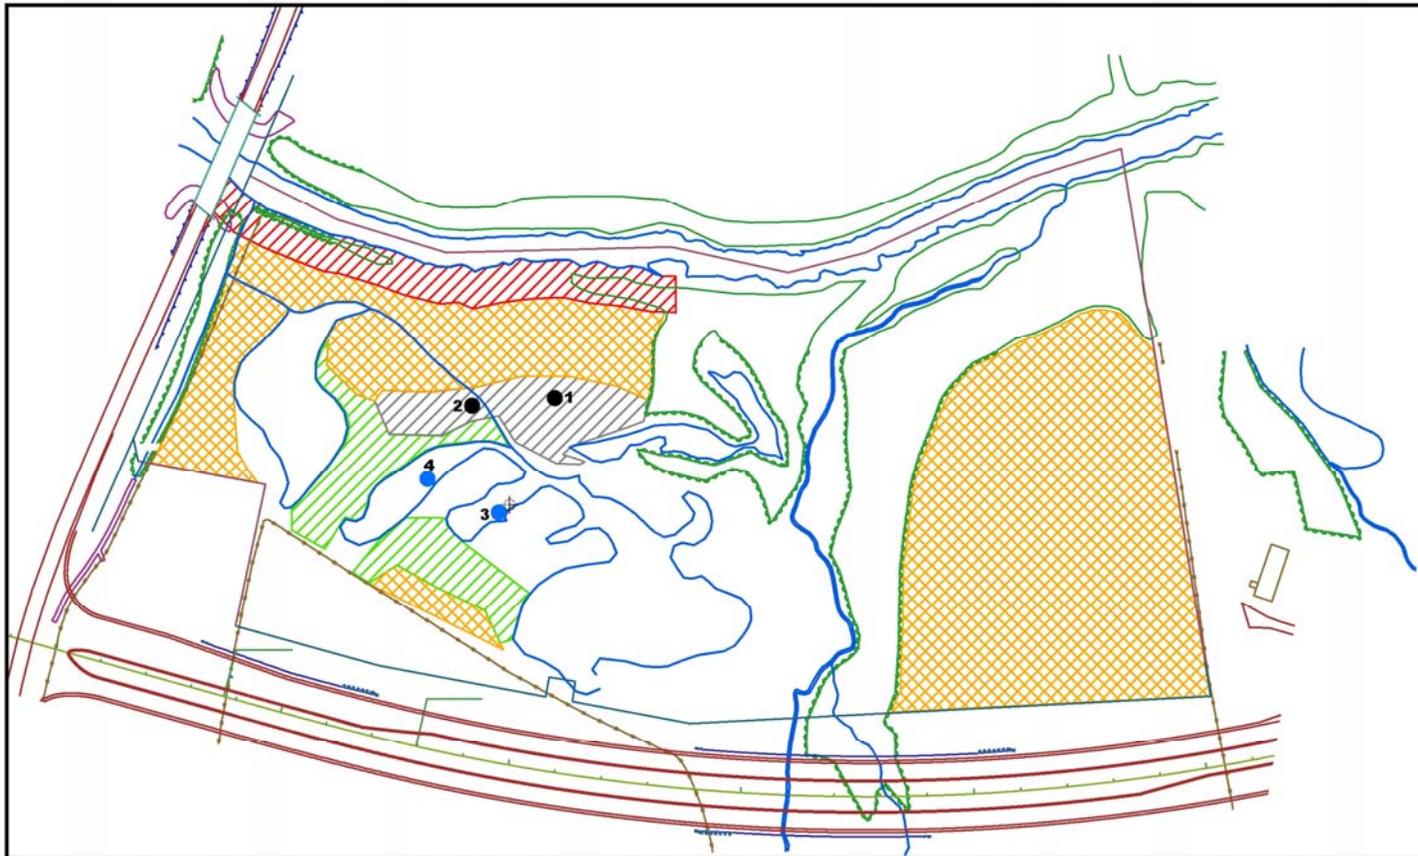
**Figure 3. 2006 Hydrologic Monitoring Gauge Results**

The maximum number of consecutive days that the groundwater was within twelve inches of the surface was determined for each gauge. This number was converted into a percentage of the 222-day growing season. The results are presented in Table 1. Figure 3 also provides a graphical representation of the hydrologic results. Gauges highlighted in blue indicate wetland hydrology for more than 10% of the growing season. Gauges highlighted in red show hydrology between 5% and 10% of the growing season. Those gauges highlighted in black indicate no wetland hydrology (< 5% of the growing season).

<b>Monitoring Gauge</b>	<b>&lt;5%</b>	<b>5%-10%</b>	<b>&gt;10.0%</b>	<b>Actual %</b>	<b>Success Dates</b>
GW-1(Creation)	<b>X</b>			<b>3.6</b>	
GW-2 (Creation)	<b>X</b>			<b>4.1</b>	
GW-3+ (Preservation)			<b>X</b>	<b>40.1</b>	March 28-June 18 August 8-Nov 4
GW-4+ (Preservation)			<b>X</b>	<b>11.3</b>	April 19-May 13 October 12-Nov 4

The 2006-year represents the second year for hydrology monitoring. Two of the four-groundwater gauges located in the wetland preservation area, exceeded the success criteria of saturation within 12" of the soil surface for greater than 10% of the growing season. The two gauges that failed to meet the success criteria are located in the wetland creation area and will be investigated by NCDOT.

Two of the four groundwater-monitoring gauges in the wetland preservation area met the hydrology success criteria on the Indian Creek Mitigation Site in 2006. The two gauges that are located in the wetland creation area recorded hydrology for less than 5% (consecutive) of the growing season. NCDOT will investigate the gauges that failed to meet the success criteria during the 2006-monitoring year.

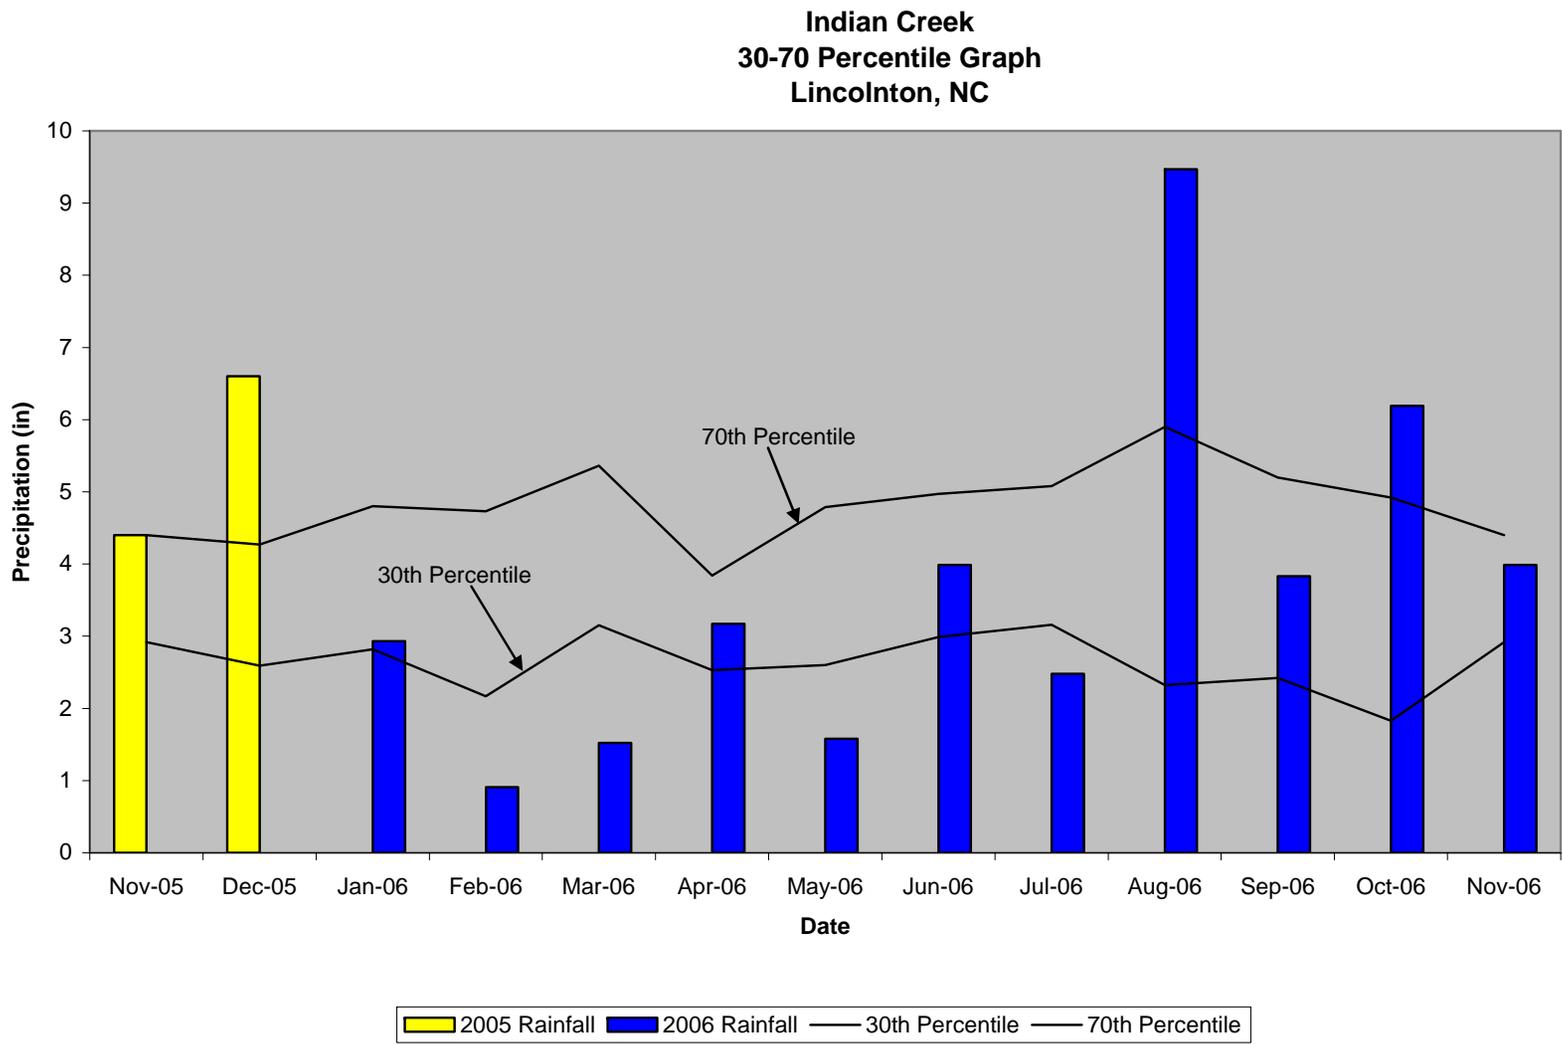
Figure 4: 30-70 Percentile Graph

Figure 4 is a comparison of monthly rainfall for the period of November 2005 through November 2006 to historical precipitation (collected between 1975 and 2006) for Lincolnton, North Carolina. This comparison gives an indication of how 2006 relates to historical data in terms of climate conditions. The NC State Climate Office provided all local rainfall information.

For the 2006-year; August and October experienced above average rainfall. The months of February, March, May, and July recorded below average rainfall for the site, while January, April, June, September, and November recorded average rainfall. Overall, 2006 experienced an average rainfall year.
