# ANNUAL REPORT FOR 2007

**Indian Creek Mitigation Site  
Lincoln County  
TIP No. R-0617BA**

Prepared By:  
Natural Environment Unit & Roadside Environmental Unit  
North Carolina Department of Transportation  
January 2008

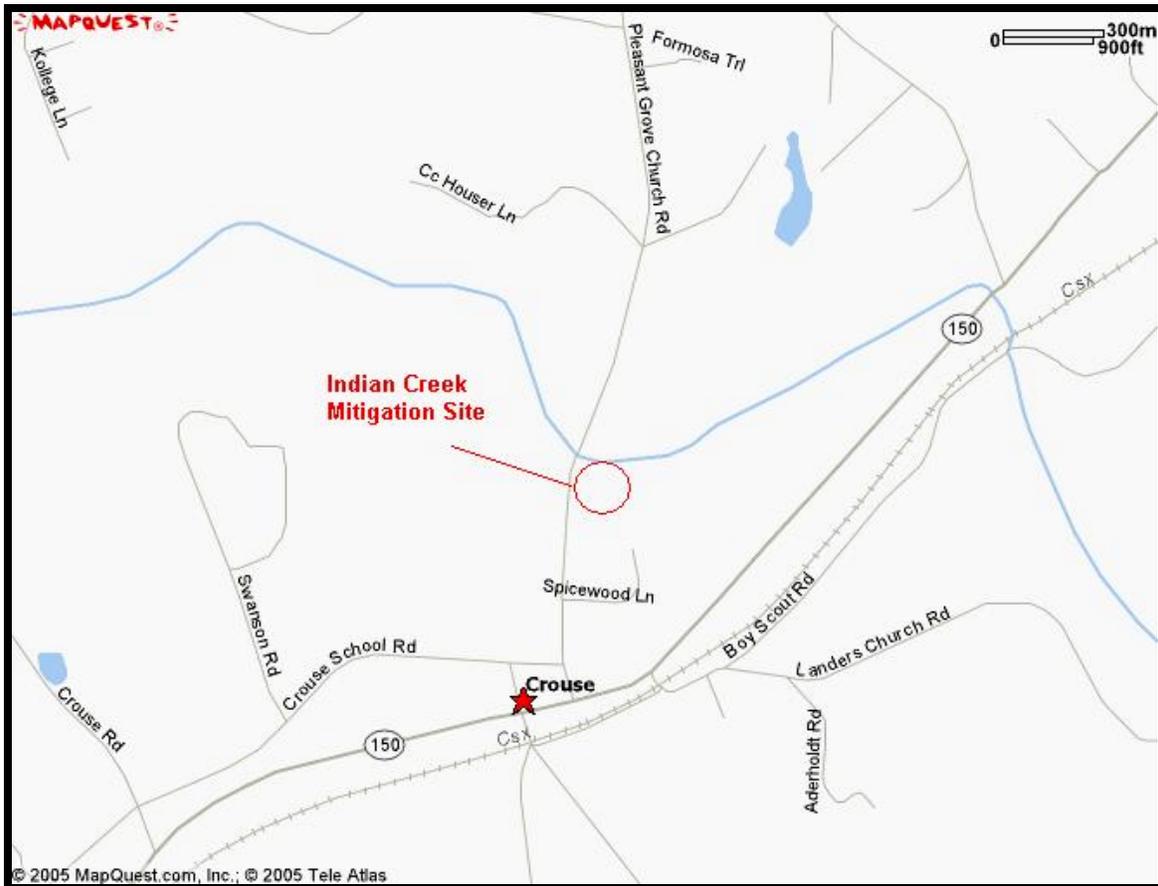
Figure 1. Site Location Map

The Indian Creek Mitigation Site is located on Pleasant Union Church Road, south of Lincolnton and just north of the town of Crouse. The site is adjacent to Indian Creek in Lincoln County (Figure 1). NCDOT is using onsite mitigation at the Indian Creek Site to offset impacts to existing wetlands and streams from the construction of NC 150 in Lincoln County.

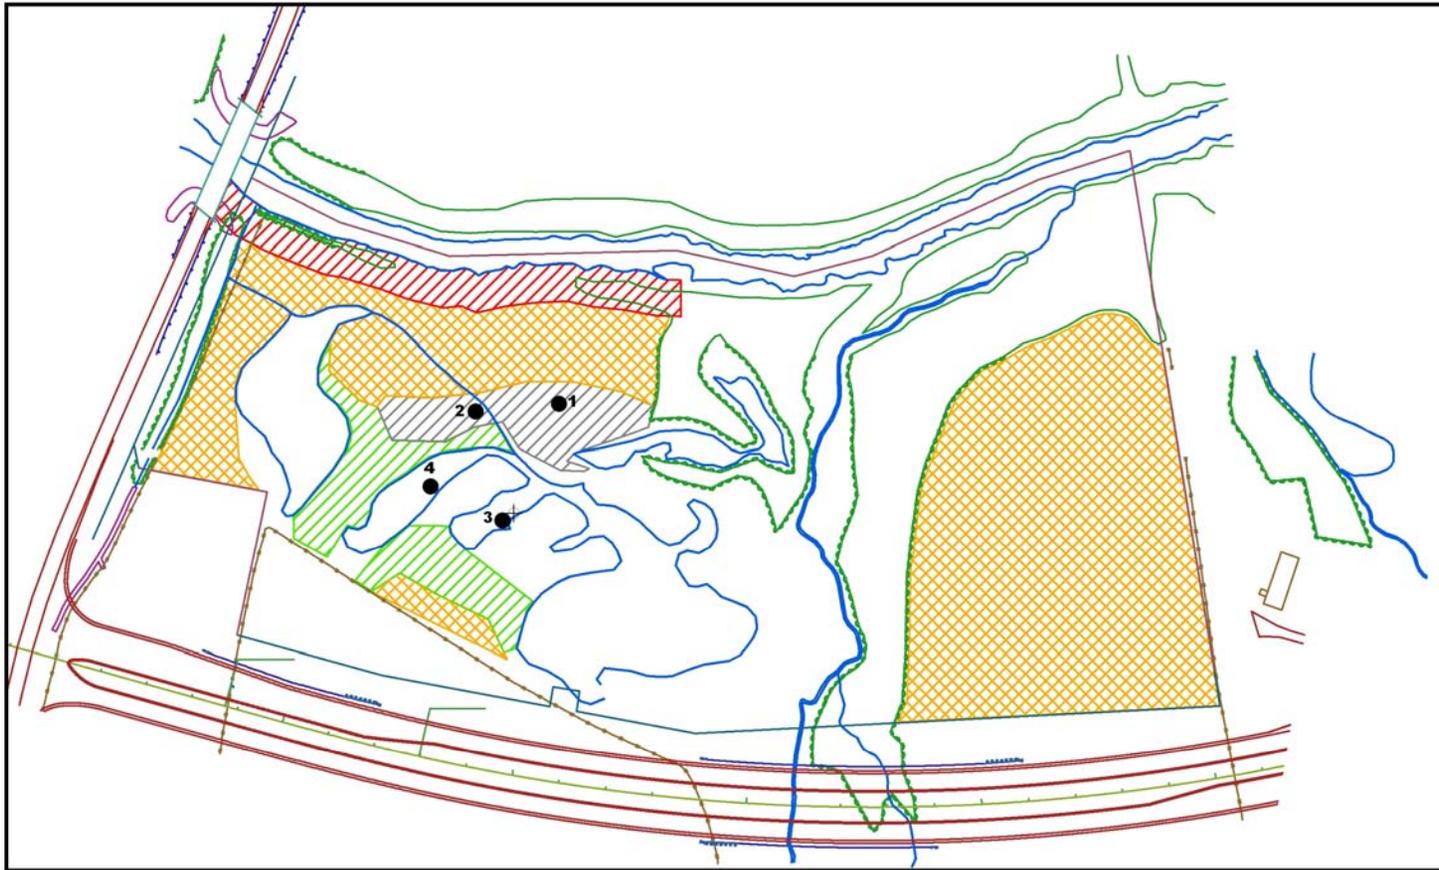
**Figure 2. Gauge Location Map**

In March 2005, four groundwater gauges were installed across the site (Figure 2). The automatic monitoring gauges record daily readings of groundwater depth. The 2007 year represents the third growing season that the monitoring gauges have been in place since construction of the site.

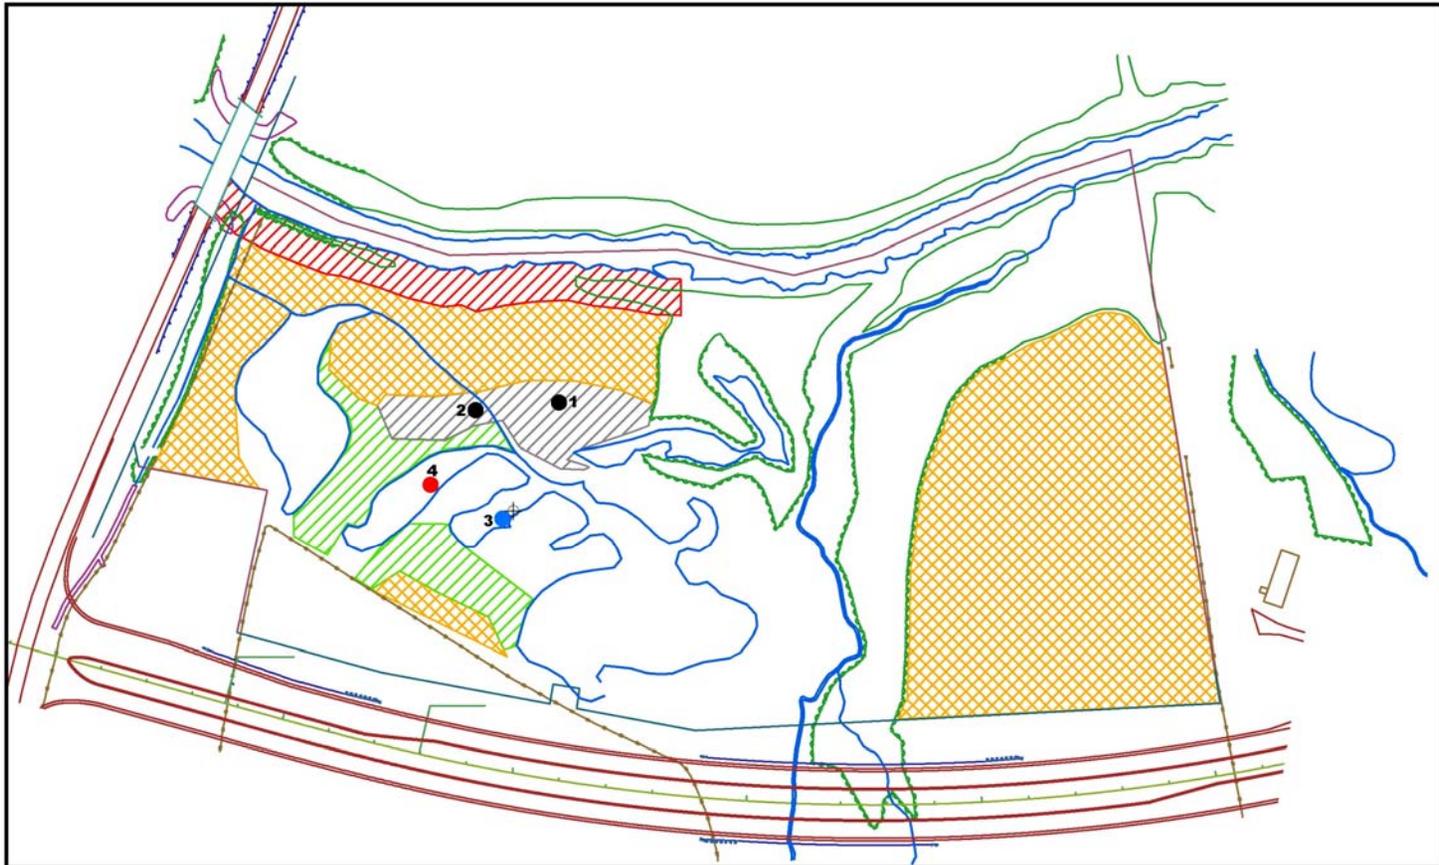
**Figure 3. 2007 Hydrologic Monitoring Gauge Results**

The maximum number of consecutive days that the groundwater was within twelve inches of the surface was determined for each gauge. This number was converted into a percentage of the 222-day growing season. The results are presented in Table 1. Figure 3 also provides a graphical representation of the hydrologic results. Gauges highlighted in blue indicate wetland hydrology for more than 10% of the growing season. Gauges highlighted in red show hydrology between 5% and 10% of the growing season. Those gauges highlighted in black indicate no wetland hydrology (< 5% of the growing season).

Monitoring Gauge	<5%	5%-10%	>10.0%	Actual %	Success Dates
GW-1 (Creation)	X			1.4	
GW-2 (Creation)	X			1.4	
GW-3+			X	27.5	March 28-May 27 June 12-July 1
GW-4		X		6.3	April 19-May 2

- Gauge (GW-4) experienced malfunction and stopped recording data (March 21-April 18)

One of the four groundwater monitoring gauges met the hydrology success criteria at the Indian Creek Mitigation Site in 2007. The gauge located in the preservation area experienced a gauge malfunction at the beginning of the growing season, resulting in the gauge meeting hydrology only 6.3% of the growing season. The two gauges that are located in the wetland creation area recorded hydrology for less than 5% (consecutive) of the growing season. NCDOT will investigate the gauges along with the creation area that failed to meet the success criteria during the 2007 monitoring year.

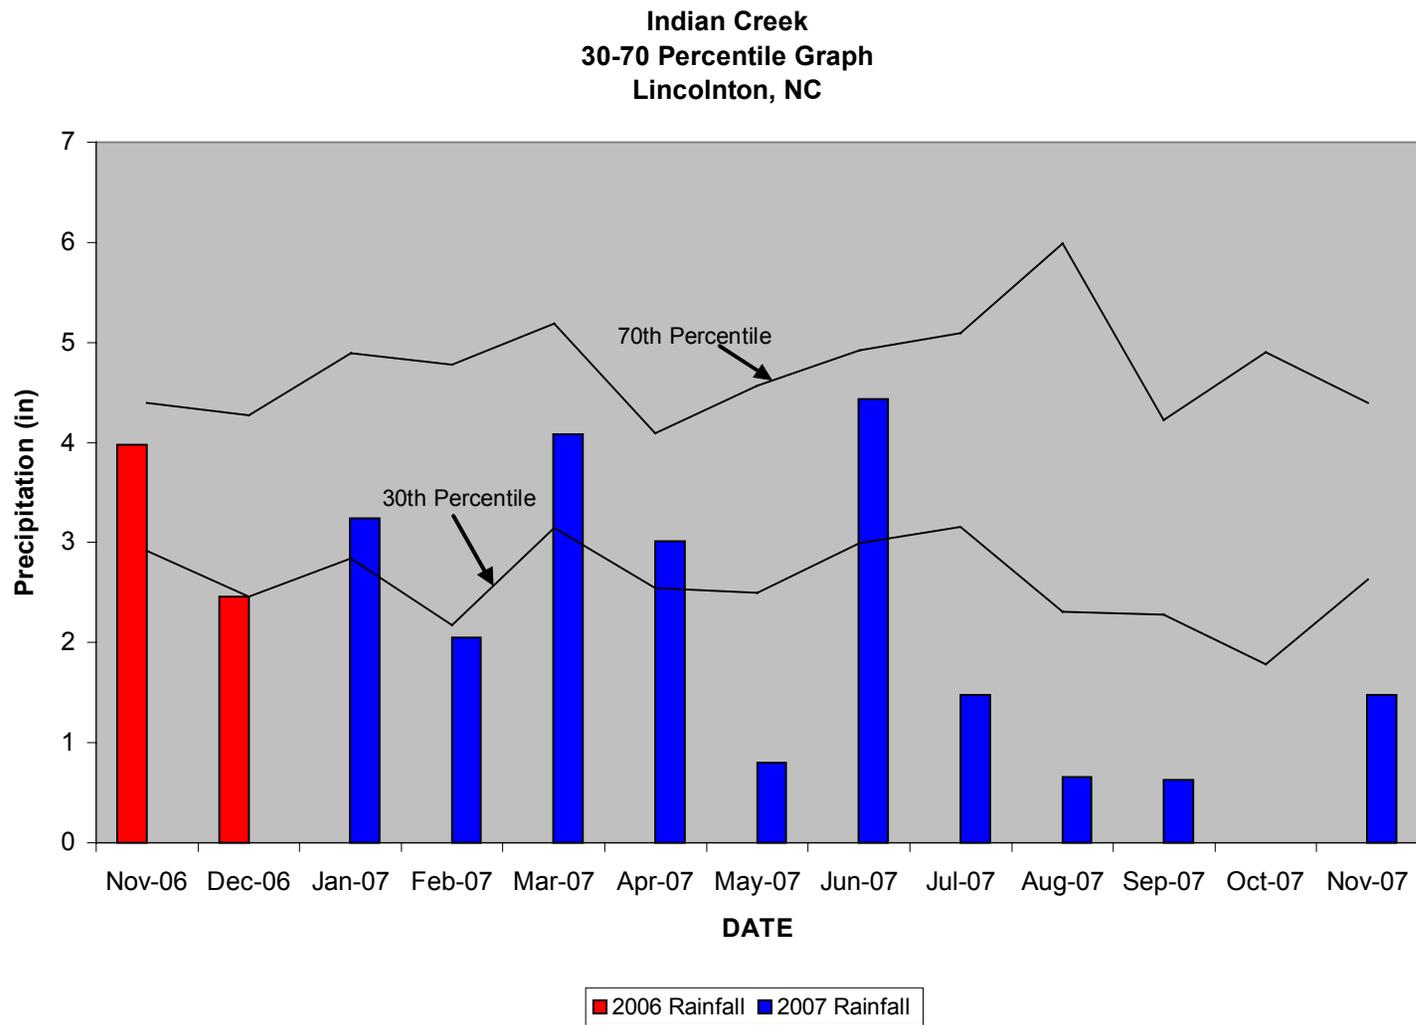
**Figure 4: 30-70 Percentile Graph**

Figure 4 is a comparison of monthly rainfall for the period of November 2006 through November 2007 to historical precipitation (collected between 1976 and 2007) for Lincolnton, North Carolina. This comparison gives an indication of how 2007 relates to historical data in terms of climate conditions. The NC State Climate Office provided all historical rainfall information.

For 2007, February, May, July, August, September, October, and November recorded below average rainfall for the site. The months of January, March, April and June recorded average rainfall. Due to the drought, 2007 was a below average rainfall year.

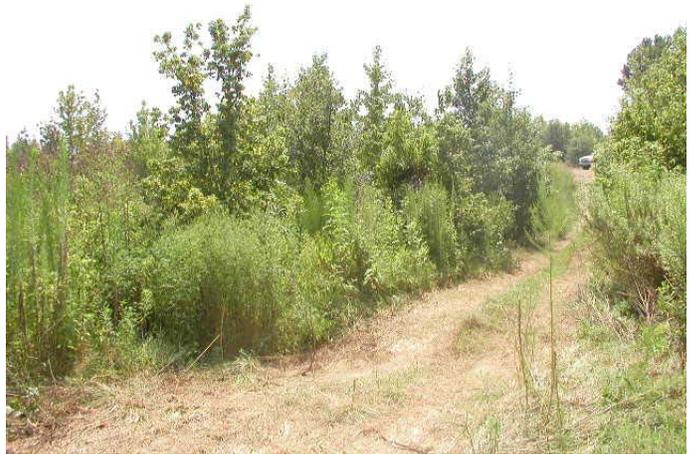
Photo 4

**Site Notes:** Other vegetation noted: goldenrod, fennel, poison ivy, sweetgum, woolgrass, red maple, *Juncus* sp., horse-nettle, black willow, blackgum and various grasses. Green ash was noted in the creation area, though none were counted in the plot. There was some ATV and vehicle activity noted on site during the monitoring evaluation in the upland buffer enhancement area (photos 4 and 5) and steps are being taken to stop the vehicular trespass.
