Monitoring Data Record

Project Title: R-977A US 64 COE Action ID: 2005301150
Stream Name: UT to Hiwassee River (Site 11) DWQ Number: 3487
City, County and other Location Information: Murphy, Cherokee County, US 64, from
US 19-74-129 in Murphy to East of NC 141 in Peachtree (Sta. 12+20 to 15+50)
Date Construction Completed: March 2007 Monitoring Year: (5) of 5
Ecoregion: _____ 8 digit HUC unit 06020002
USGS Quad Name and Coordinates: _____

Year 5 Summer – August 2012

UT Hiwassee River
R-977A
Cherokee County

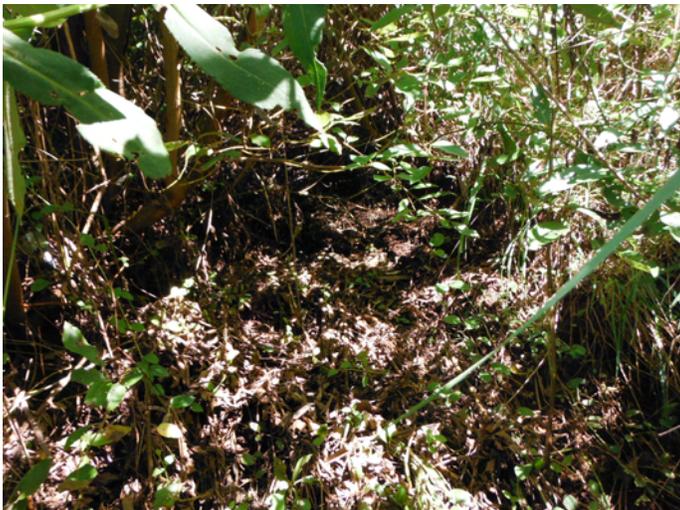
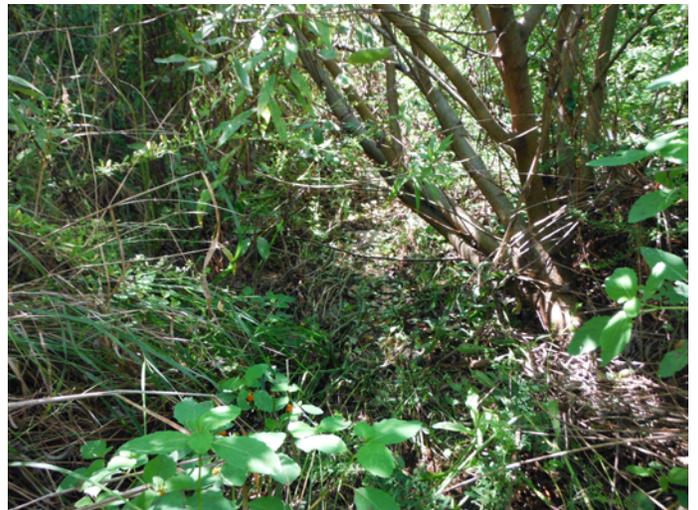
Photo Point #6 (Upstream)

This is the Year 5 Summer evaluation for the UT Hiwassee River stream relocation. The channel is stable at this time but water continues to piping underground around Photo Point #6 due to blasting to relocate the channel. Water was flowing under two crossvanes downstream of Photo Point #7. A permit modification was completed to relocate an additional 135 feet of stream at Site 11. Photo Point numbers 10 and 11 up and downstream, respectively shows this additional 135 feet. This section of the stream relocation is mainly bedrock.

Date Inspected 8/21/12	Up and Downstream of PP#6	Downstream of PP#7	Station Number	Station Number	Station Number
Structure Type		Crossvanes			
Is water piping through or around structure?	No flow in channel. Water is piping underground due to blasting to relocate the channel.	Water piping under two crossvanes			
Head cut or down cut present?					
Bank or scour erosion present?					
Other problems noted?

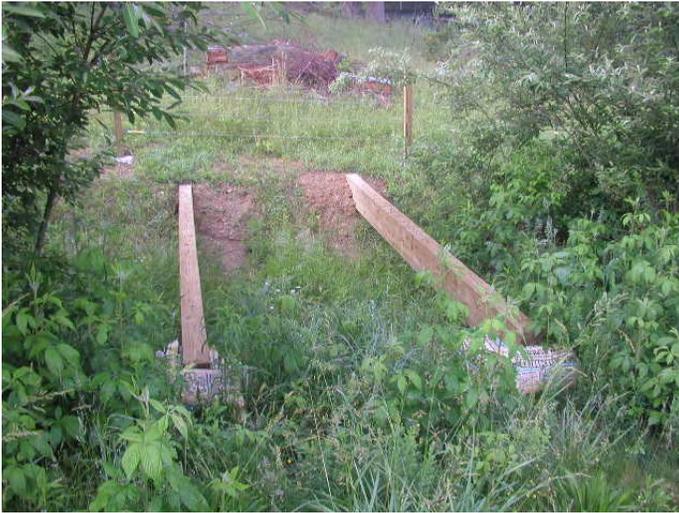
On May 17, 2012, NCDOT became aware that an adjacent landowner had placed a fence and bridge along this stream relocation. A letter was sent on June 5, 2012 to the landowner requesting that the fence and bridge be removed. During the August 21, 2012 monitoring evaluation it was confirmed that the fence and bridge were removed. See the attached photos of before and after the fence and bridge were removed and the letter sent to the landowner. Signs were installed on May 17, 2012 around the perimeter of the site noting that this is a mitigation site and it is not to be disturbed. NCDOT proposes to discontinue channel stability monitoring at the UT Hiwassee River stream relocation.

Bridge and Fence Encroachment 5/17/12

Recent compliance inspections conducted by both NCDOT and environmental agencies have shown that this particular section of stream has been encroached upon by a fence and bridge. These have been illegally placed within the right-of-way limits of SR1558, Harshaw Road which is 88.57 feet from the centerline. I have attached a photo showing the encroachments. NCDOT has been notified that unless the area is allowed to grow and canopy the stream as intended that the area will be disqualified as a mitigation site.

By copy of this letter I am respectfully requesting that you remove the fence and bridge placed on the right-of-way of SR 1558. The removal should occur as soon as possible and within 15 days of receiving this letter. Your cooperation in carrying out this request and your prompt compliance with this notice is certainly appreciated. Should you have questions or require additional information do not hesitate to call me at 828-321-4105.

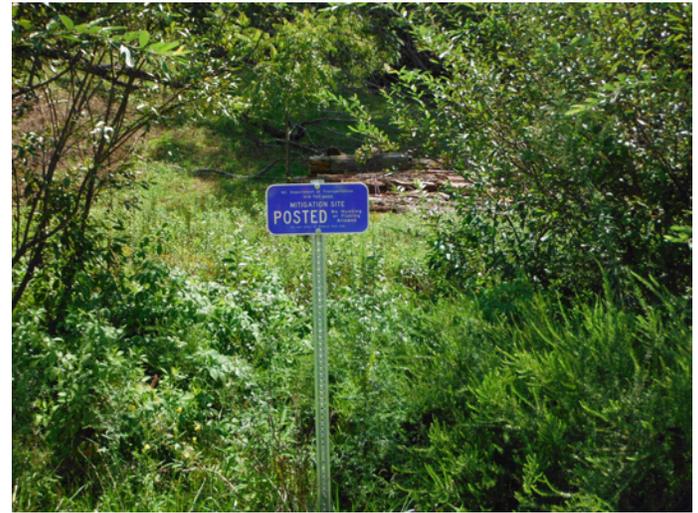
Bridge and Fence Removed 8/21/12
