Monitoring Data Record

Project Title: I-540 Northern Wake Expressway (R-2000AB) COE Action ID: 200021863
Stream Name: UT to Kit Creek DWQ Number: 030918
City, County and other Location Information: Wake County, Site 6 (Sta.10+41 to 12+76 YRPA-)
Date Construction Completed: March 2005 Monitoring Year: (3) of 5
Ecoregion: _____ 8 digit HUC unit 03030002
USGS Quad Name and Coordinates: _____

UT Kit Creek

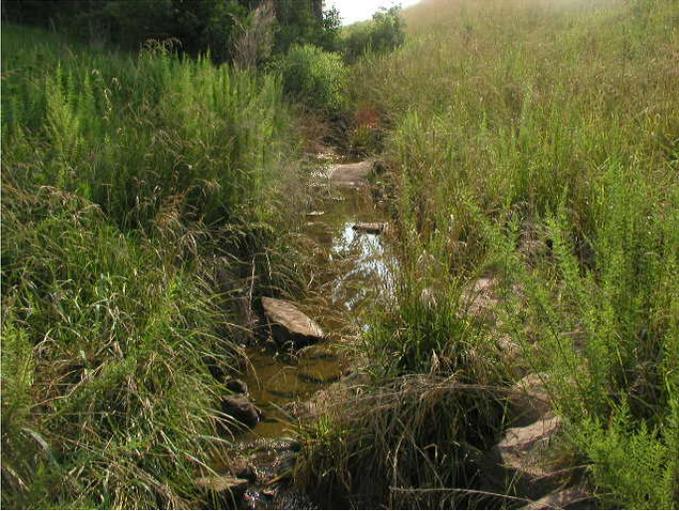
Photo Point #1 (Upstream)

There is evidence of beaver activity between photo point #1 and photo point #2.

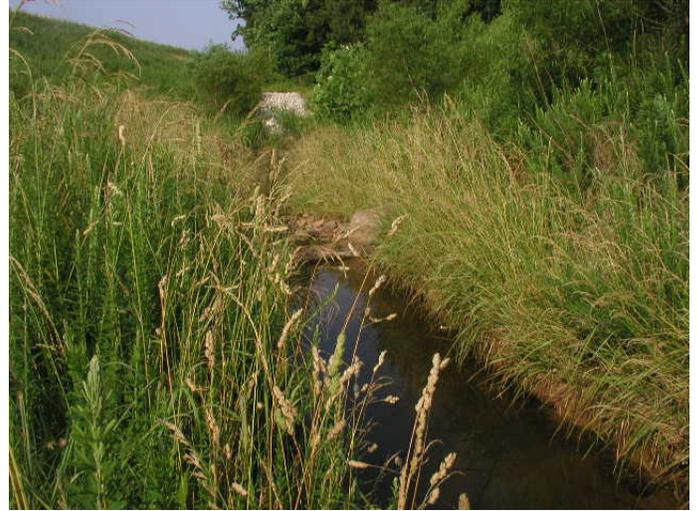
Photo Point #4 (Downstream)

The stream is stabilized for the Year 3 Summer evaluation. There is evidence that a bankfull event has occurred since the last monitoring evaluation. There is also water piping under the crossvane at Sta. 2+00-stream1- as seen from photo point #4 (downstream). NCDOT will continue to monitor this stream relocation.

6/11/08	Station 2+00 -Stream 1-	Station Number	Station Number	Station Number	Station Number
Structure Type	Crossvane				
Is water piping through or around structure?	Water is piping under crossvane				
Head cut or down cut present?					
Bank or scour erosion present?					
Other problems noted?
