ANNUAL REPORT FOR 2003

**Southwest Creek Mitigation Site
Lenoir County
Project No. 6.201014
TIP No. R-2001B**

Prepared By:
Office of Natural Environment & Roadside Environmental Unit
North Carolina Department of Transportation
December 2003

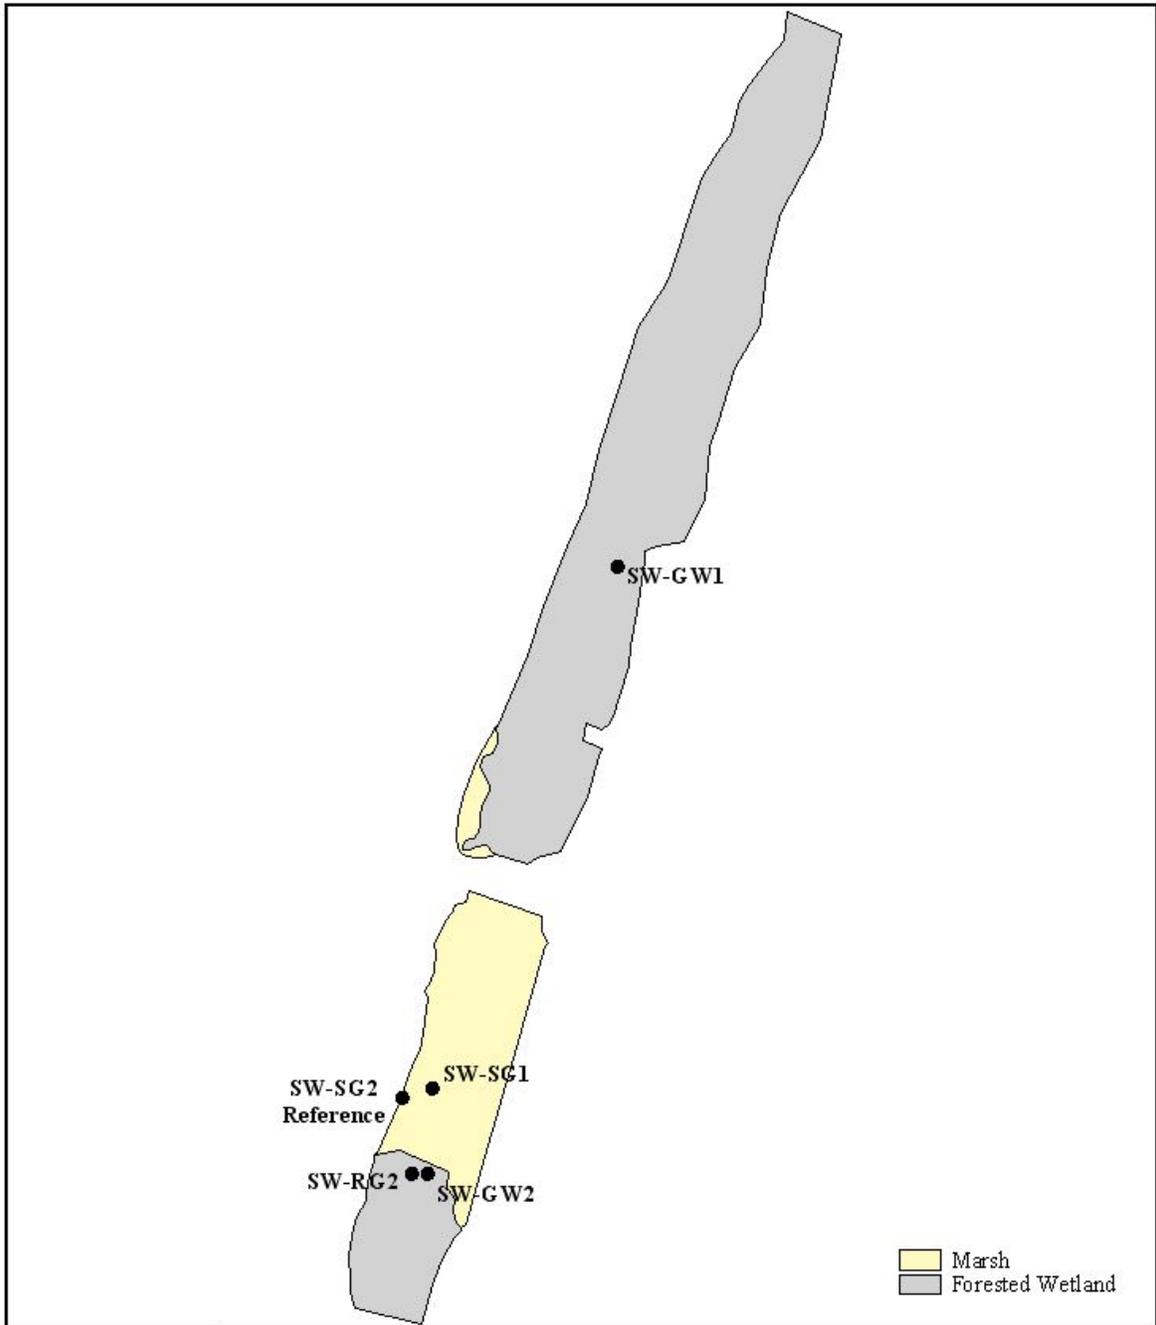
Figure 2. Gauge Location Map

Two groundwater gauges are used to measure groundwater levels within the forested wetland portions of the site. An additional two surface gauges are located within the marsh area (one gauge in the restored area, another gauge serves as a reference within the existing marsh (reference marsh) adjacent to the site). The data from the two surface gauges will be compared in order to determine the success of the marsh portion. A rain gauge is also located within the swamp area in order to get accurate site rainfall measurements. The site rainfall data is used to analyze the site's (specifically, the swamp portion's) response to rainfall events. Figure 2 is a location map showing the location of all of the site gauges.

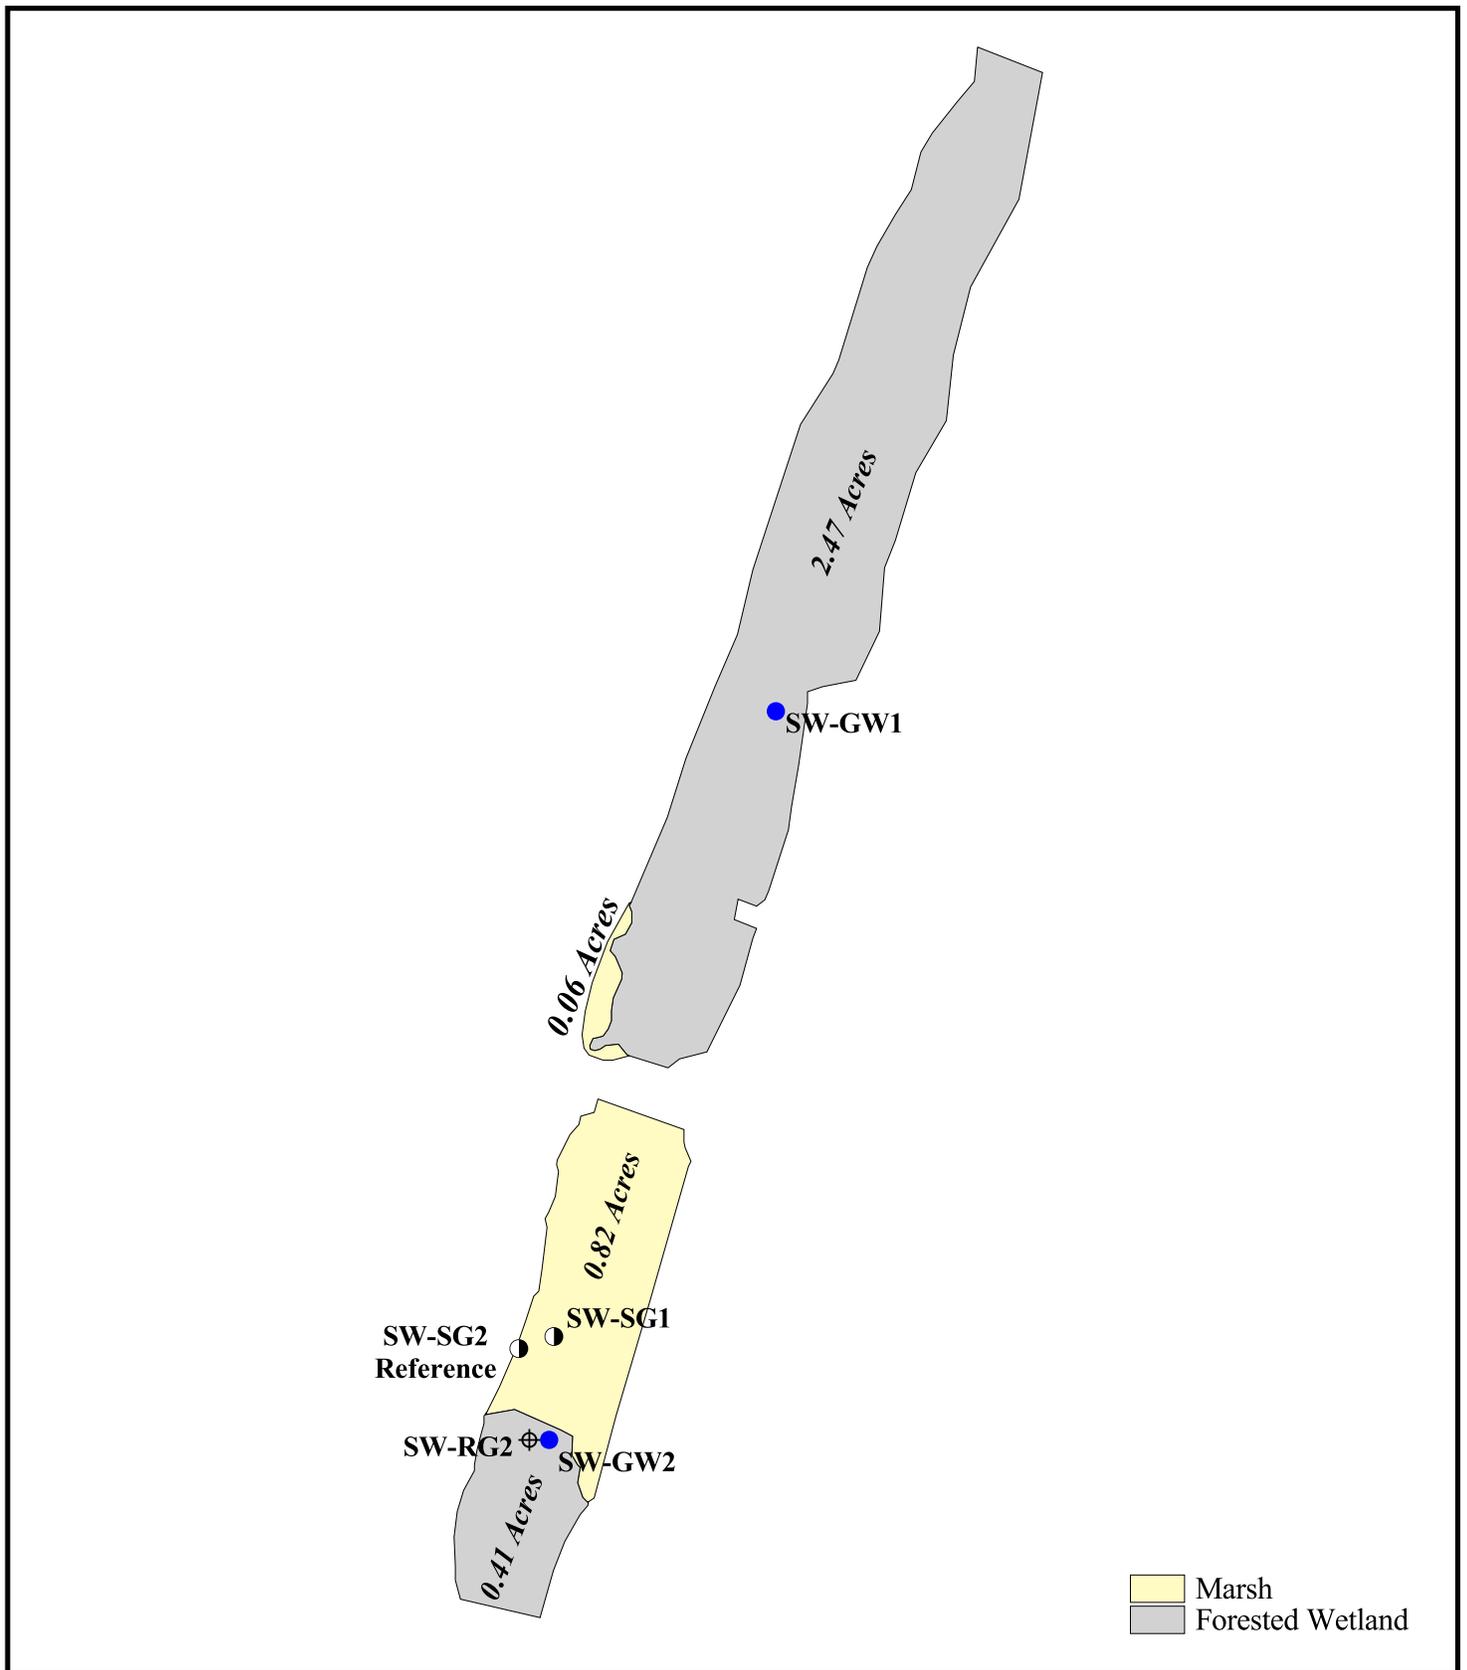
Figure 3. 2003 Hydrologic Monitoring Gauge Results

The total number of consecutive days that the groundwater was within twelve inches of the surface was determined at each groundwater monitoring gauge location. This number was converted into a percentage of the total growing season. Table 3 presents the hydrologic results for 2003. Figure 3 is a graphical representation of the hydrologic monitoring results for 2003.

The restored marsh gauge (SG-1) was comparable with the flooding patterns and inundation periods from the reference marsh gauge (SG-2).

Monitoring Gauge	< 5%	5-8%	8-12.5%	>12.5%	Actual %	Dates of Saturation
SW-GW1				×	75.4	May 16-November 15
SW-GW2				×	75.4	May 16-November 15

The 2003-year represents the first full growing season for which the hydrologic data has been examined. Both groundwater gauges in the forested wetland met the requirement for jurisdictional wetland hydrology (12.5% of the growing season). The restored marsh gauge (SG-1) was comparable with the flooding patterns and inundation periods from the reference marsh gauge (SG-2).

Hydrologic monitoring has indicated that the site has met the success criteria for the 2003-year.

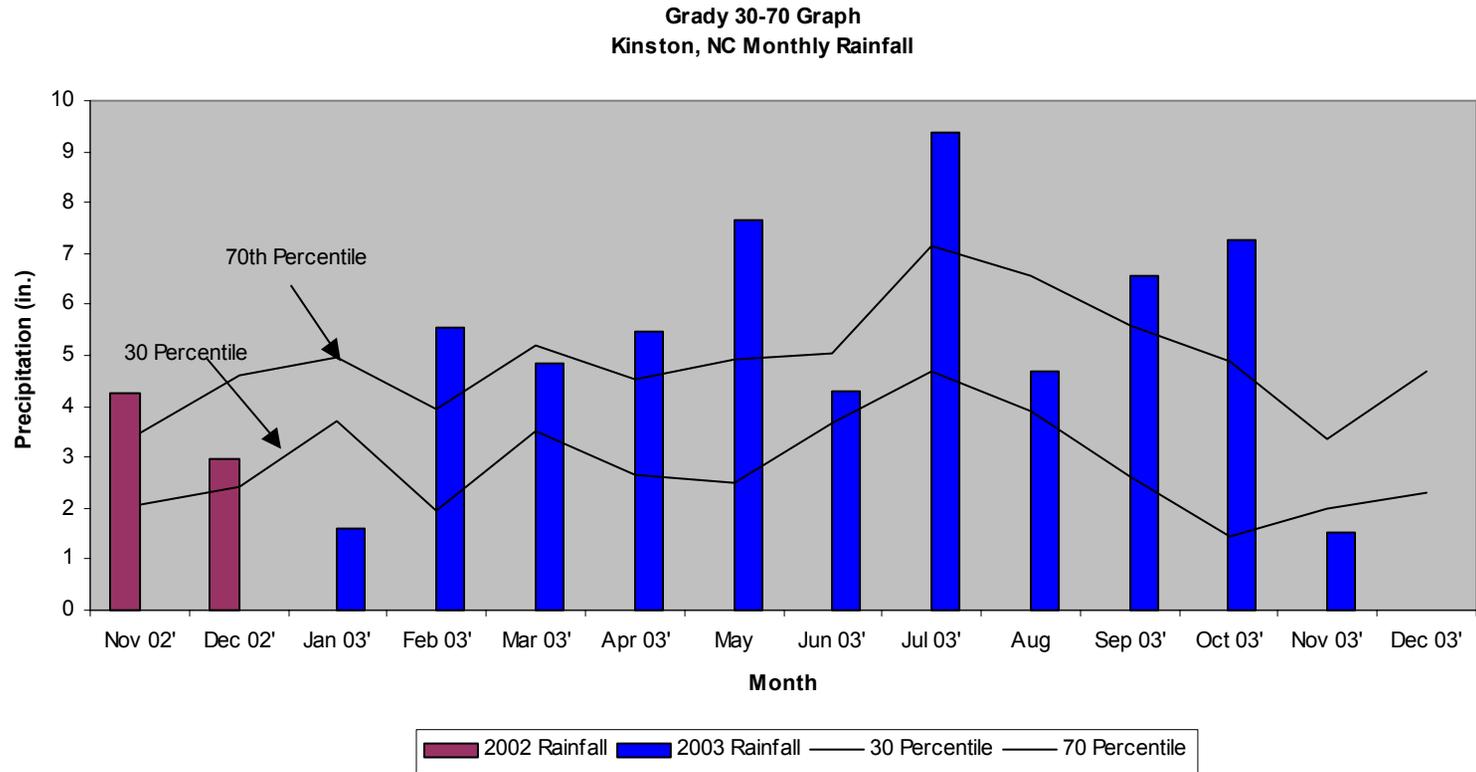
Figure 4. 30-70 Percentile Graph, Kinston, NC

Figure 4 is a comparison of monthly rainfall for the period of November 2002 through August 2003 to historical precipitation (collected between 1972 and 2003) for Kinston, North Carolina. This comparison gives an indication of how 2003 relates to historical data in terms of climate conditions. The NC State Climate Office provided all local rainfall information.

For the 2003-year, November (02'), February, April, May, July, September, and October experienced above average rainfall. The months of January and November recorded below average rainfall for the site. December (02'), March, June, and August experienced average rainfall. Overall, 2003 experienced an average to above average rainfall year.
