ANNUAL REPORT FOR 2004

**Deer Creek Mitigation Site
Carteret County
Project No. 6.16901T
TIP No. R-2105 WM**

Prepared By:
Office of Natural Environment & Roadside Environmental Unit
North Carolina Department of Transportation
December 2004

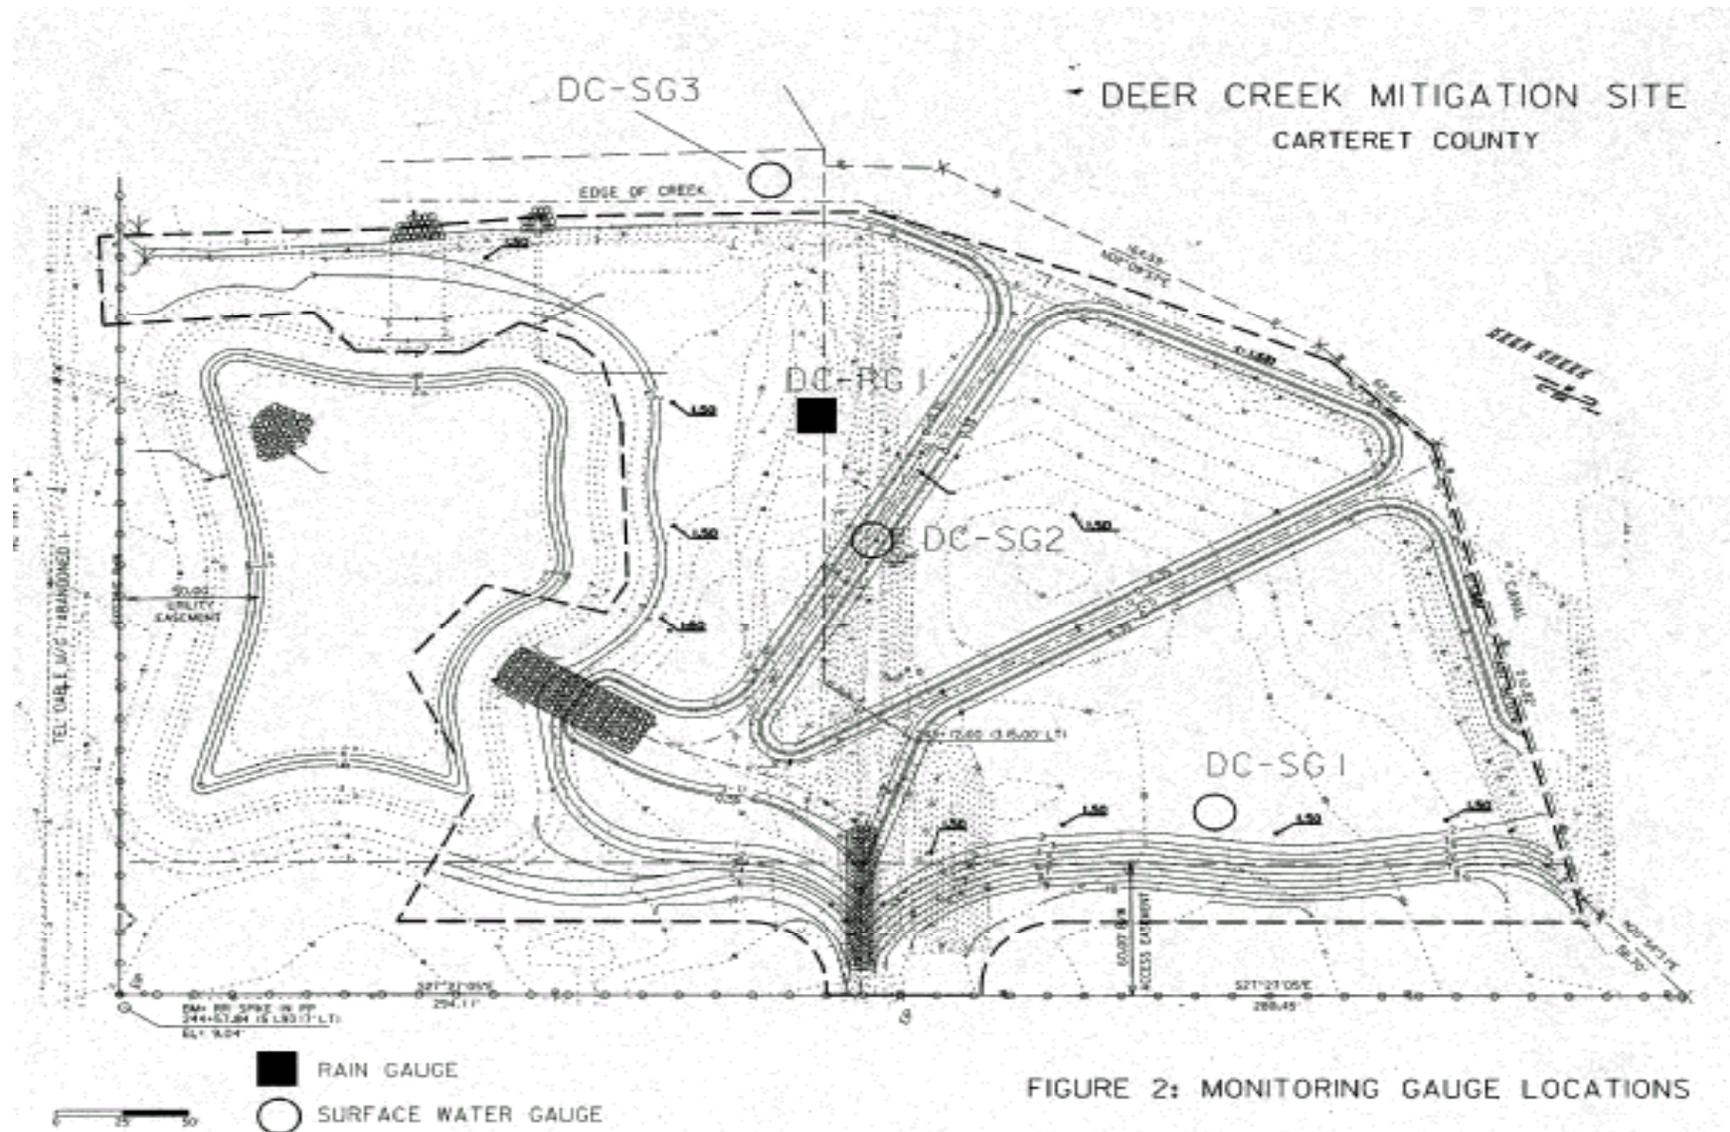
Figure 2. Gauge Location Map

Three surface water monitoring gauges and one rain gauge were installed onsite in June 2001 (Figure 2). The surface water gauges record surface water readings every hour. The Infinities rain gauge records rainfall amounts on a daily basis.

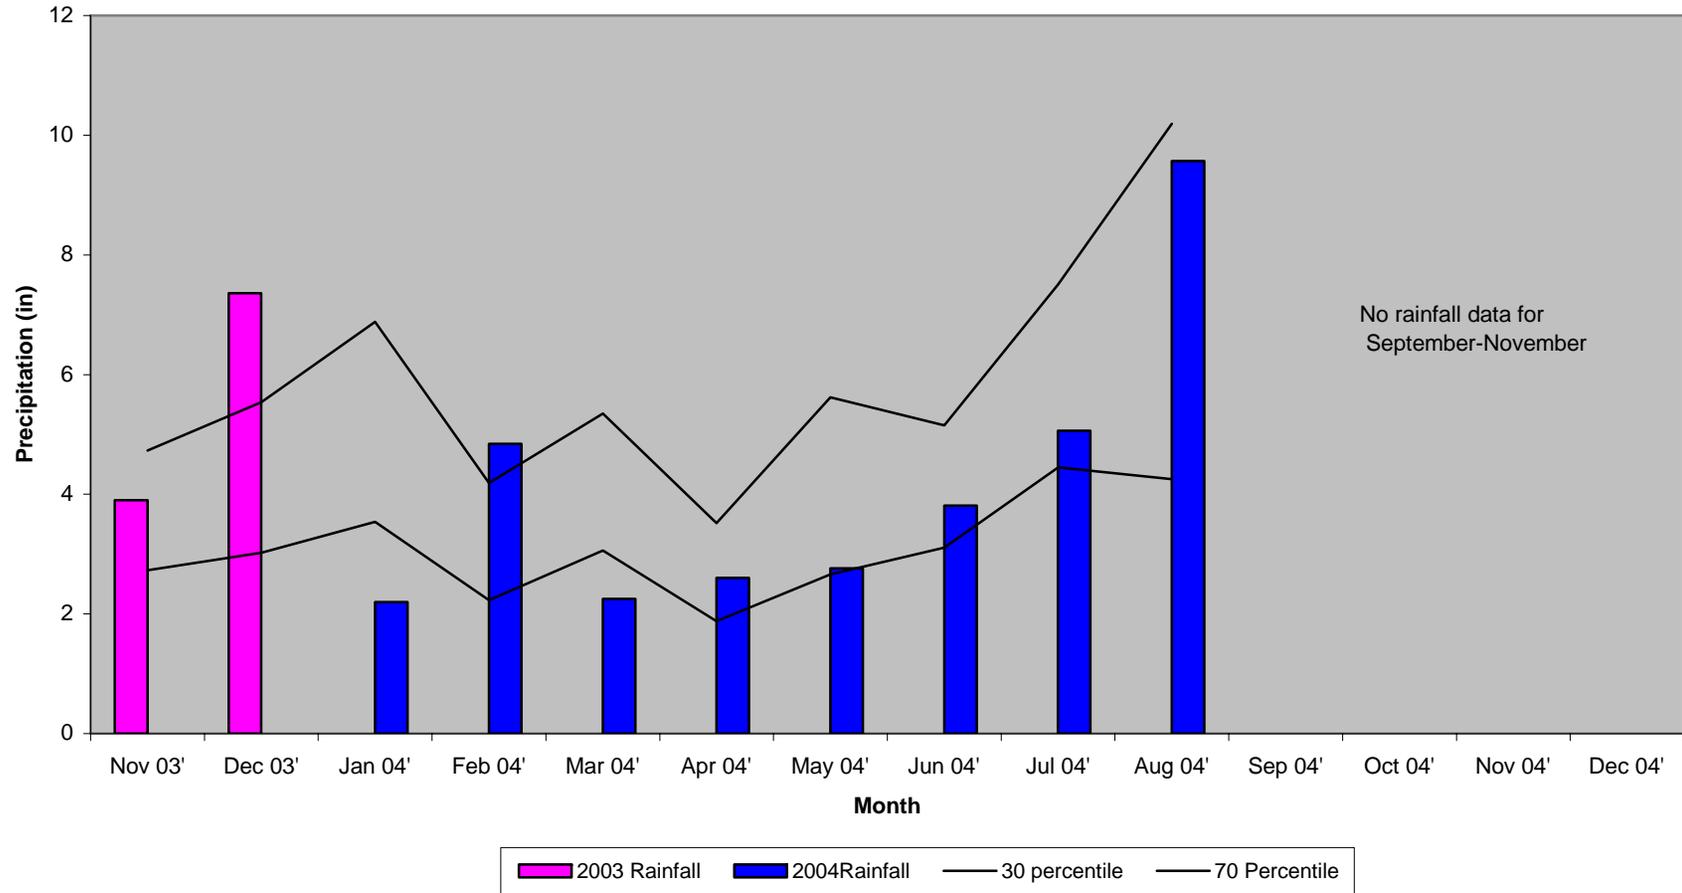
Figure 3. Deer Creek 30-70 Percentile Graph

Figure 3 is a comparison of monthly rainfall (November 2003- August 2004) to historical precipitation for the area. The rainfall data for the months of September-November 2004 were not included in the graph. The two lines represent the 30th and 70th percentiles of monthly precipitation for Morehead City, NC. These percentiles represent monthly rainfall data collected between 1973 and 2004 that was provided by the State Climate Office of North Carolina at NC State University.

For the 2004-year, December (03') and February experienced above average rainfall. The months of January, March and May recorded below average rainfall for the site and November (03'), April, June, July, and August experienced average rainfall. Overall, the site met the hydrologic criteria in a year of average climate conditions. However, precipitation is not the primary hydrologic input for the site; therefore, it is expected that the site would show the required flooding regardless of area rainfall totals.

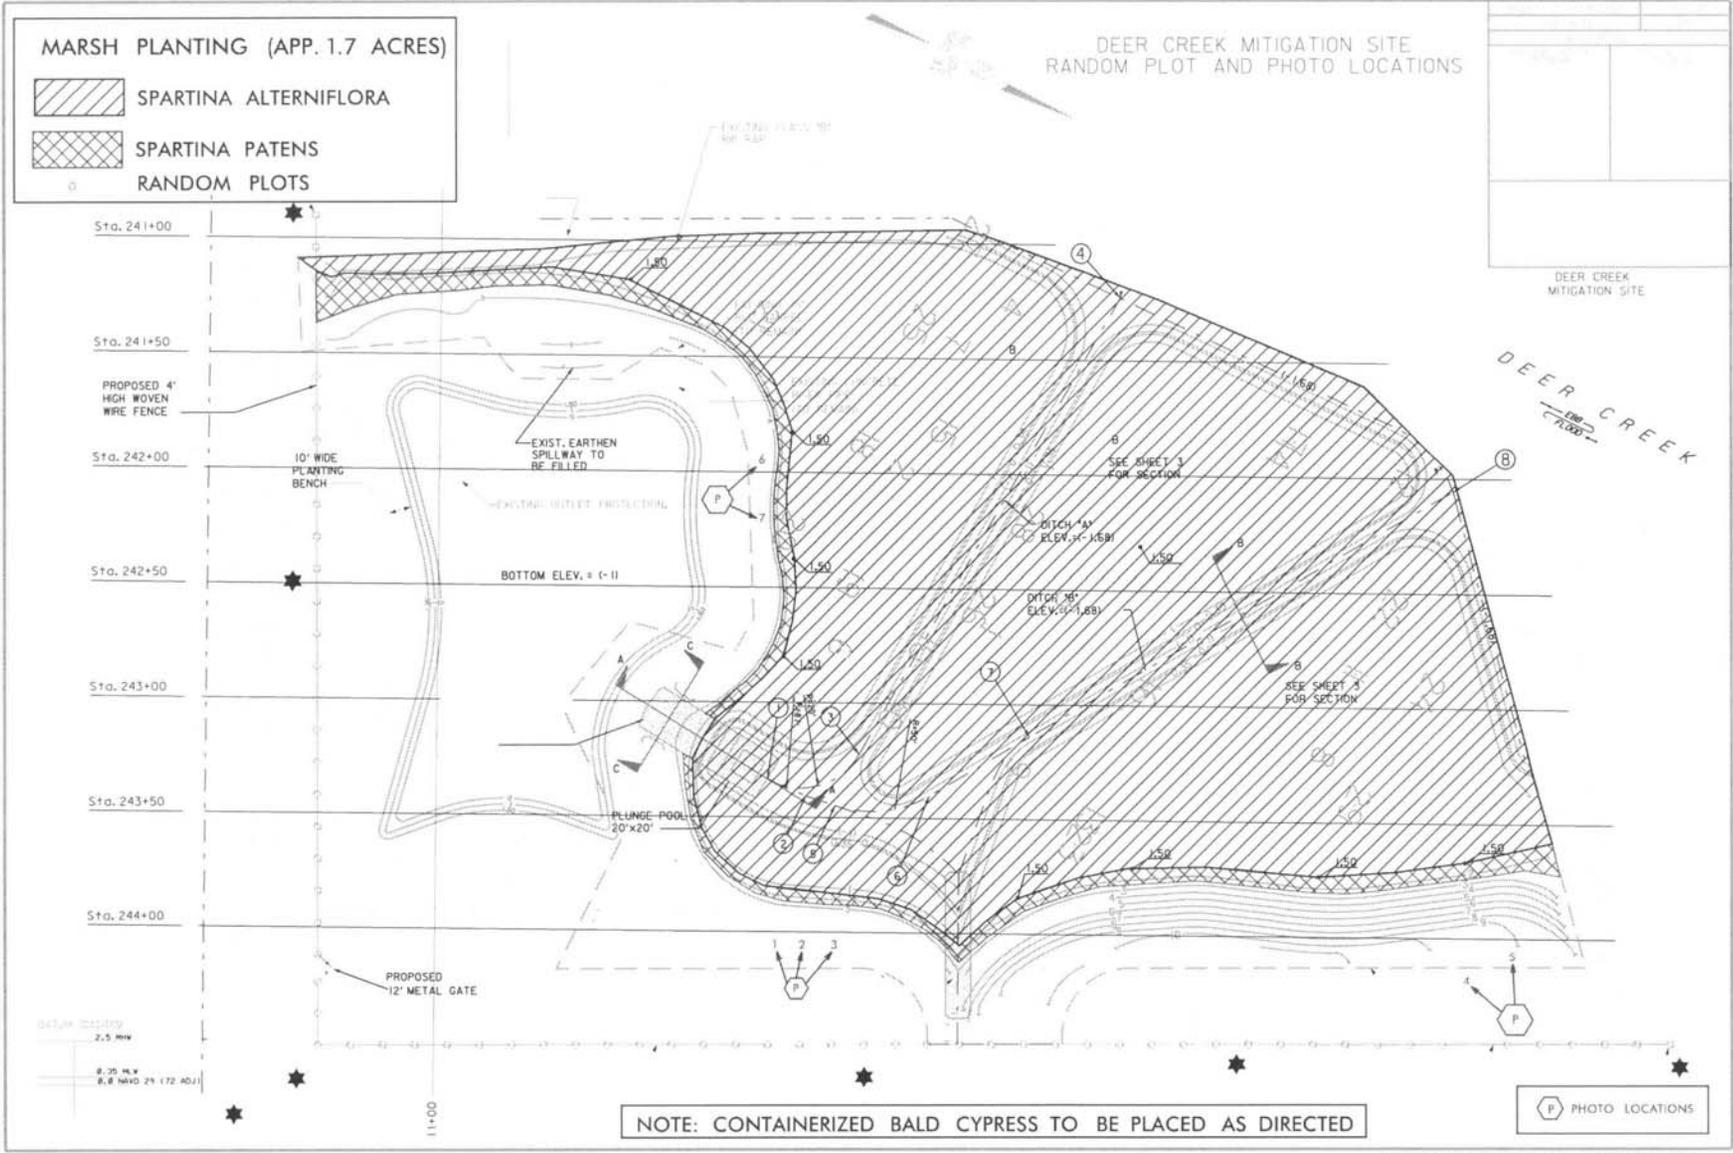
DEER CREEK MITIGATION SITE
RANDOM PLOT AND PHOTO LOCATIONS

MARSH PLANTING (APP. 1.7 ACRES)

SPARTINA ALTERNIFLORA

SPARTINA PATENS

RANDOM PLOTS
