# ANNUAL REPORT FOR 2010

**UT Forney Creek Wetland Mitigation Site  
Lincoln County  
TIP No. R-2206B**

Prepared By:  
Natural Environment Unit & Roadside Environmental Unit  
North Carolina Department of Transportation  
December 2010

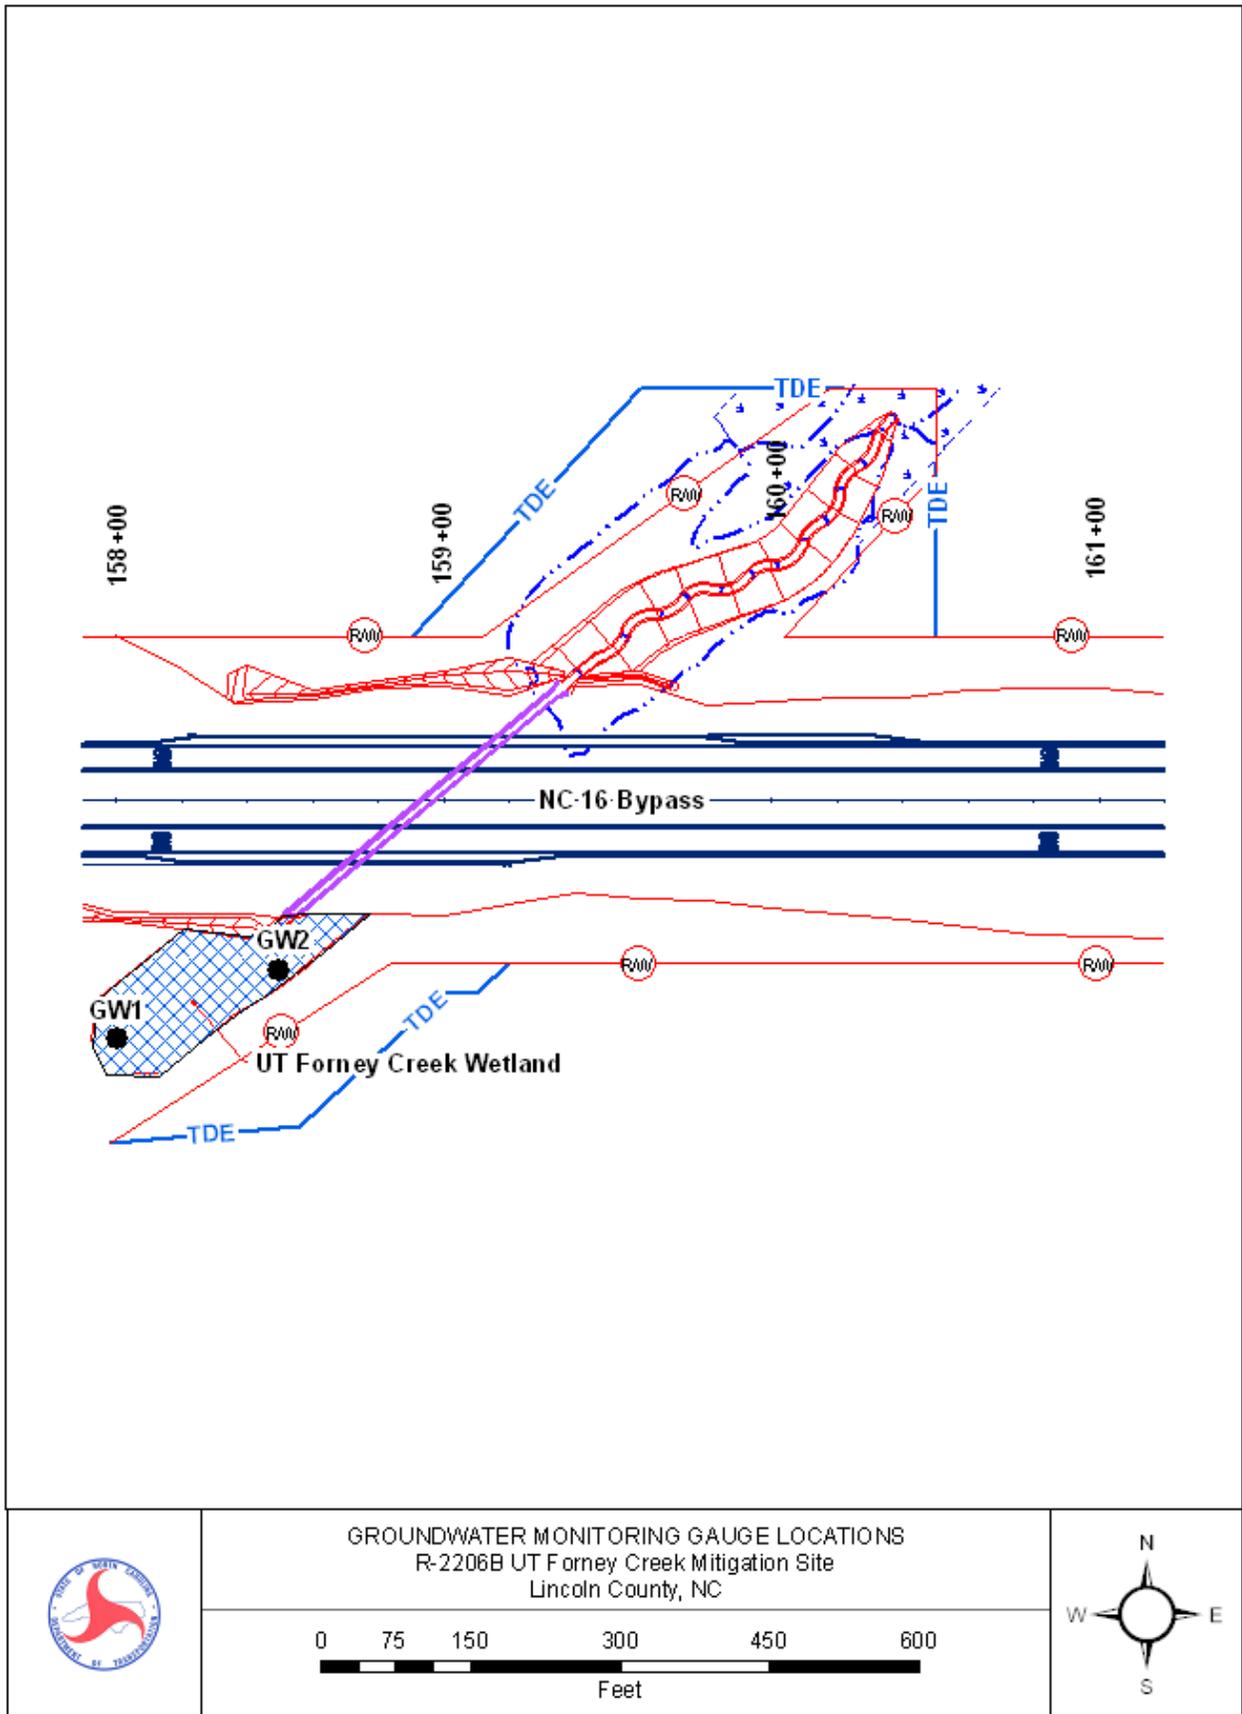
**Figure 2. Monitoring Gauge Location Map**

Two groundwater monitoring gauges were installed on the site (Figure 2) in February 2008 in the wetland restoration area. The groundwater gauges record water levels on a daily basis. A rain gauge is also located on the site to assist in comparison of the rainfall data from an official weather station in Lincolnton (supplied by the NC State Climate Office). Monitoring data for 2010 represents the third year of hydrologic monitoring for the site.

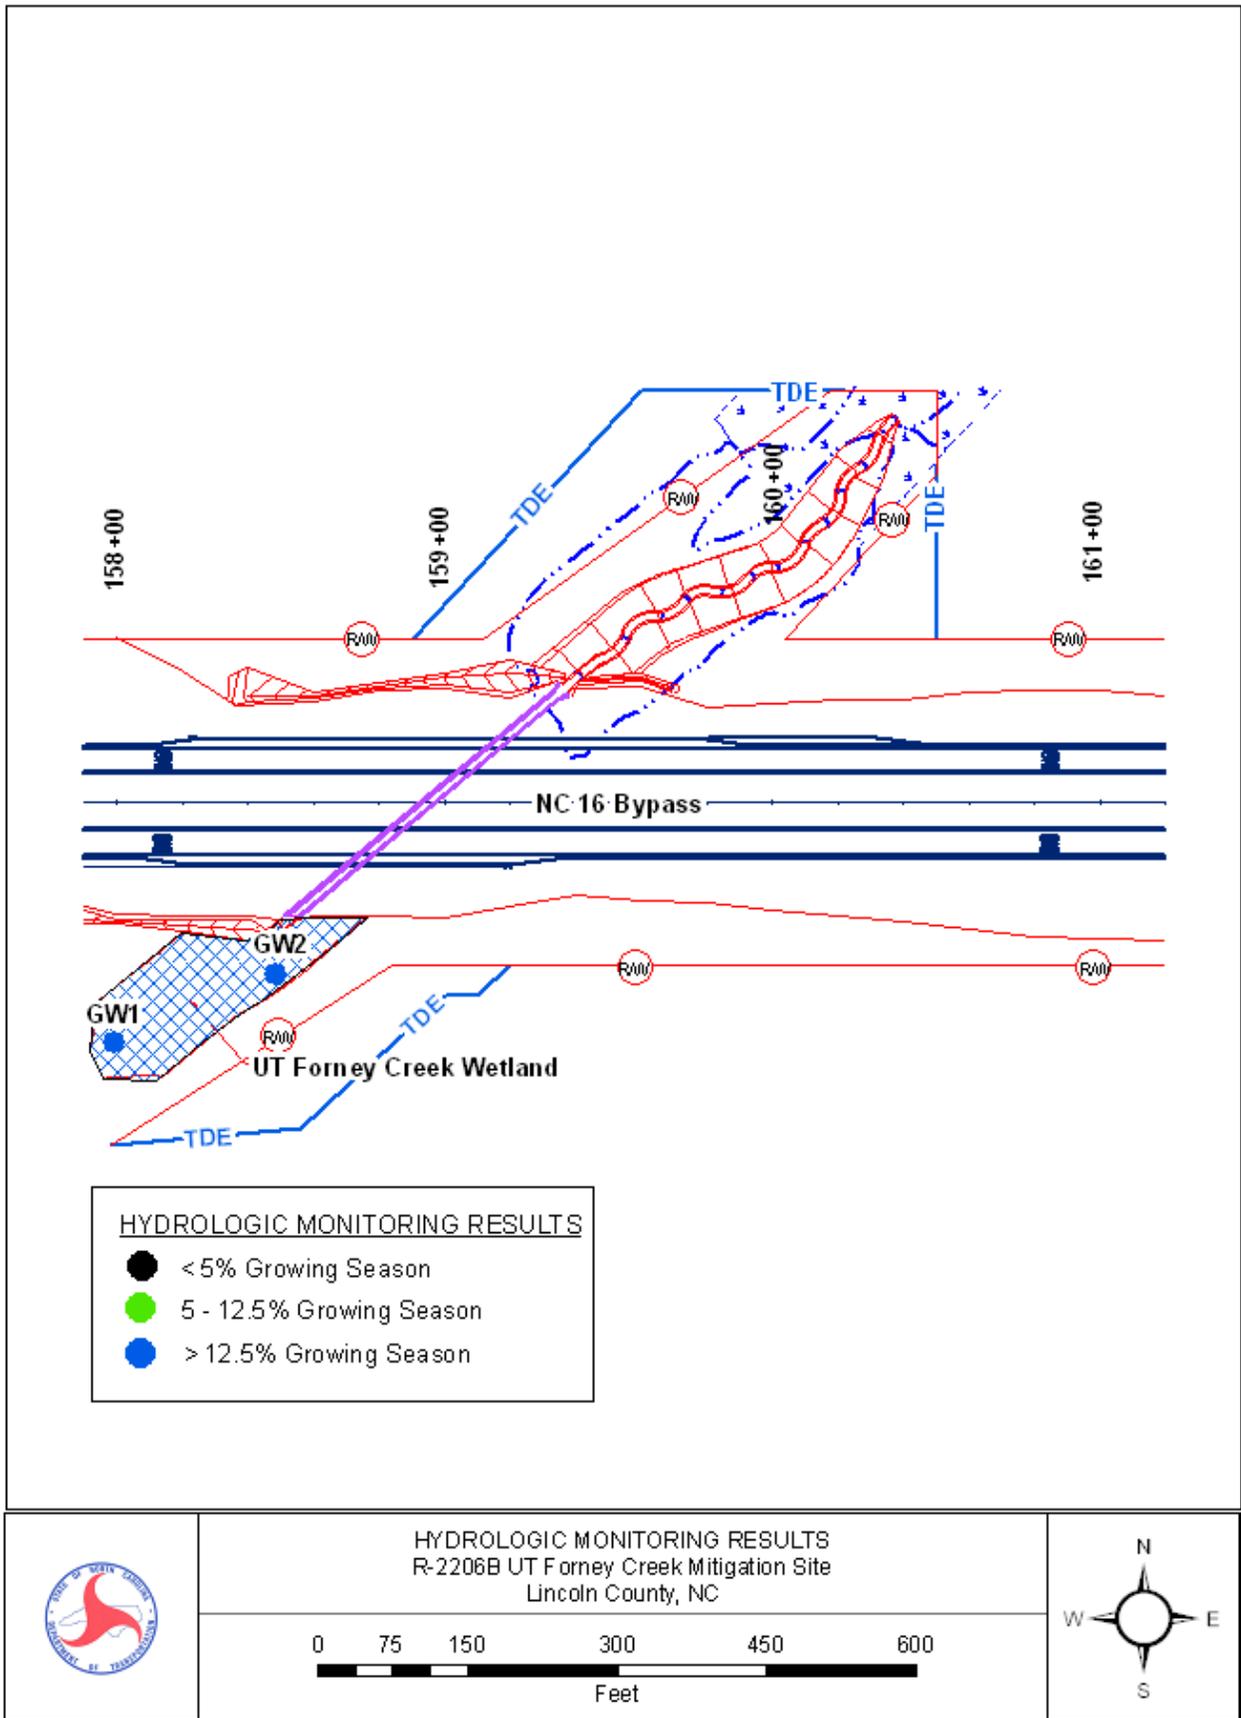
**Figure 3. Hydrologic Monitoring Results Map**

The maximum number of consecutive days that the groundwater was within twelve inches of the surface was determined for each gauge. This number was converted into a percentage of the 222-day growing season. The results are presented in Table 1. Figure 3 also provides a graphical representation of the hydrologic results. Gauges highlighted in blue indicate wetland hydrology for more than 12.5% of the growing season. Those gauges highlighted in black indicate no wetland hydrology (< 5% of the growing season) while gauges highlighted in green indicate hydrology between 5% and 12.5%.

<b>Monitoring Gauge</b>	<b>&lt; 5%</b>	<b>5-8%</b>	<b>8-12%</b>	<b>&gt; 12.5%</b>	<b>Actual %</b>	<b>Success Dates</b>
GW-1+				<b>X</b>	100	March 28 - Nov 4
GW-2+				<b>X</b>	100	March 28 - Nov 4

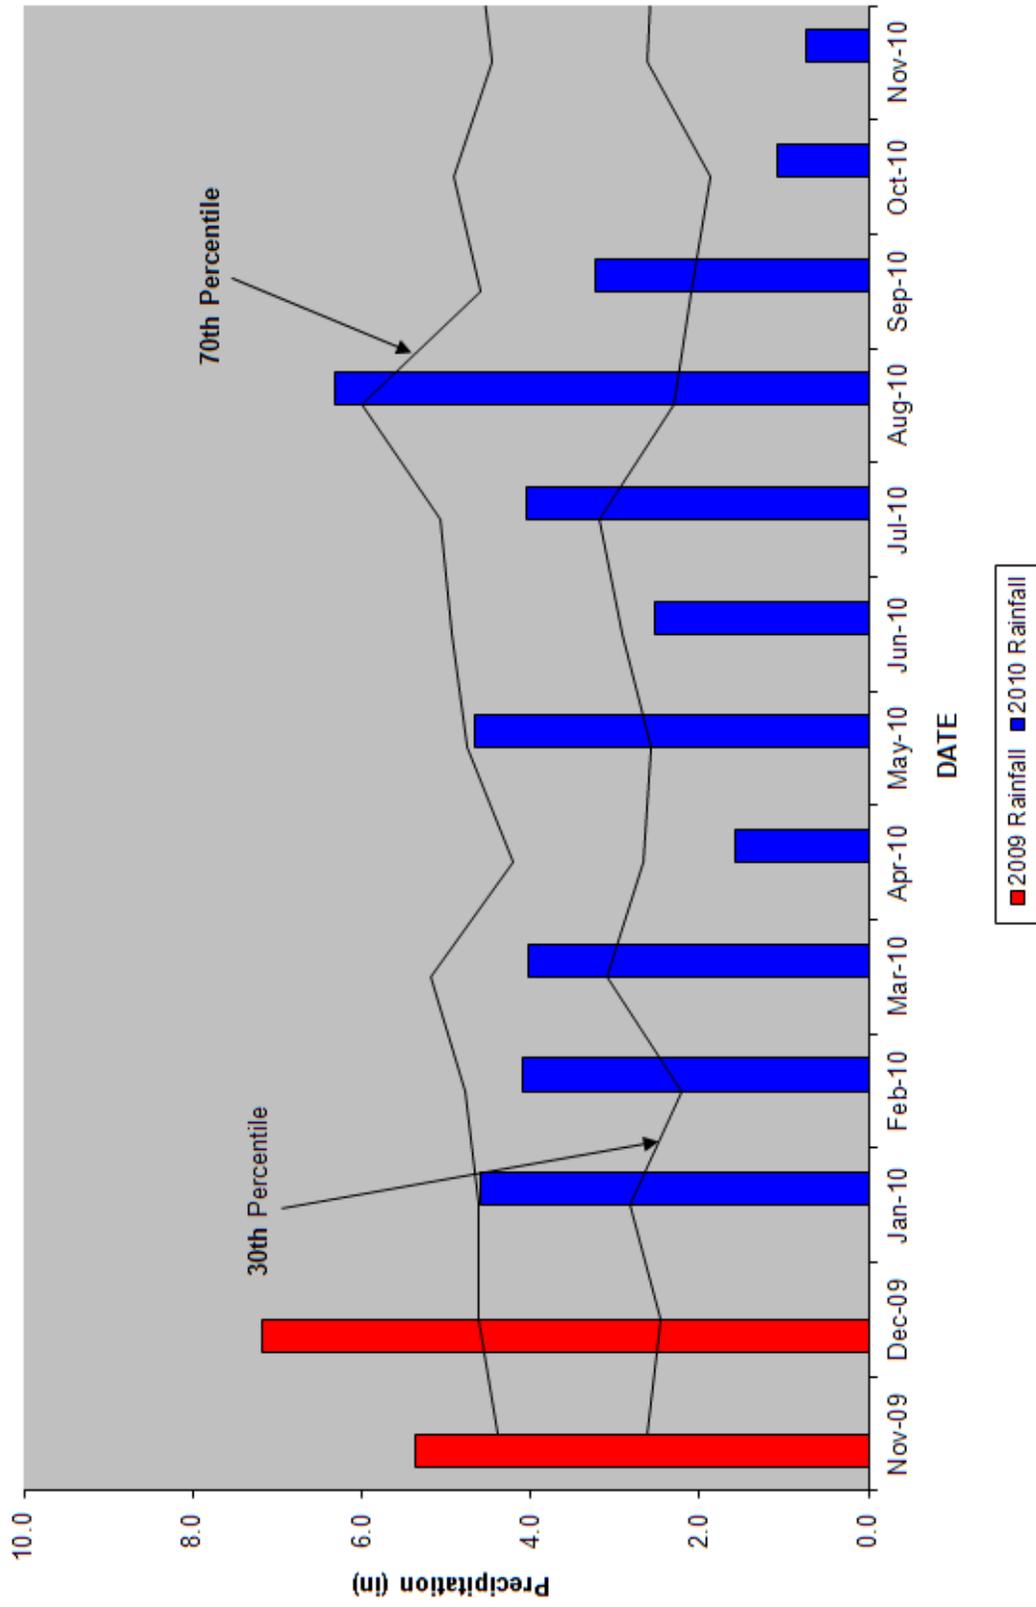
**Figure 4. 30-70 Percentile Graph**

Figure 4 is a comparison of the 2010 monthly rainfall to the historical precipitation (collected between 1978 and 2009) for Lincolnton, North Carolina. This comparison gives an indication of how 2010 relates to historical data in terms of climate conditions. The NC State Climate Office provided all of the historical rainfall information.

Based on the historical data, January, February, March, May, July, and September recorded average rainfall for the site in 2010. The months of April, June, October and November recorded below average rainfall while August recorded above average rainfall. Overall, the 2010 monitoring year was an average rainfall year.

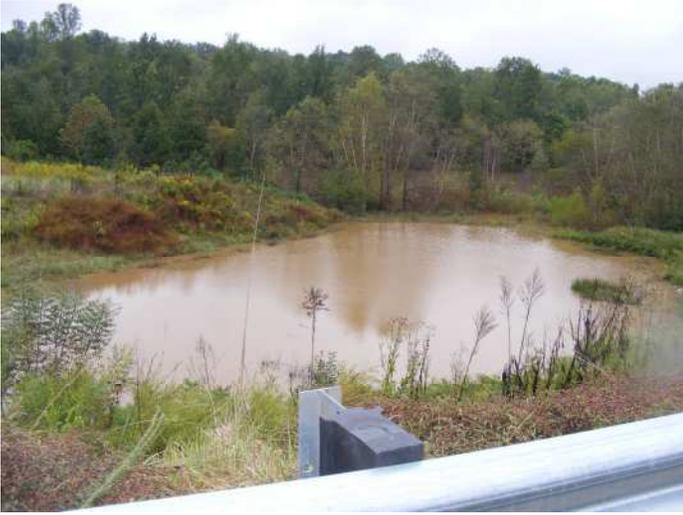
Photo 1

The third year of visual monitoring of the wetland restoration area shows that it is re-attaining wetland jurisdictional status but the planted species are not surviving in the planted areas. The site was supplementally planted in January 2009 with Baldcypress seedlings. Due to the excessive amount of water that has been present on the site throughout the growing season, it is expected that none of the planted species have survived. The restoration area has been inundated throughout the past year due to a combination of beaver activity and off-site activity by the adjacent property owner. A site visit will be scheduled at this year's annual monitoring meeting to review the site and determine a course of action.
