ANNUAL REPORT FOR 2002

Dismal Swamp Mitigation Site
Gates / Perquimans County
Project No. 6.129003T
TIP No. R-2208 WM

Prepared By:
Office of Natural Environment & Roadside Environmental Unit
North Carolina Department of Transportation
December 2002

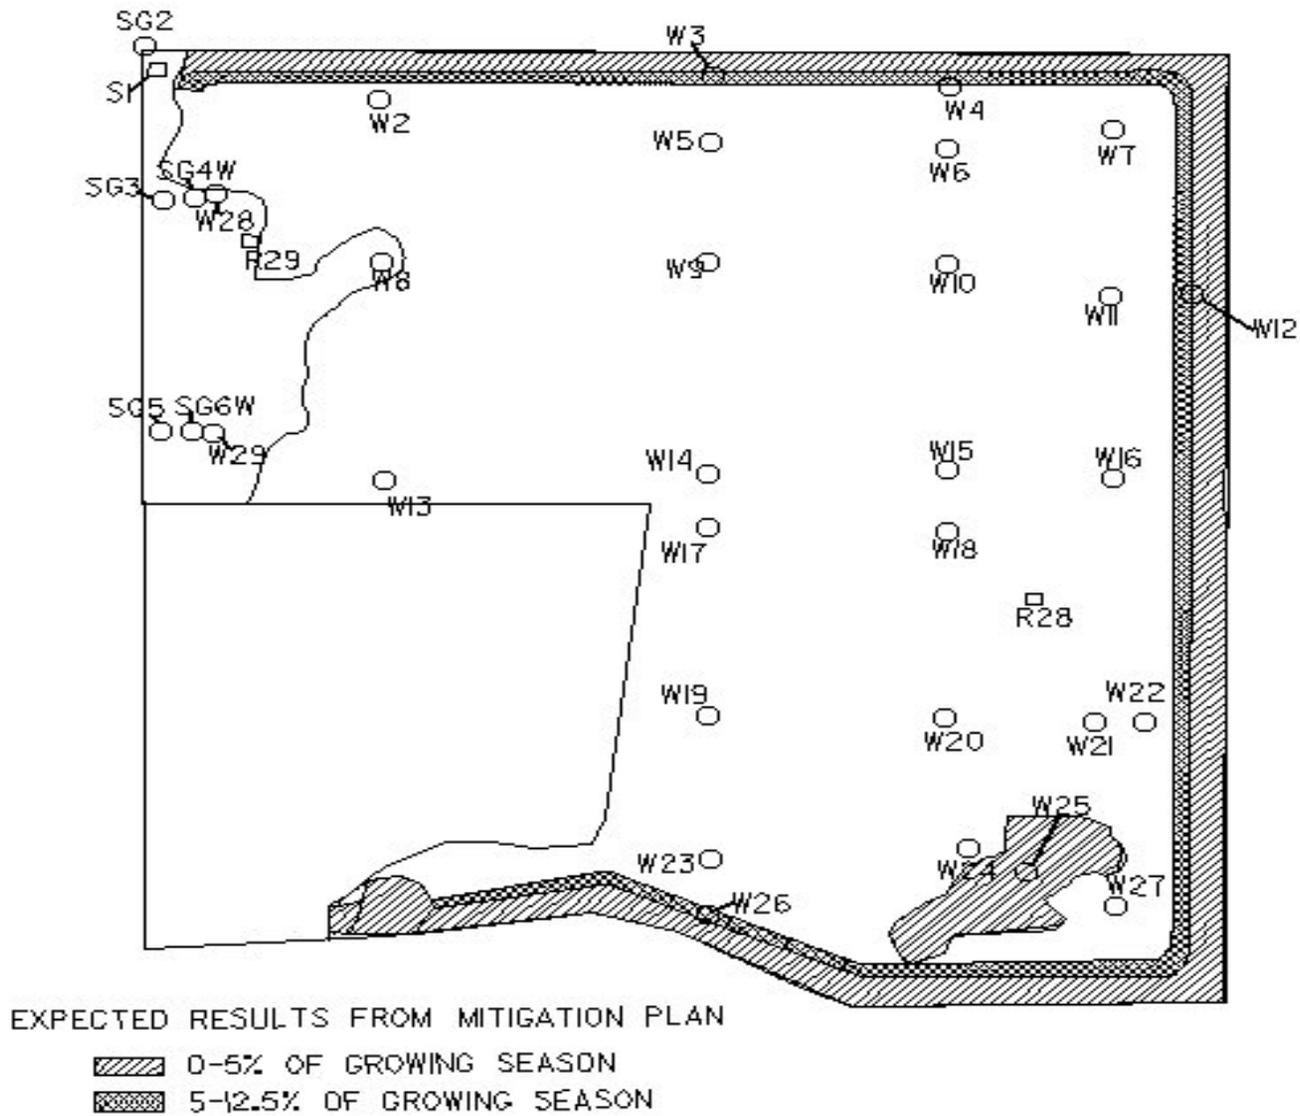
Figure 2: Gauge Location Map

Twenty-eight groundwater-monitoring gauges, two rain gauges, and six surface gauges are currently in use at Dismal Swamp. One surface water gauge was installed on site in 1997 while 5 Infinity surface gauges and 2 groundwater gauges were recently installed in spring 2002. (Figure 2). The 5 Infinity gauges were installed to illustrate surface water levels in the riverine area. The 2 groundwater gauges were installed adjacent to the surface gauges to show groundwater in the absence of surface water. The monitoring gauges record daily readings of groundwater depth. The rain gauges were replaced in spring 2000 with Infinity rain gauges.

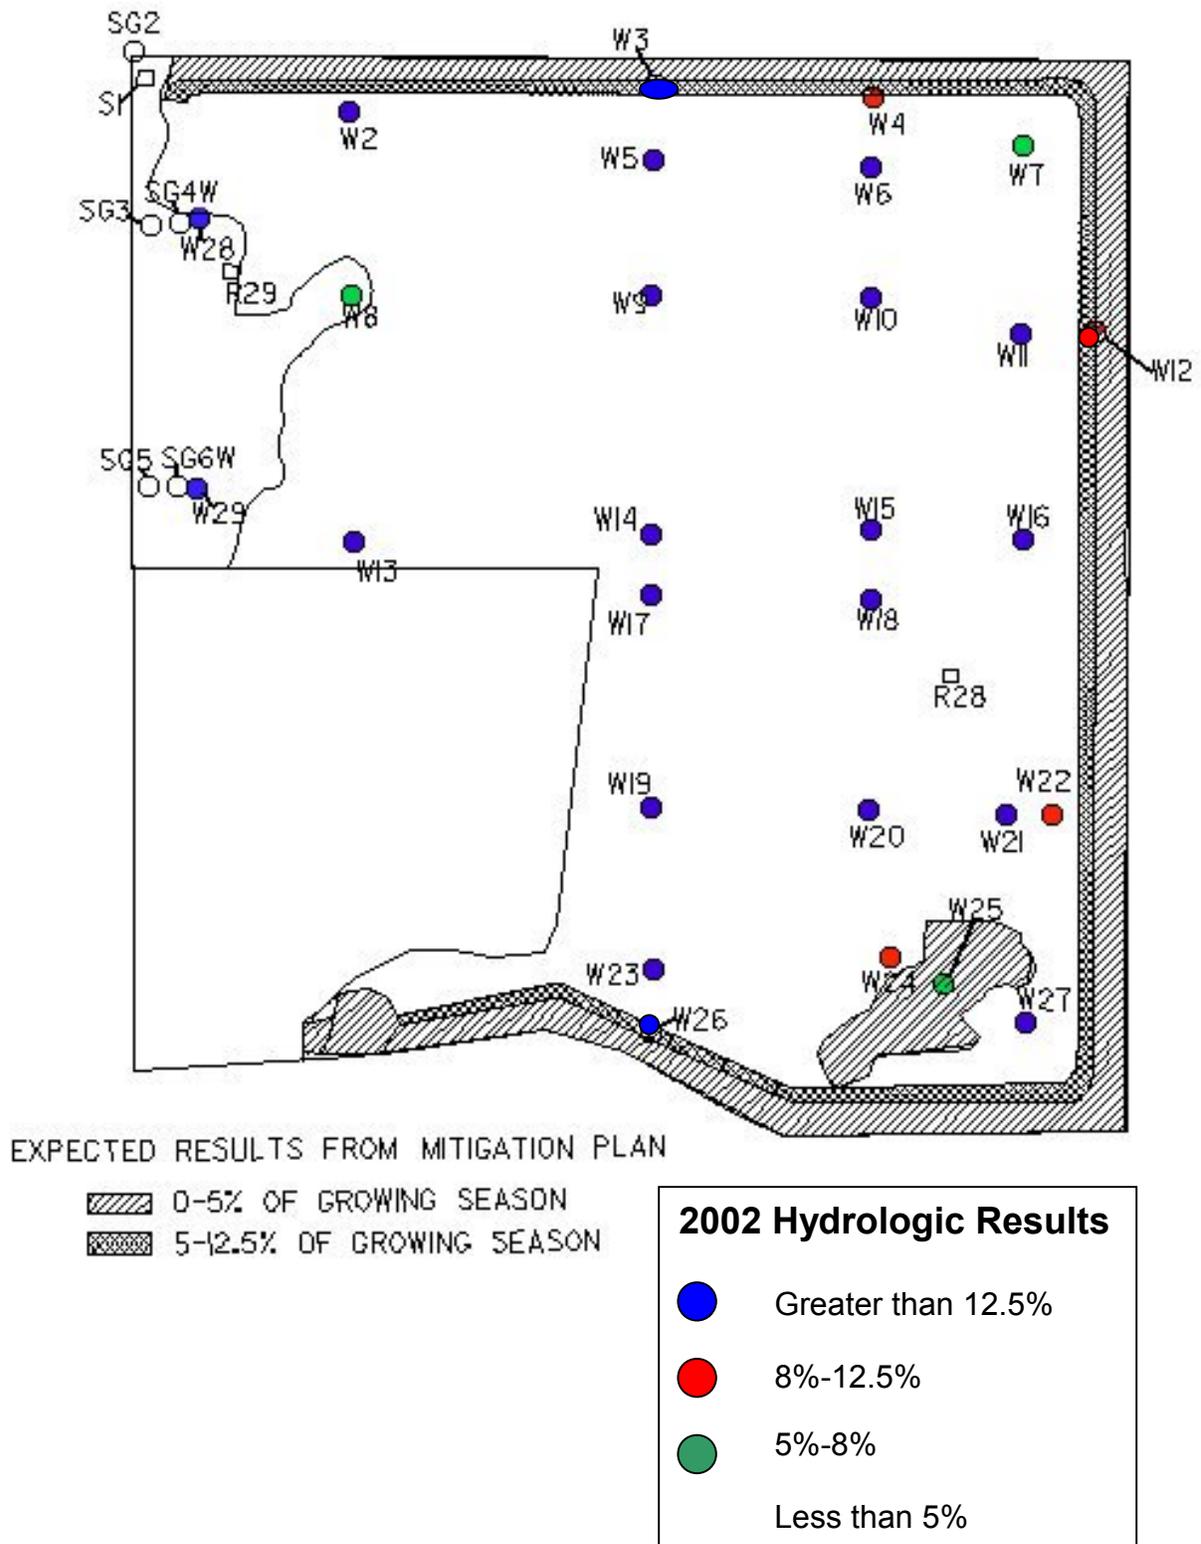
Figure 3: 2002 Hydrologic Monitoring Results

Figure 3 is an illustration of the 2002 hydrologic results. A blue square indicates hydrology for greater than 12.5% of the growing season; a red square means the gauge showed between 5% and 12.5%. A black square indicates hydrology less than 5% of the season. It is this hydrologic data which will determine the success of the site. The surface water gauges have recorded appreciable surface water throughout the growing season. Refer to Appendix A for the groundwater and surface water graphs.

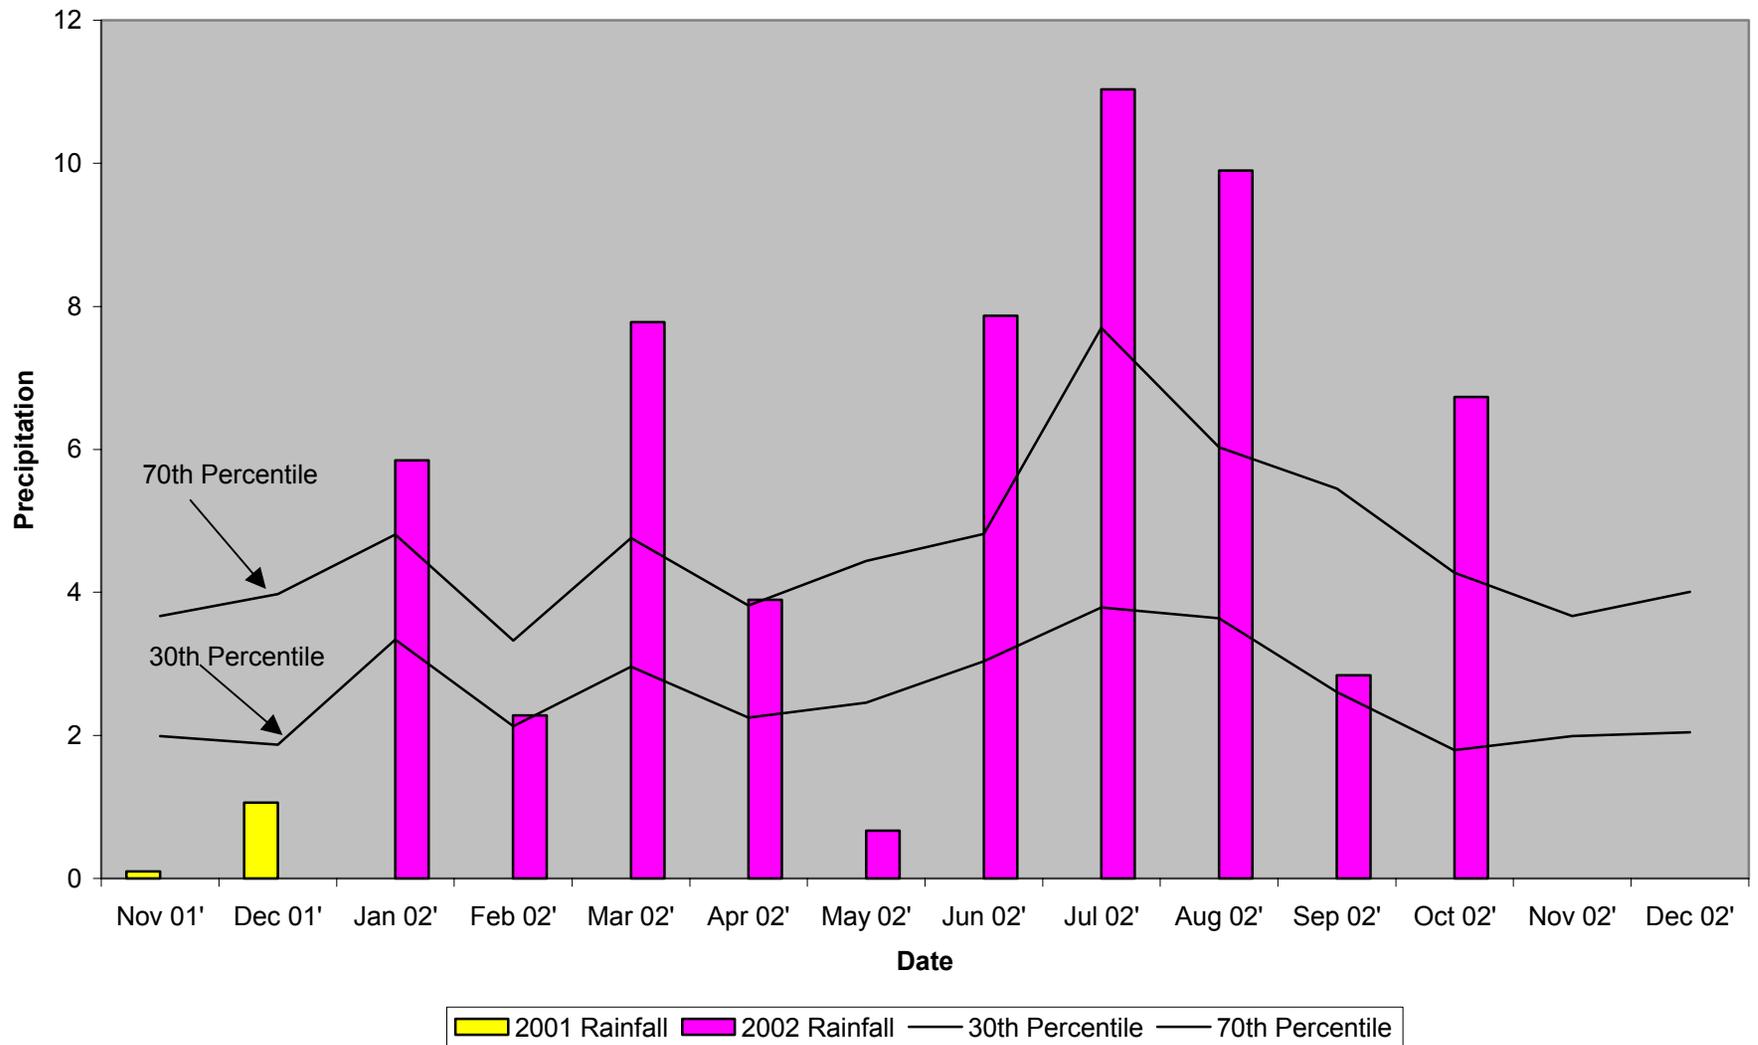
Figure 4
Dismal Swamp 30-70 Percentile Graph 2002
Elizabeth City, NC

Figure 4 is a comparison of monthly rainfall for the period of November 2001 through October 2002 to historical precipitation (collected between 1971 and 2002) for Elizabeth City, North Carolina. This comparison gives an indication of how 2002 relates to historical data in terms of climate conditions. All off-site data was provided by the NC State Climate Office. February and May experienced below average rainfall. The months of April and September all recorded average rainfall for the site. January, March, June, July, August, and October experienced above average rainfall. No data is available for November or December however; the site meets hydrologic success criteria without these data. Overall 2002 experienced an average to below average rainfall year.
