ANNUAL REPORT FOR 2001

**Friedburg Marsh Mitigation Site
Forsyth County
Project NO. 6.628001T
TIP No. R-2247**

Prepared By:
Natural Systems Unit
North Carolina Department of Transportation
December 2001

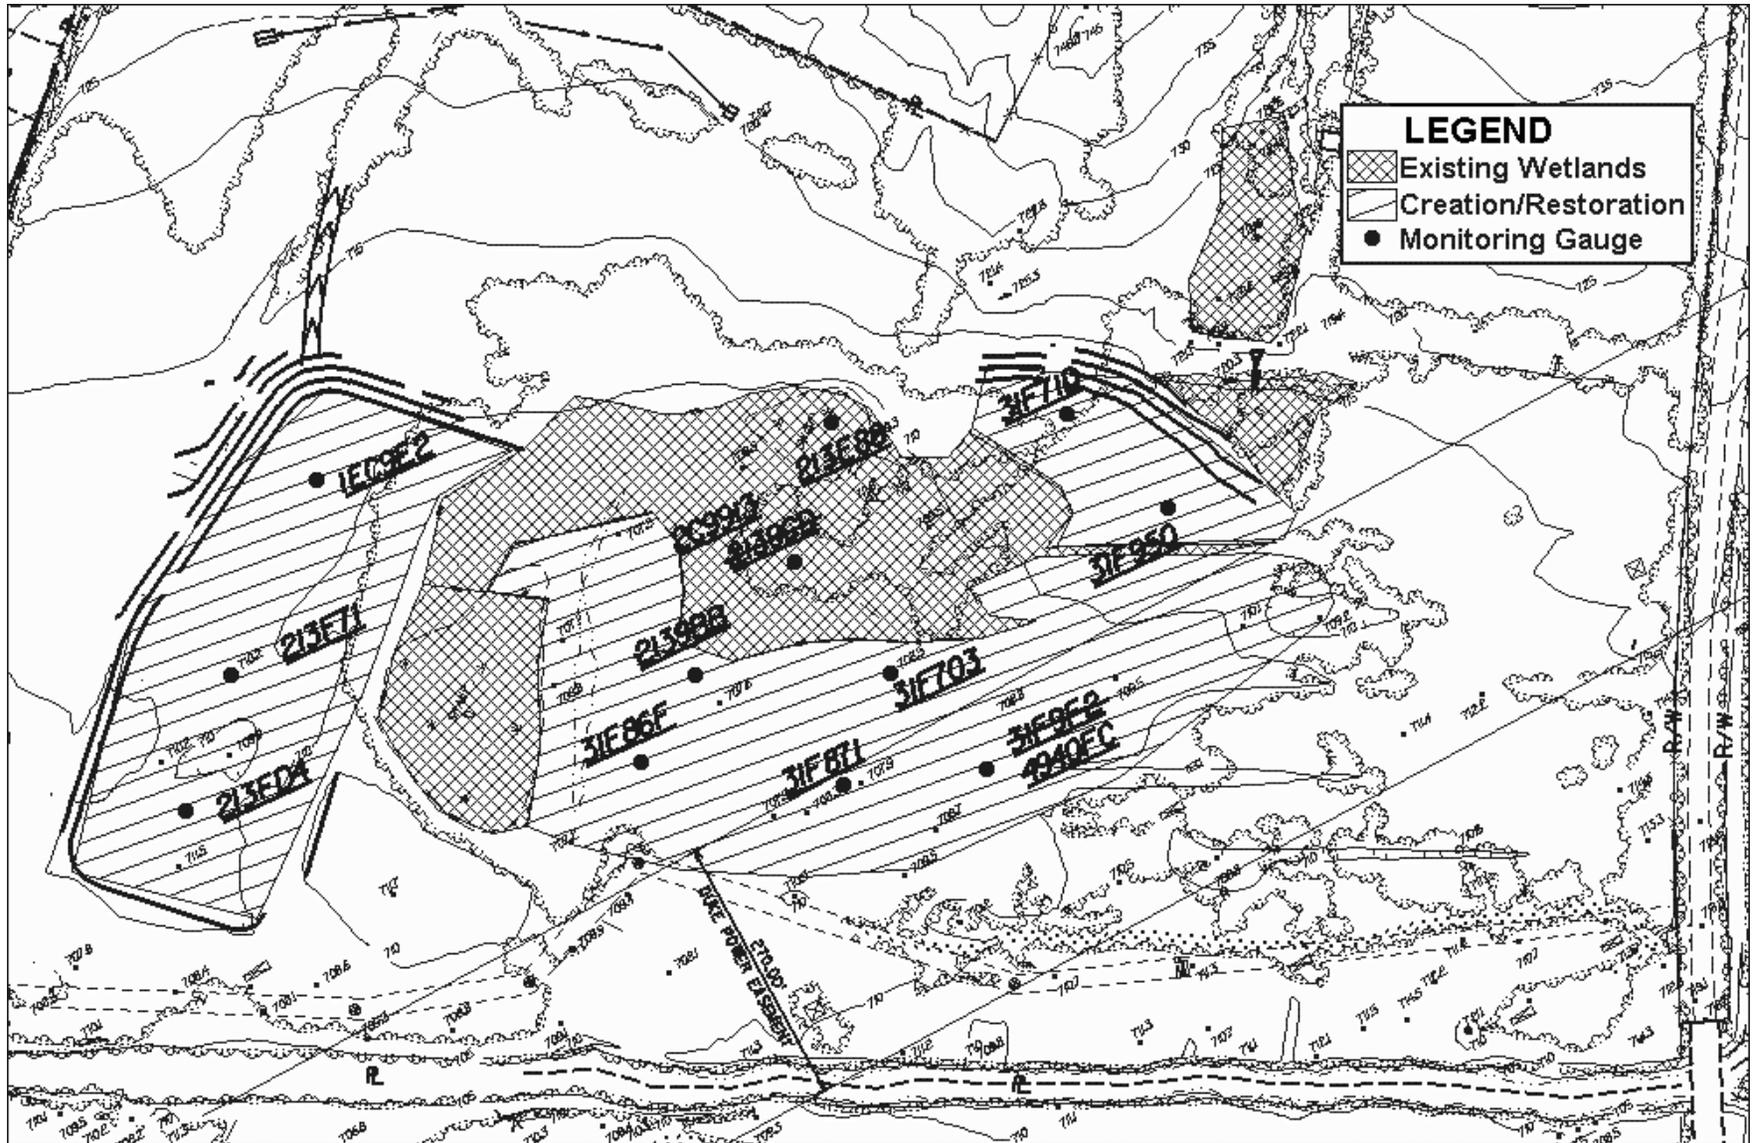
Figure 2. Friedburg Marsh Monitoring Gauge Location

RDS WL40 and WL20 units record all groundwater and surface water data (Figure 2). Depth to groundwater is recorded daily at 7:00 AM. The RDS units are downloaded in the field on a monthly basis. In November 1997 six groundwater gauges were installed at Friedburg Marsh to monitor pre-construction hydrology and develop a mitigation plan, of which one gauge location (2139CD) was installed to record surface water and groundwater depths. Following construction six additional groundwater gauges were installed, of which one gauge location (2139BB) was installed to record surface water and groundwater depths.

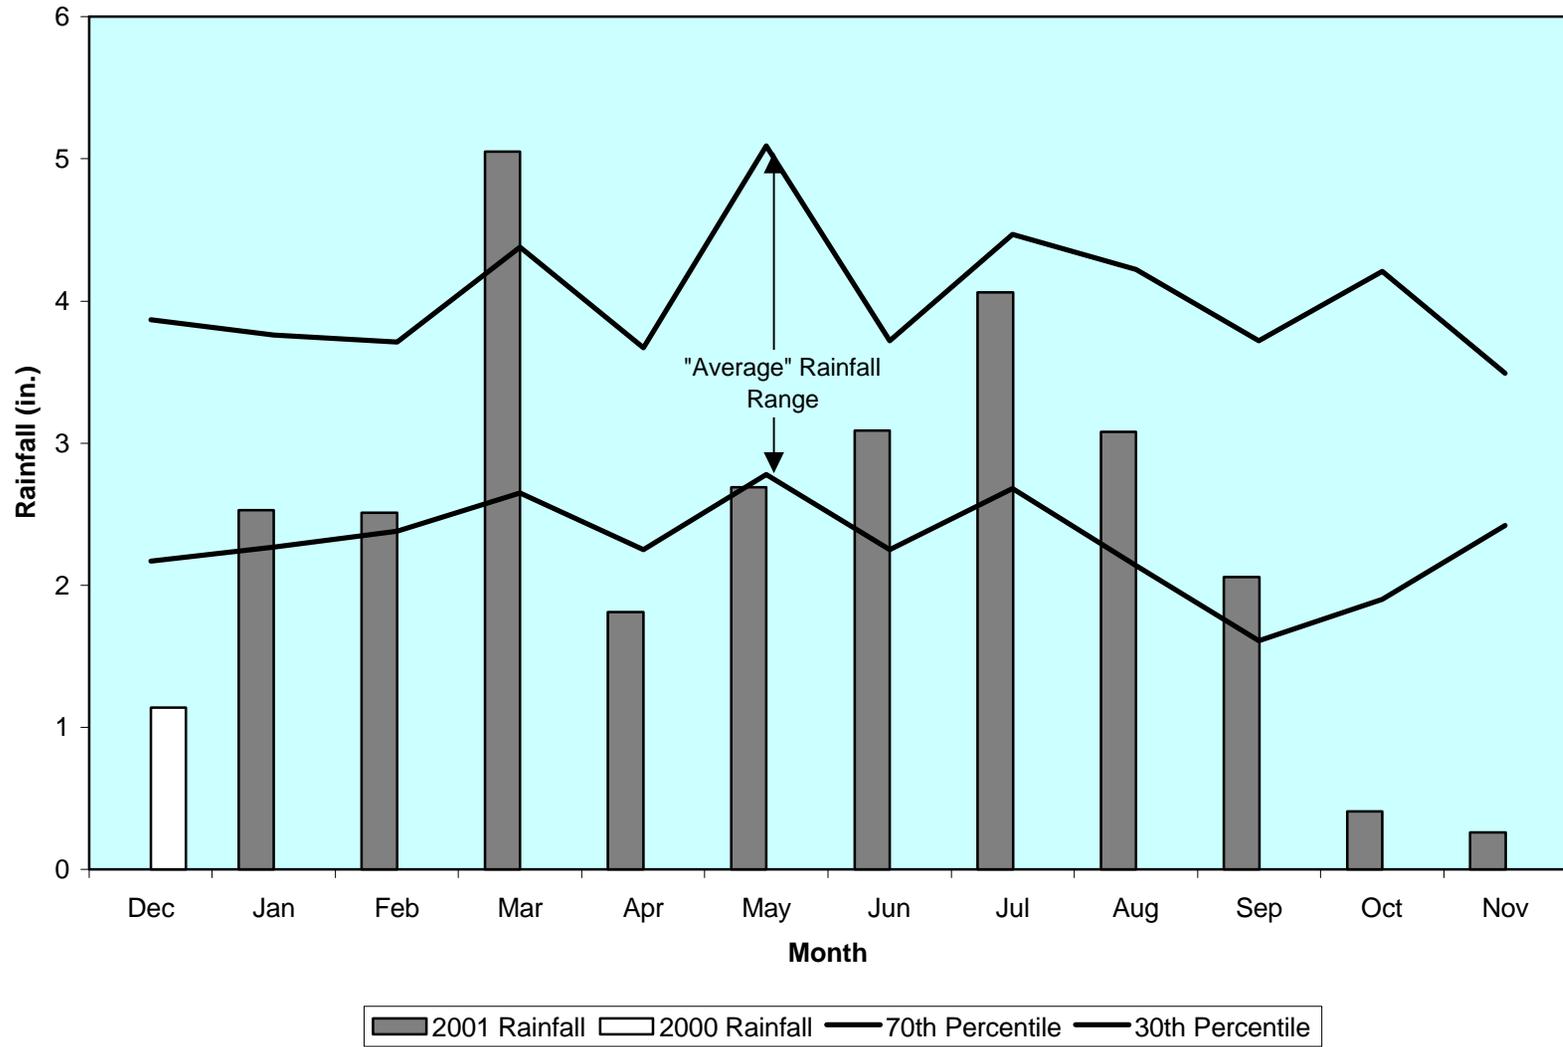
Figure 4: Friedburg Marsh 30-70 Percentile Graph, Forsyth County, NC

Figure 4 represents an examination of year 2001 rainfall in comparison with historical rainfall data in order to determine whether 2001 was “average” in terms of precipitation. The historical rainfall data was collected from 1968 through 1997 (30 years). All rainfall data was collected from the NC Climate Office, Greensboro Airport weather station.

The monthly rainfall totals for the period of December 2000 through November 2001 are shown in Figure 4. The data for this period shows rainfall within average limits for six months (January, February, June, July, August, and September), and below average limits for four months (December, April, October, and November). March rainfall was 0.67 inches above the average limit. The observed cumulative rainfall of 28.69 inches is far below the 30-year average rainfall range of 38.43 to 45.47 inches.

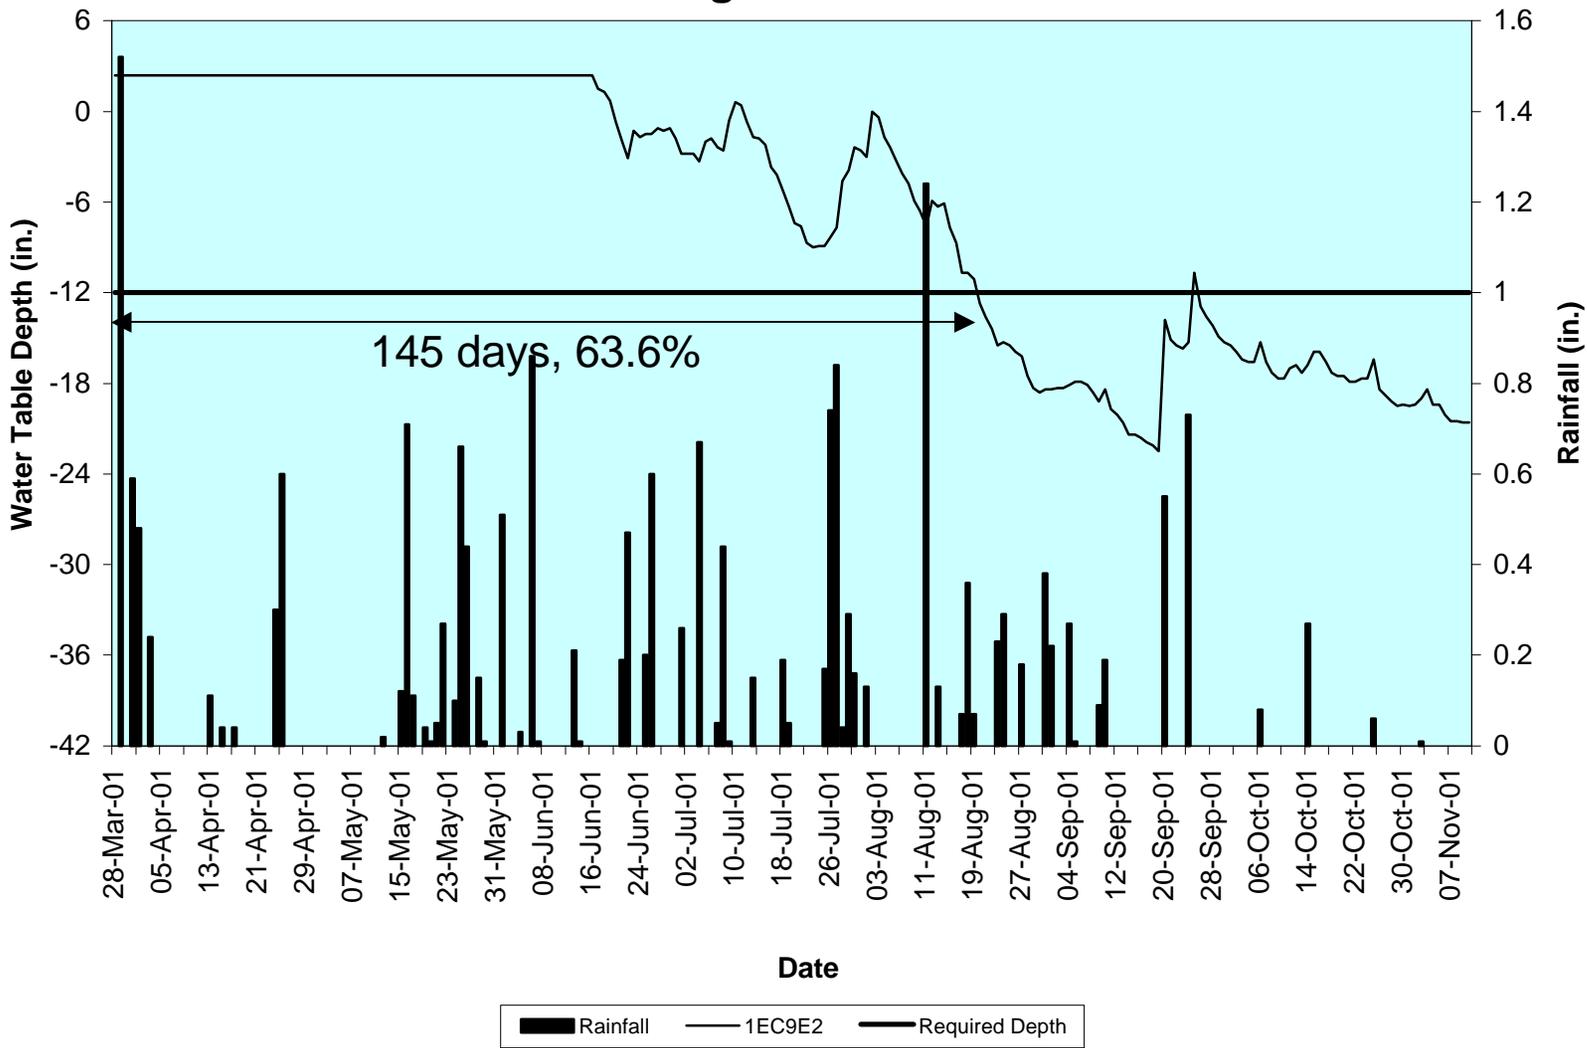
Friedburg Marsh 1EC9E2

Monitoring Gauge	<5%	5% - 8%	8% - 12.5%	>12.5%	Actual %	Success Dates
1EC9E2				✓	63.6	Mar. 28 – 19 Aug.
2139BB				✓	43.0	Mar. 28 – Jul. 3
2139CD/ 2C9913				✓	24.6	Mar. 28 – 22 May
213E88				✓	64.0	Mar. 28 – Aug. 20
213F71			✓		9.6	Mar. 28 – Apr. 18
213FD4			✓		8.8	Mar. 28 – Apr. 16
31F703				✓	32.5	Mar. 28 – Jun. 9
31F71D				✓	15.8	Mar. 28 – May 2
31F86F				✓	41.7	Mar. 28 – 30 Jun.
31F871				✓	31.6	Mar. 28 – Jun. 7
31F950			✓		10.1	Mar. 28 – Apr. 19
31F9F2/ 4940FC				✓	18.9	Mar. 28 – May 9

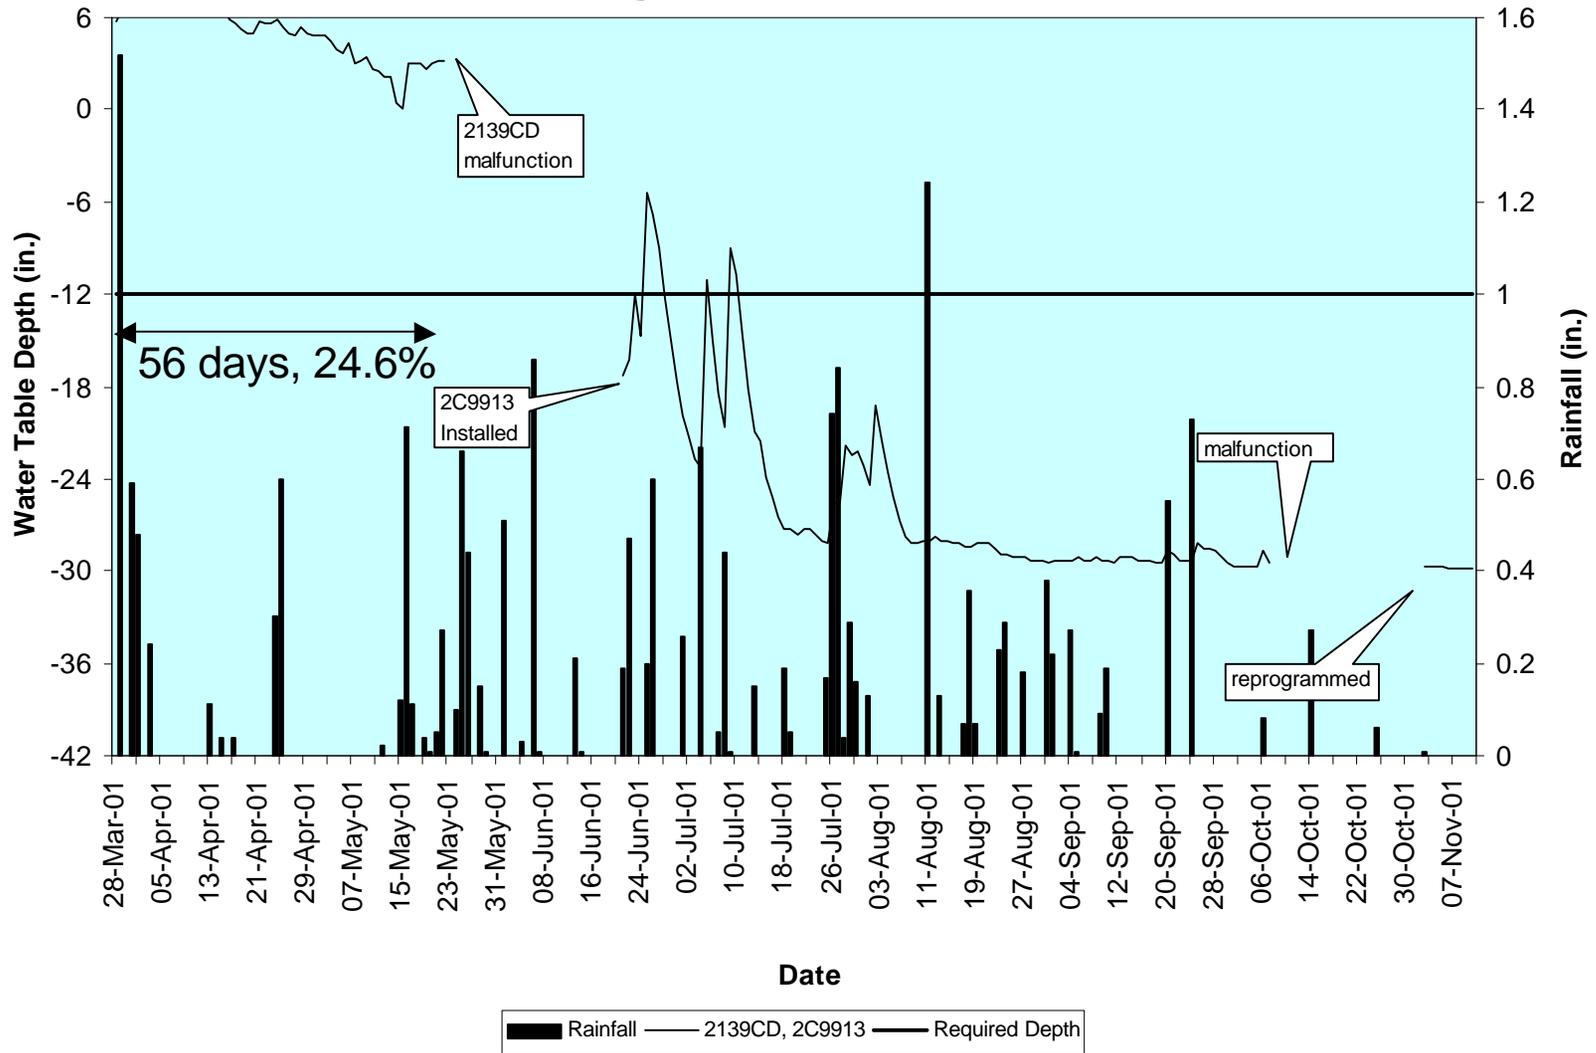
Friedburg Marsh 2139CD, 2C9913

2139CD: Data was lost due to an unknown malfunction from May 23 to June 21, when 2C9913 was installed in that location.

2C9913: Data was lost due to battery failure from October 8 to November 1.

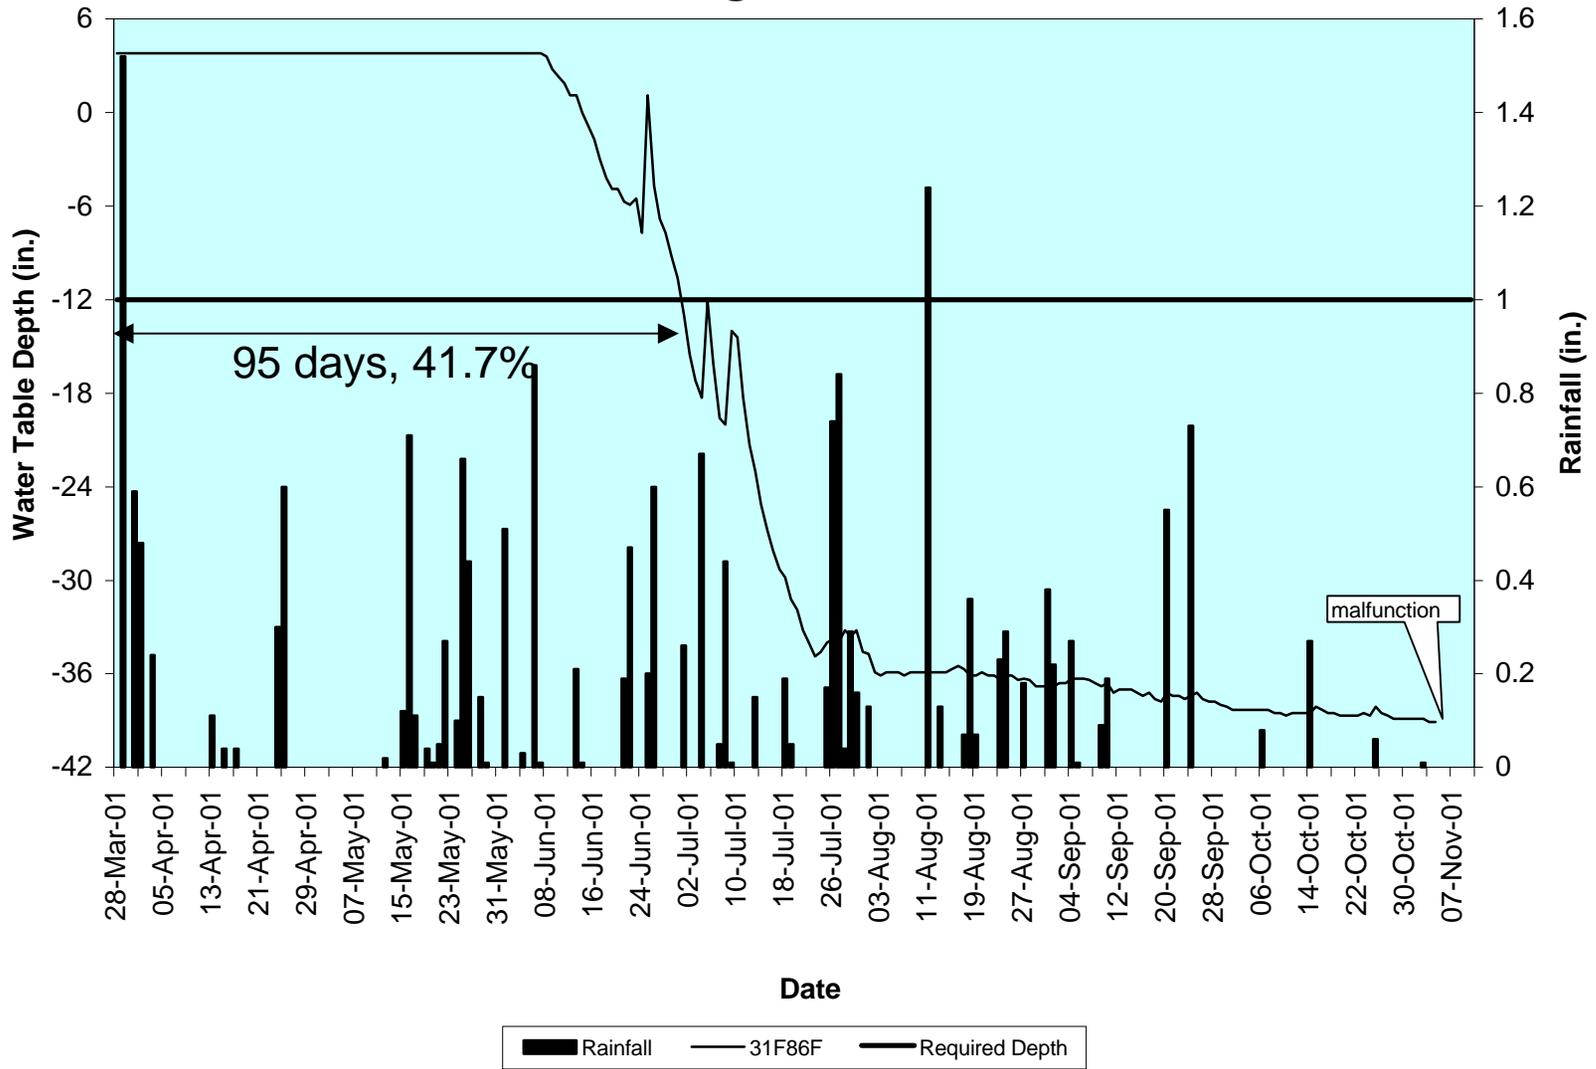
Friedburg Marsh 31F86F

- 31F86F: Data was lost due to battery failure from November 5 to November 30.
- 31F9F2: Data was lost due to an unknown malfunction from July 12 to November 1, when 4940FC was installed in that location.
