Monitoring Data Record

Project Title: R-2408A COE Action ID: SAW-2009-00860  
Stream Name: UT to Little Tennessee River DWQ Number: 20090451  
City, County and other Location Information: Macon County, Intersection of Riverview St. and Woodland Hills Drive Sta. 28+00-L- RT.  
Date Construction Completed: Site planted on 2/10/12 & water turned into stream on 6/28/12  
Monitoring Year: ( 3 ) of 3  
Ecoregion: \_\_\_\_\_ 8 digit HUC unit 06010202  
USGS Quad Name and Coordinates: Franklin 35.194470, -83.386015

# UT Little Tennessee River

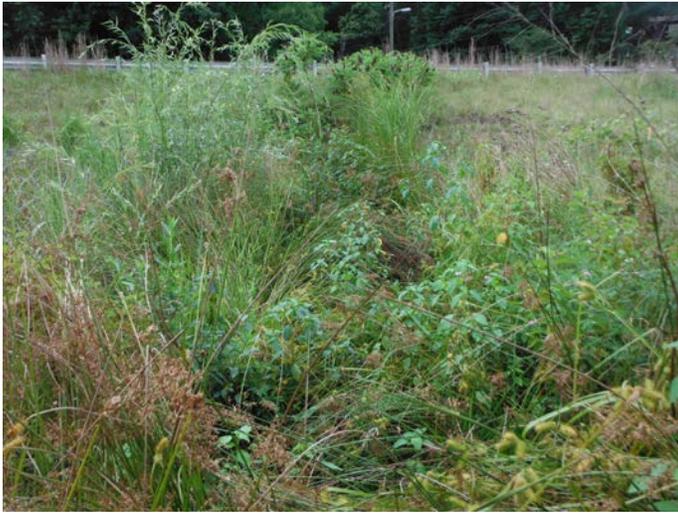
Photo Point #1 (Upstream)

This is the Year 3 evaluation for the UT to Little Tennessee River stream restoration site. The channel is stable at this time and water was flowing over top of all of the cross vanes at the time of monitoring. NCDOT proposes to discontinue monitoring channel stability at the UT to Little Tennessee River stream restoration site.

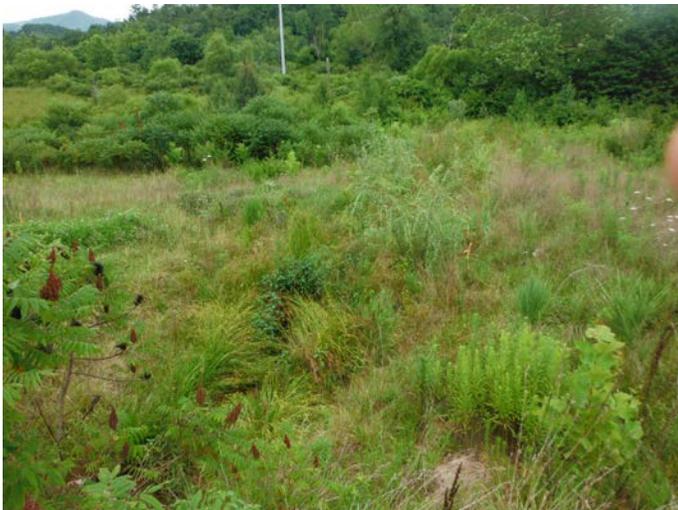
Overview photo taken from Riverview St.  
Year 3 – July 2014

A few small patches of Japanese knotweed were noted onsite.

**ADDITIONAL COMMENTS:** The planted vegetation is surviving and consisted of black willow and silky dogwood live stakes and tulip poplar, sycamore, black cherry, and river birch bareroot seedlings. Other vegetation noted included briars, sumac, *Juncus* sp., red maple, *Scirpus* sp., Japanese knotweed, jewelweed, and various grasses. A supplemental planting was completed on 1/8/13 due to missing planted vegetation noted the previous year. NCDOT proposes to discontinue monitoring plant survival at the UT to Little Tennessee River stream restoration site.

Estimated causes, and proposed/required remedial action: NCDOT sprayed the Japanese Knotweed noted onsite on 8/20/13 and 7/24/14. NCDOT has sprayed the Japanese knotweed throughout the monitoring period.

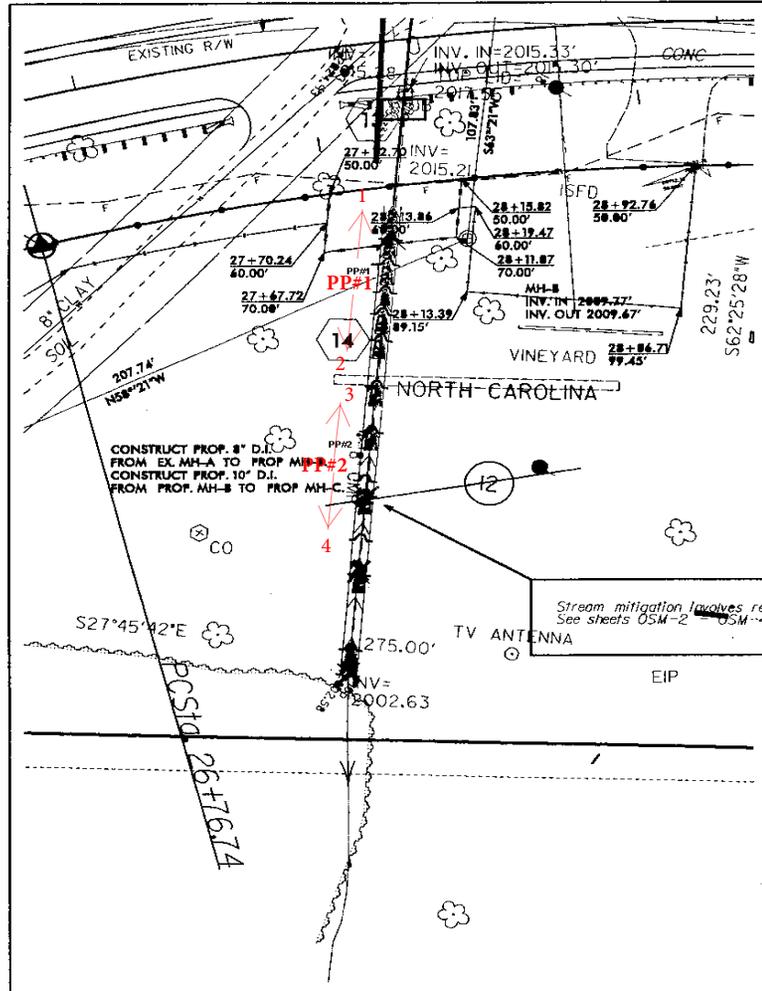
R-2408 On-Site Stream Mitigation  
 As-Built Drawings  
 UT to Little Tennessee Site

Stream mitigation involves removal of existing 18" RCP and reestablishment of stream channel  
 See sheets OSM-2, OSM-3, OSM-4 for typicals, profile, and details
