2000 MONITORING REPORT
- FINAL REPORT -
For
SEVEN SPRINGS
WETLAND MITIGATION PROJECT
Wayne County, NC

January 22, 2001

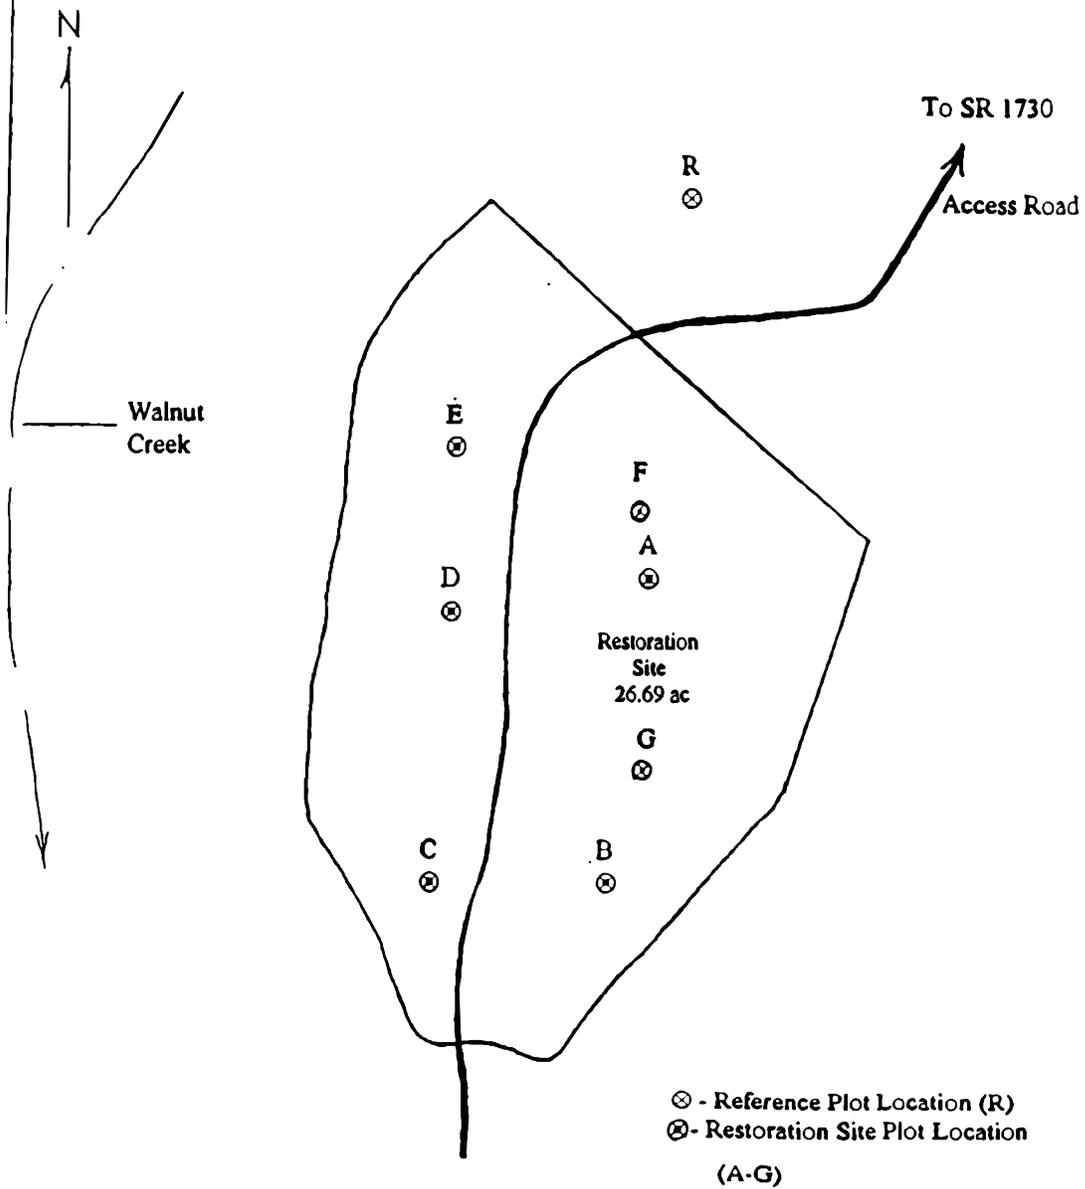
Figure 2
Neuse River Mitigation Project
Seven Springs Section
Plot Locations 1]

1] Data collected at the reference and restoration sites include vegetation, soils, and hydrology (groundwater well, iron rod, and redox electrodes).

Plant community data were collected in November, 2000 at seven 0.10-acre circular monitoring plots centered on the monitoring wells (A - G). Estimates of woody species regeneration, and size of woody regeneration were recorded. Overall survival and species diversity of planted and naturally regenerating woody species were acceptable (Appendix B – Seedling Inventory).

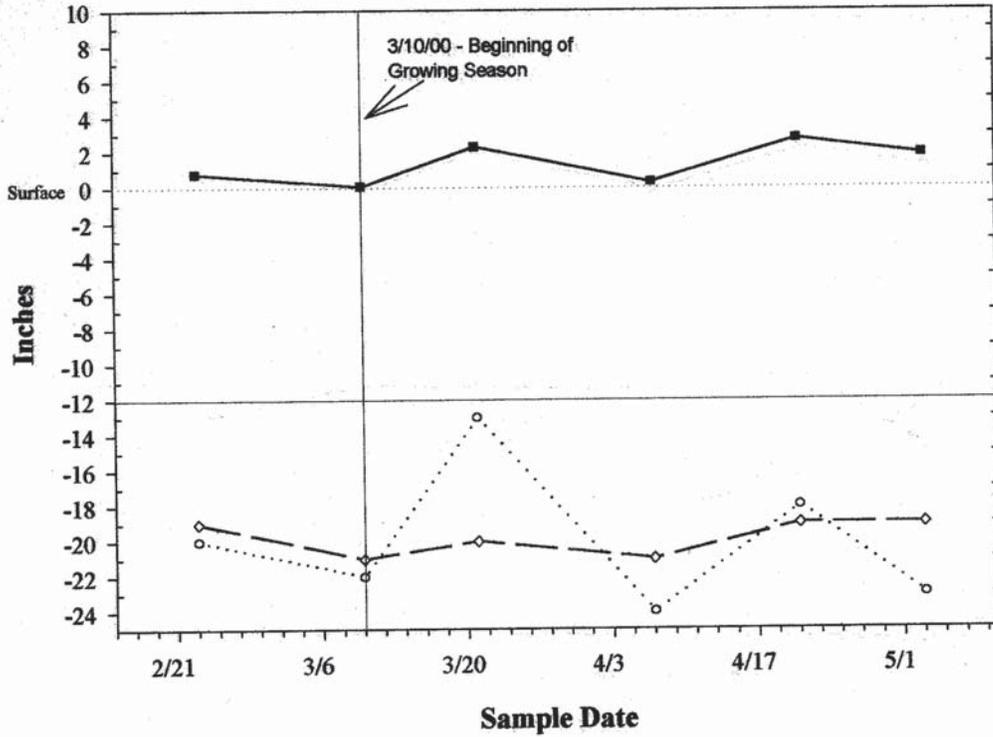
**2000 Hydrological Monitoring
Seven Springs
Wayne County, NC
Well A**

—■— Cumulative Precipitation (Between Sample Events)
 Gauge: Goldsboro 4SE, NC UCAN: 1418, COOP: 313510
*(Information was provided by the State Climate
 Office of North Carolina at NC State University).*
 ...○... Water Level
 —◇— Iron Rod Oxidation

Groundwater well and iron rod oxidation data were collected from February 23, to May 3, 2000. Average depth to groundwater during the 2000 growing season ranged from 17.1 inches on March 10 to 8.5 inches on March 21 (Appendix A –2000 Well Hydrographs). Average groundwater depth in the reference plot during the 2000 growing season was 14.2 inches. Average iron rod oxidation depth for plots A - G ranged from 14.3 inches on March 10 to 13.4 inches on March 21. Average iron rod oxidation depth for the reference area during the growing season was 12.2 inches.

During the 2000-early growing season, only plots C and F met the criteria for wetland hydrology. For those plots achieving wetland hydrology, ground water was within 12 inches of the soil surface for 14 consecutive days during the growing season. Although the majority of groundwater wells did not indicate wetland hydrology this growing season, the general trend for this site for the last six growing seasons has indicated wetland hydrology.

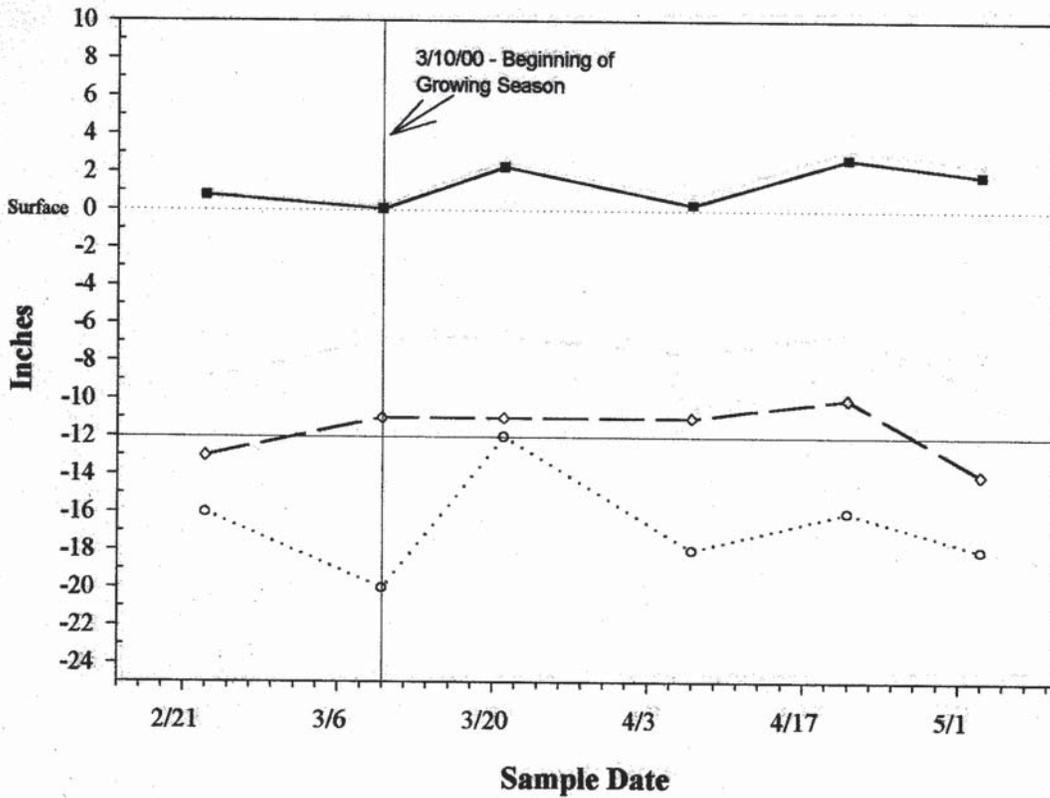
**2000 Hydrological Monitoring
Seven Springs
Wayne County, NC
Well B**

—■— Cumulative Precipitation (Between Sample Events)
 Gauge: Goldsboro 4SE, NC UCAN: 1418, COOP: 313510
 (Information was provided by the State Climate
 Office of North Carolina at NC State University).
 ...○... Water Level
 —◇— Iron Rod Oxidation

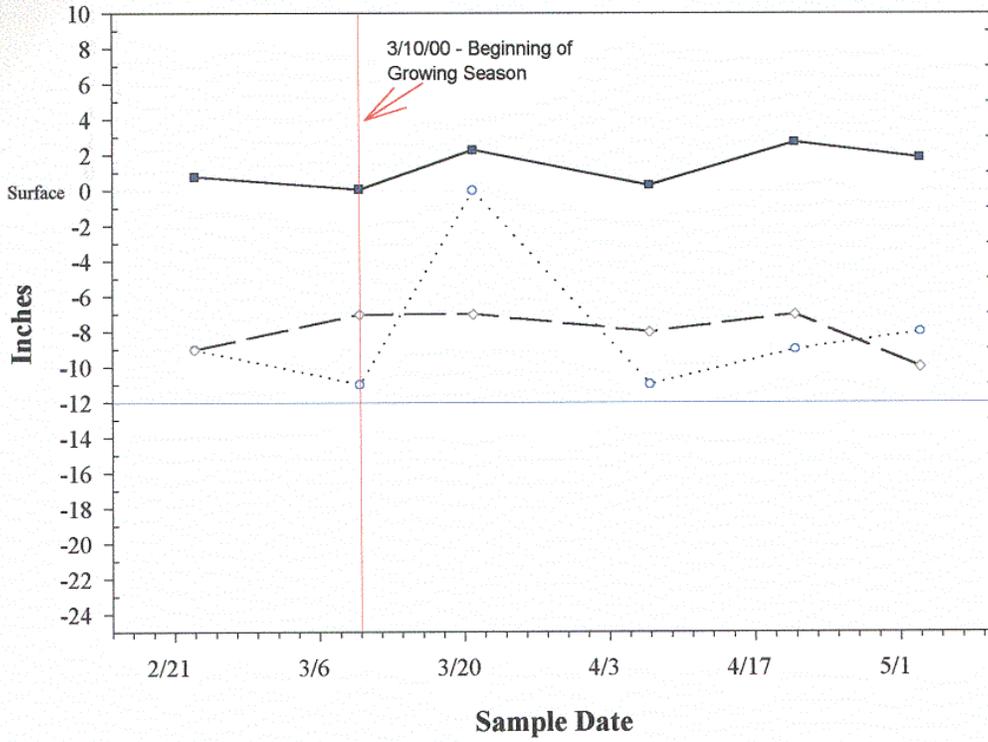
**2000 Hydrological Monitoring
Seven Springs
Wayne County, NC
Well C**

—■— Cumulative Precipitation (Between Sample Events)
 Gauge: Goldsboro 4SE, NC UCAN: 1418, COOP: 313510
(Information was provided by the State Climate Office of North Carolina at NC State University).
 ...○... Water Level
 —◇— Iron Rod Oxidation

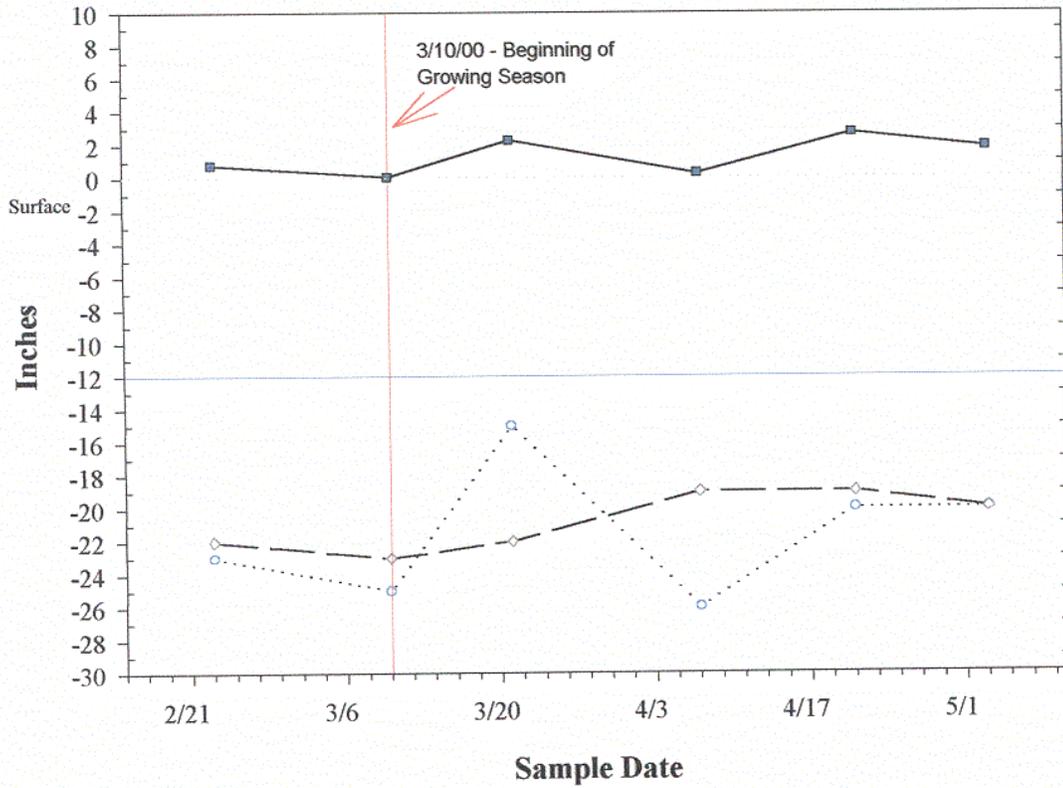
**2000 Hydrological Monitoring
Seven Springs
Wayne County, NC
Well D**

—■— Cumulative Precipitation (Between Sample Events)
 Gauge: Goldsboro 4SE, NC UCAN: 1418, COOP: 313510
(Information was provided by the State Climate Office of North Carolina at NC State University).
 ...○... Water Level
 —◇— Iron Rod Oxidation

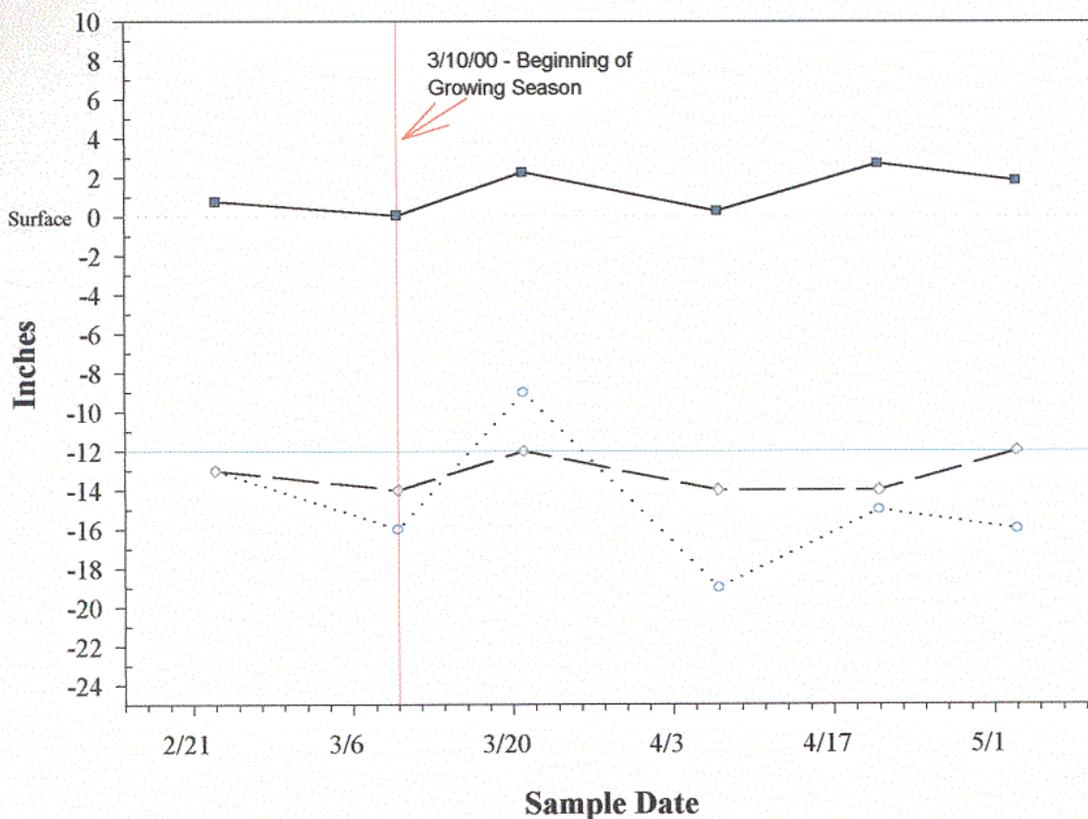
**2000 Hydrological Monitoring
Seven Springs
Wayne County, NC
Well E**

—■— Cumulative Precipitation (Between Sample Events)
 Gauge: Goldsboro 4SE, NC UCAN: 1418, COOP: 313510
*(Information was provided by the State Climate
 Office of North Carolina at NC State University).*
 ...○... Water Level
 —◇— Iron Rod Oxidation

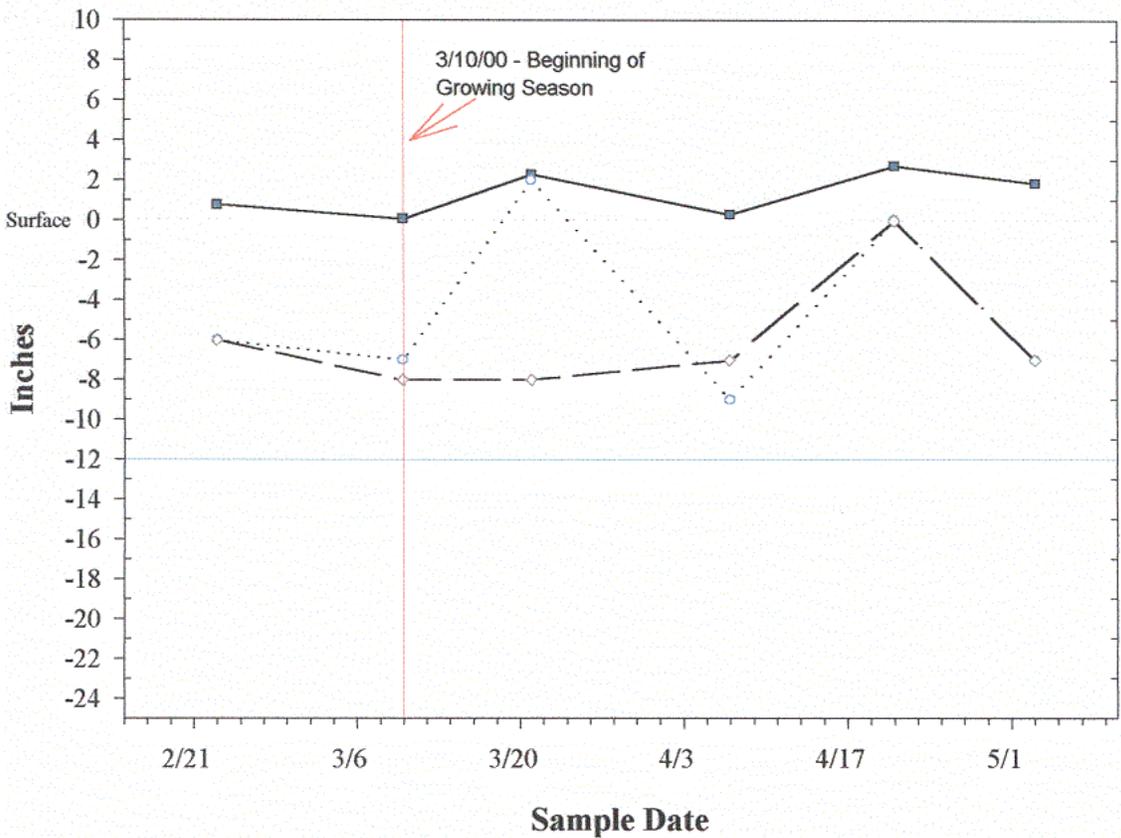
2000 Hydrological Monitoring Seven Springs Wayne County, NC *Well F*

—■— Cumulative Precipitation (Between Sample Events)
 Gauge: Goldsboro 4SE, NC UCAN: 1418, COOP: 313510
(Information was provided by the State Climate Office of North Carolina at NC State University).
 ...○... Water Level
 —◇— Iron Rod Oxidation

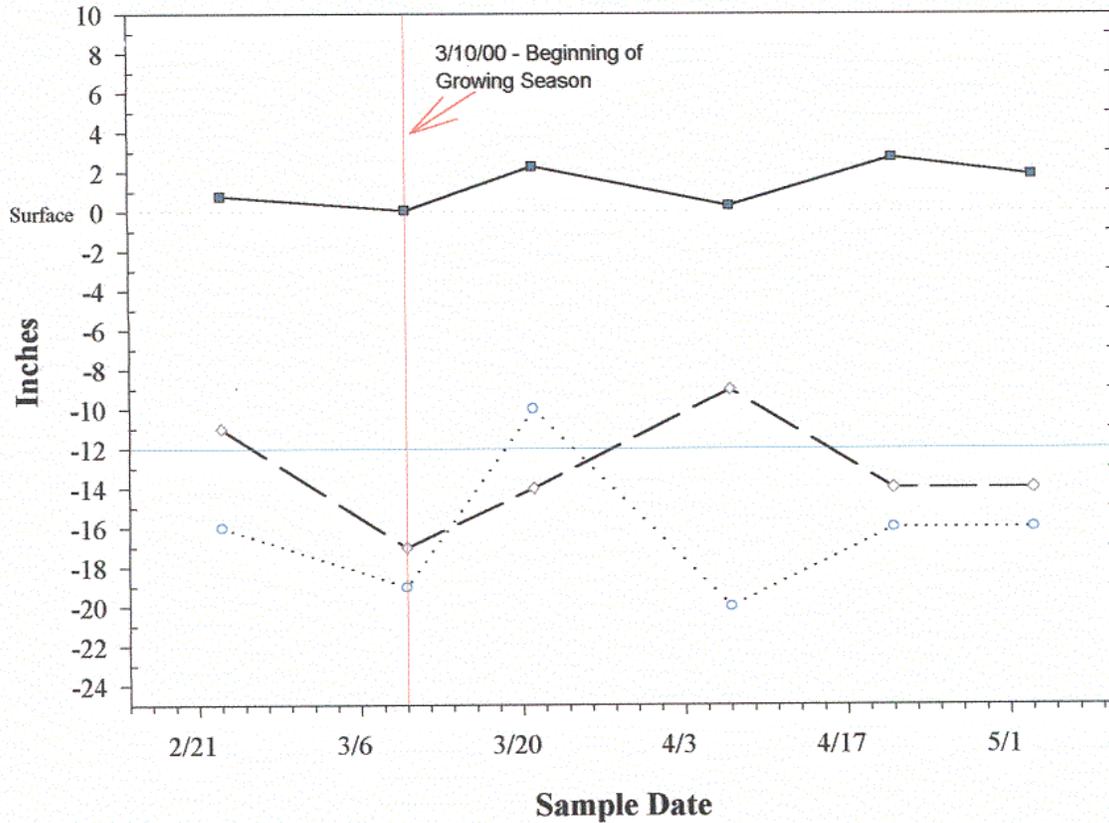
2000 Hydrological Monitoring Seven Springs Wayne County, NC *Well G*

—■— Cumulative Precipitation (Between Sample Events)
 Gauge: Goldsboro 4SE, NC UCAN: 1418, COOP: 313510
(Information was provided by the State Climate Office of North Carolina at NC State University).
 ...○... Water Level
 —◇— Iron Rod Oxidation

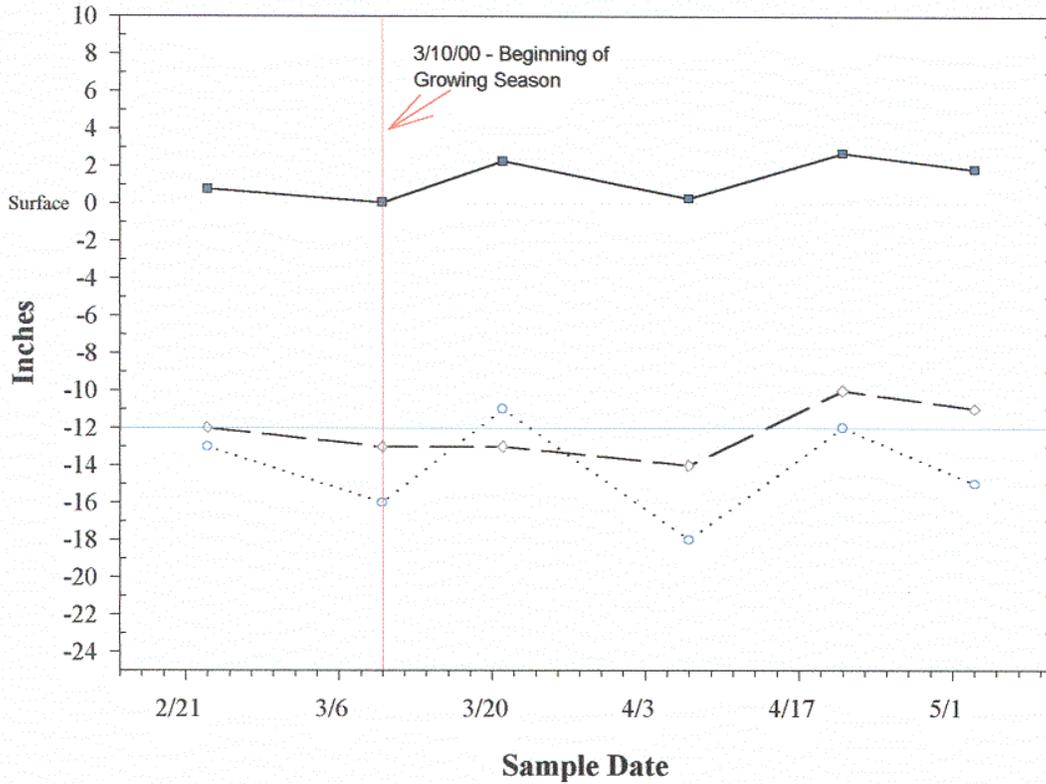
**2000 Hydrological Monitoring
Seven Springs
Wayne County, NC
Reference Well**

—■— Cumulative Precipitation (Between Sample Events)
 Gauge: Goldsboro 4SE, NC UCAN: 1418, COOP: 313510
 (Information was provided by the State Climate
 Office of North Carolina at NC State University).
 ...○... Water Level
 —◇— Iron Rod Oxidation
