ANNUAL REPORT FOR 2001

SEVEN SPRINGS MITIGATION SITE

PROJECT NO. 6.804756

SEVEN SPRINGS MITIGATION SITE 2001 REPORT - EXECUTIVE SUMMARY

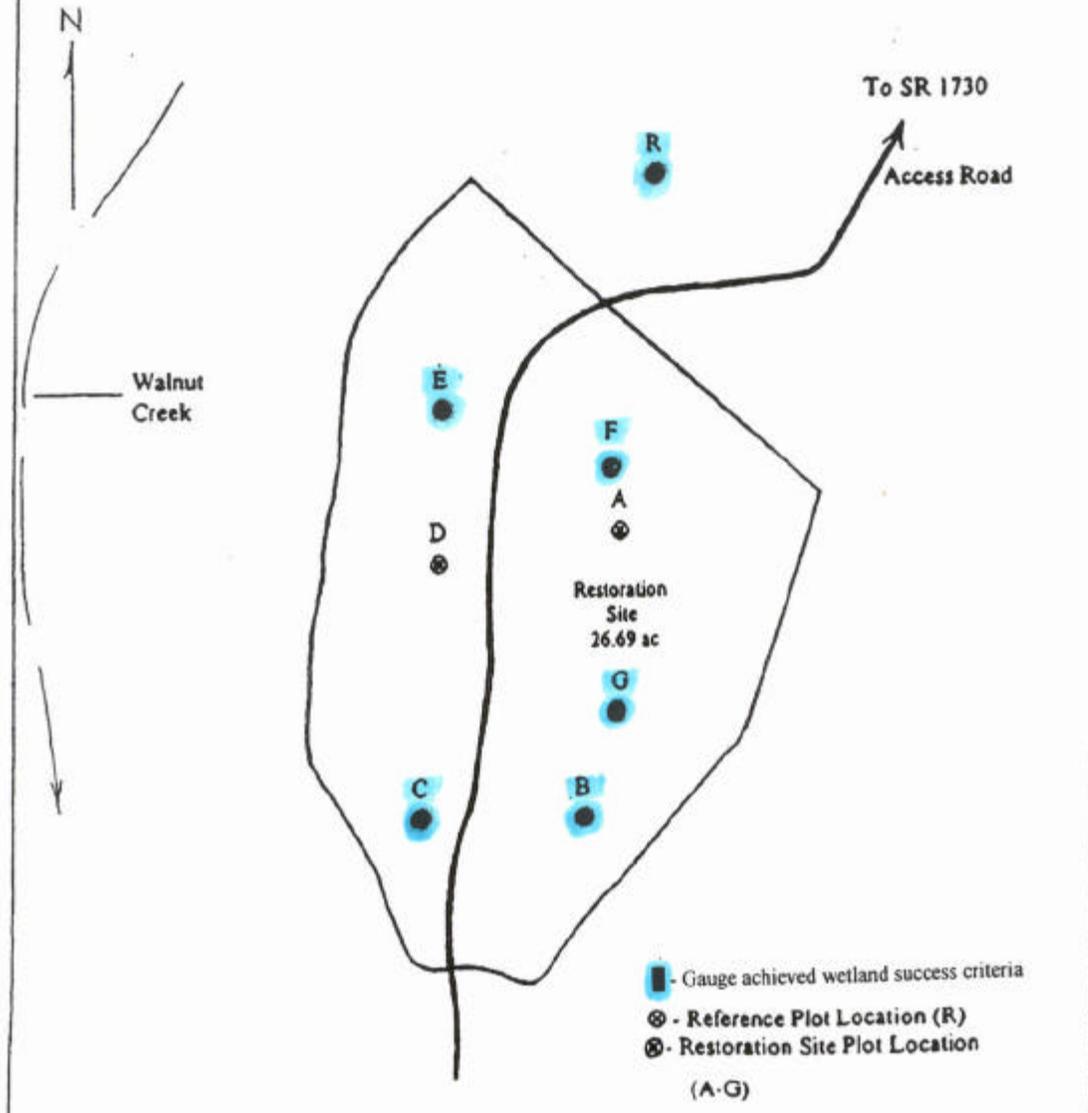
Figure 2
Neuse River Mitigation Project
Seven Springs Section
Plot Locations 1)
 Gauge Location Map

Eight manual monitoring gauges were installed in 1993 including one reference gauge (Figure 2). At the time of approval for this wetland mitigation project, annual hydrological monitoring requirements were for the early growing season only (March – May). The early growing season reflected the most likely time for seasonal saturation for wetlands that are not inundated for the entire growing season. The summer months usually are times of water deficit in the soil and monitoring data would not indicate wetland hydrology during this time period. During the early growing season in 2001 five trips were made to record groundwater depth at the project site (Appendix – 2001 Gauge Hydrographs). The Appendix contains a plot of the water depth for each groundwater monitoring gauge during the growing season. Local precipitation data are included with each of the plots. The precipitation data was obtained from a nearby weather station in Goldsboro (Goldsboro 4 SE, NC UCAN:14118, COOP: 313510). The groundwater gauge hydrographs also include iron rod oxidation/reduction data as specified in the Mitigation Plan. This data provides additional information related to the presence of saturated conditions on the site and is supplemental to the groundwater gauge data.

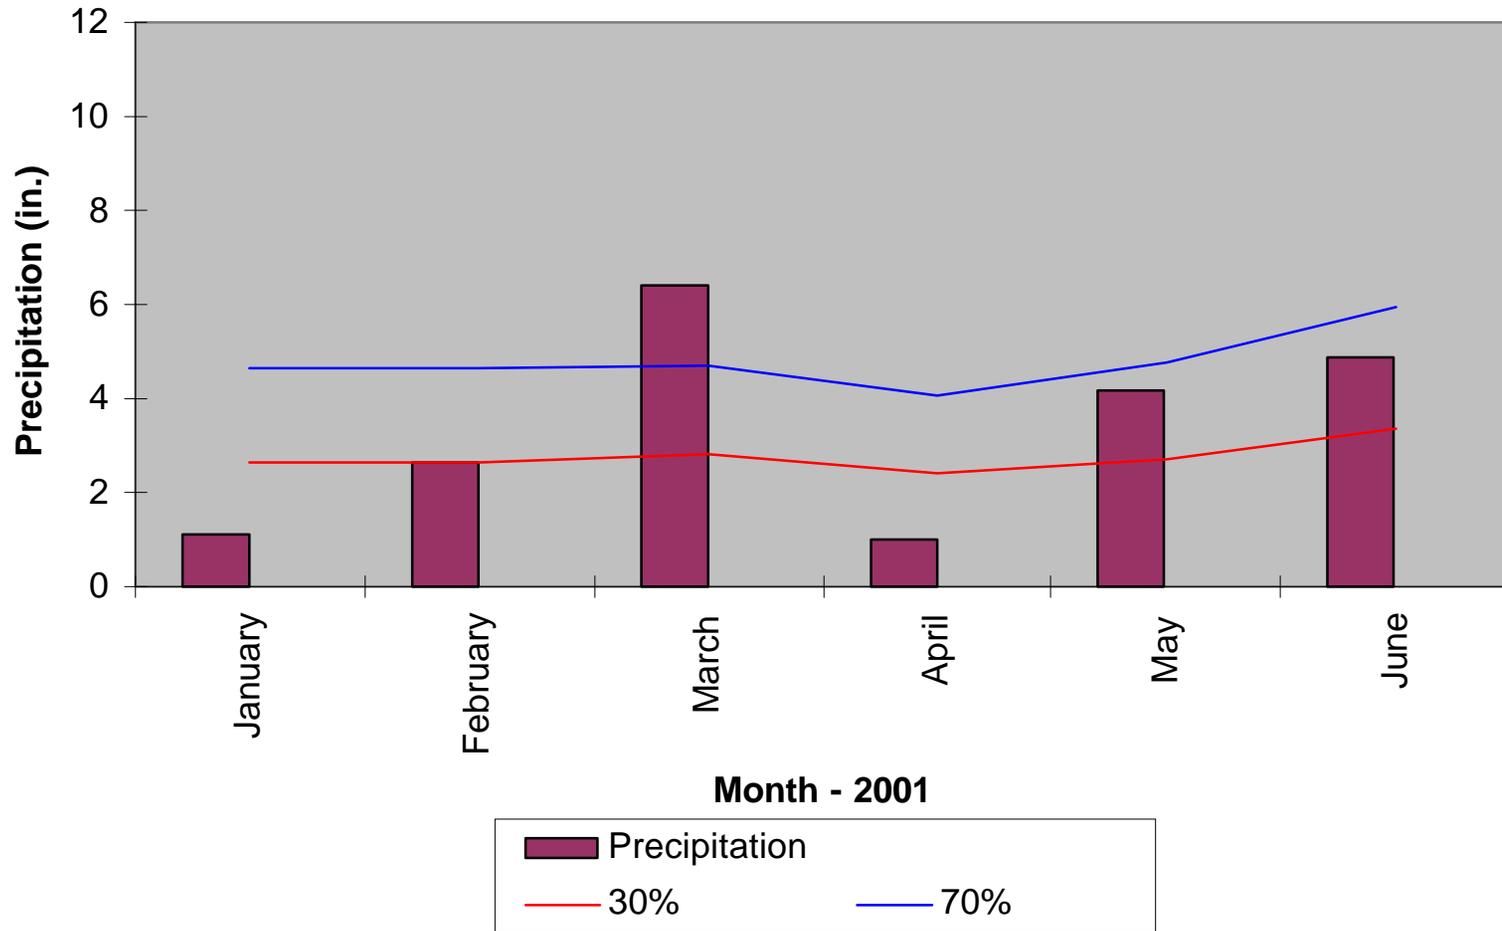
Figure 3: 2001 Seven Springs - 30-70 Graph

Figure 3 is a graph of cumulative precipitation on a monthly basis during the months of January through June 2001 to historical precipitation for the area. The two lines represent the 30th and 70th percentiles of monthly precipitation for Goldsboro, NC. These percentiles represent monthly rainfall data collected in Goldsboro between 1903 and 2001. They are designed to illustrate the “normal range” for rainfall in the area. The bars are the monthly rainfall totals for January 2001 through June 2001. The historical data was collected from a National Climatic Data Center rain gauge. The current monthly rainfall data was provided by the State Climate Office of North Carolina at NC State University.

During the 2001 growing season, five out of the seven gauges made the criteria for wetland hydrology. Gauge data trends indicate that virtually the entire site exhibits wetland hydrology. Lower groundwater data in gauges A and D can be explained by the slightly higher landscape position of these gauges and below average rainfall for April. It should be noted that these gauge locations and slightly higher elevations are not representative of the entire restoration project site. The remainder of the hydrograph gauges achieved wetland success criteria every year since 1997 except for 2000. During 2000, precipitation data for the months of February, March and May were below the 30th percentile and was evident in several gauges as well as the reference gauge.

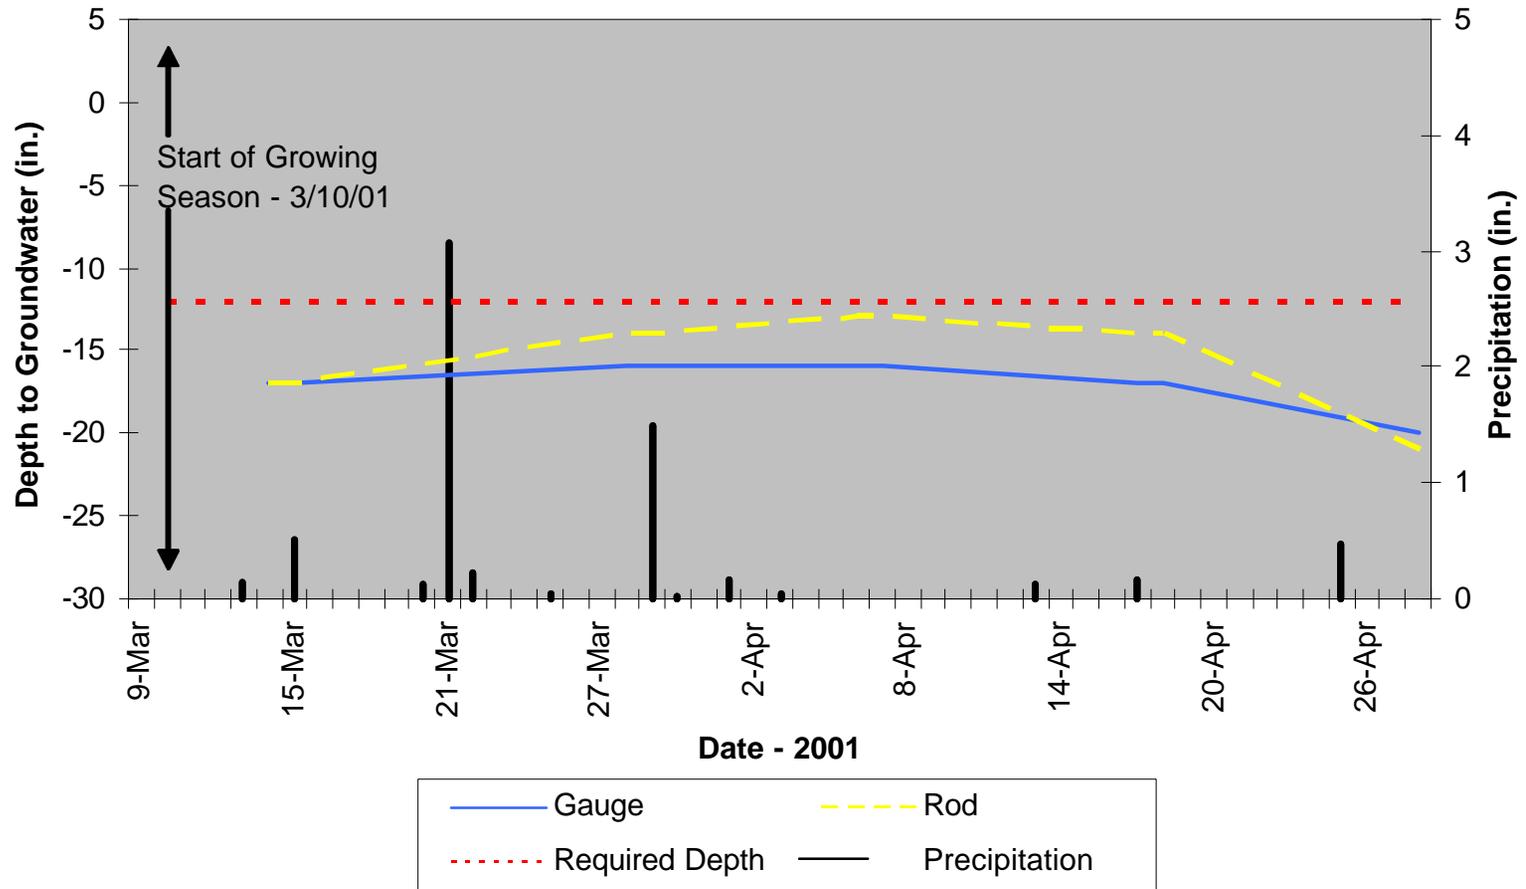
2001 Seven Springs - Gauge A

During the 2001 growing season, four out of the six gauges met the criteria (14 consecutive days) for wetland hydrology. Gauge data trends indicate that virtually the entire site exhibits wetland hydrology. Lower groundwater data in gauges A and D can be explained by the slightly higher landscape position of these gauges. It should be noted that these gauge locations and slightly higher elevations are not representative of the entire restoration project site.

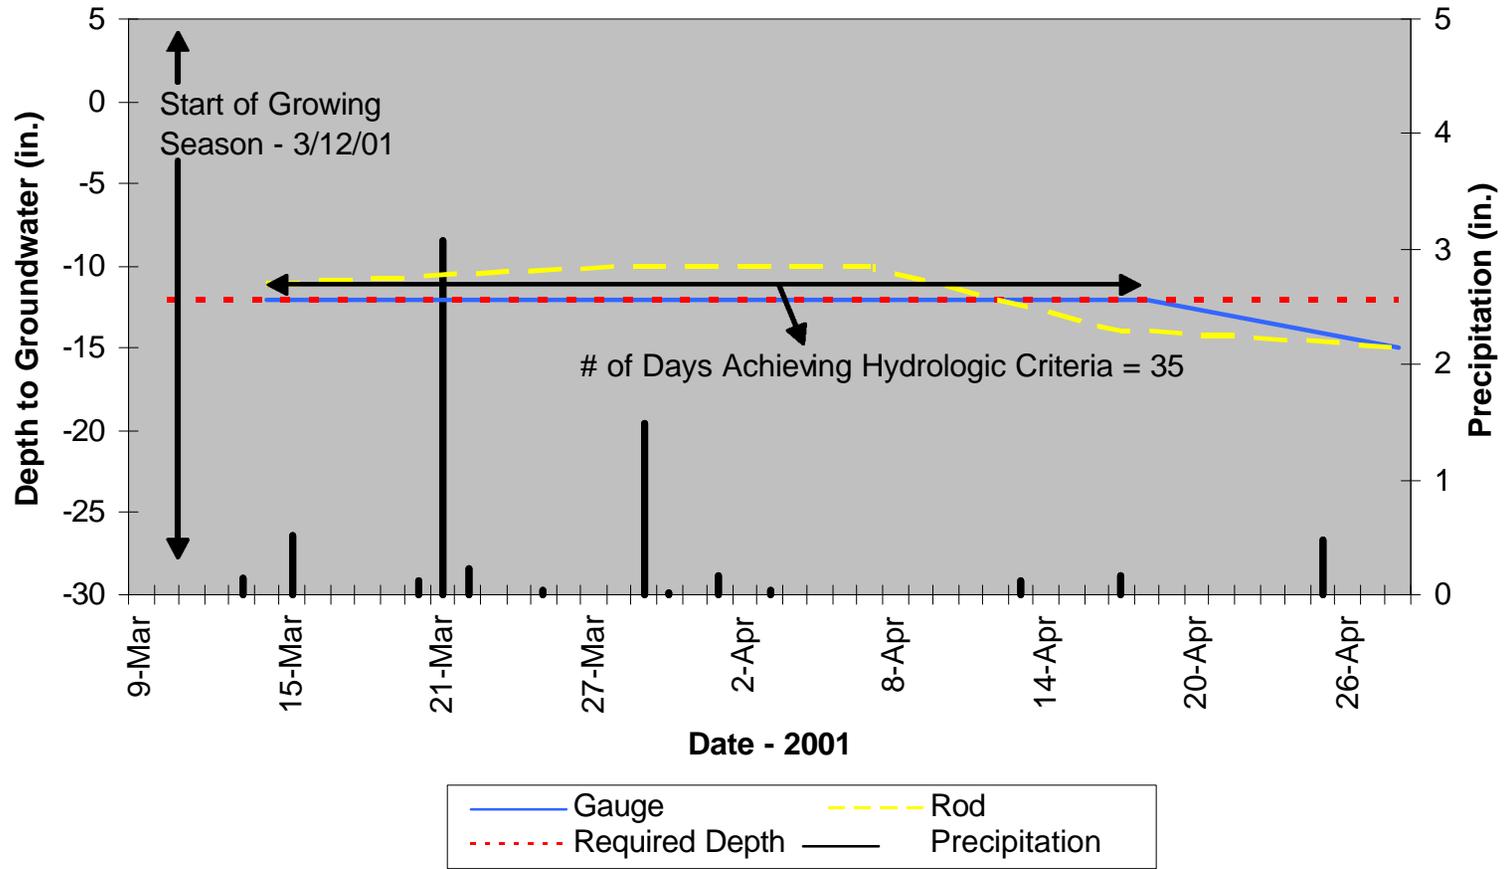
2001 Seven Springs - Gauge B

During the 2001-early growing season, gauges B, C, E, F, and G met the criteria for wetland hydrology. For those plots achieving wetland hydrology, ground water was within 12 inches of the soil surface for at least 14 consecutive days during the growing season (B –35 days, C – 48 days, E – 35 days, F – 57 days, G – 19 days, and Ref. – 54 days). The gauges that did not indicate wetland hydrology this growing season can be attributed to very little rainfall between the end of March to the middle of May (Rainfall data from Goldsboro 4 SE, NC UCAN:14118, COOP: 313510)

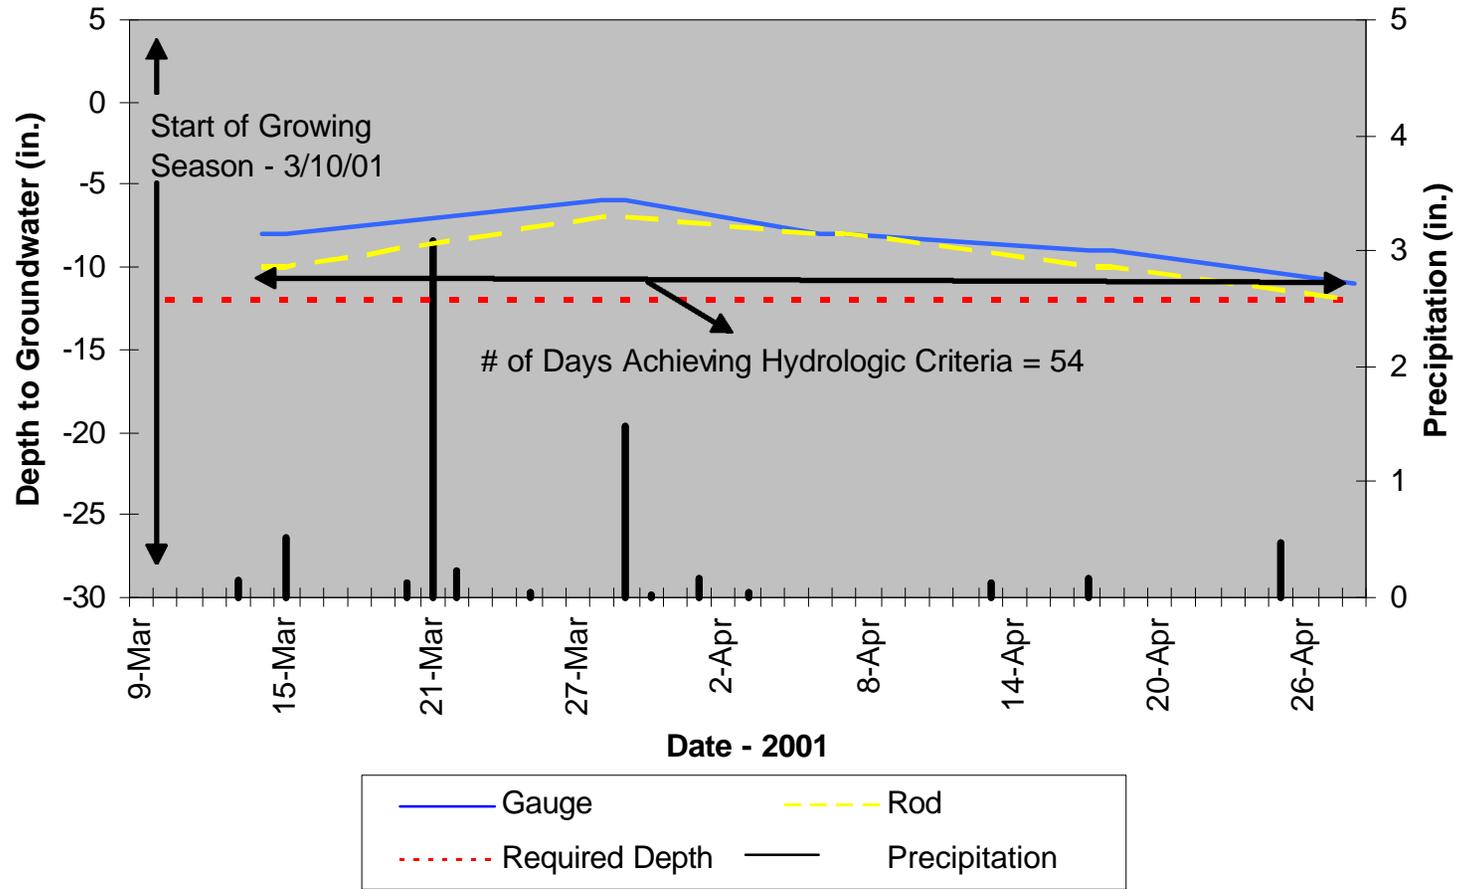
Seven Springs - Reference Gauge

Groundwater gauge and iron rod oxidation data were collected from March 14, 2001 to April 28, 2001. Average depth to groundwater during the 2001 growing season ranged from 14.4 inches on April 28 to 10.9 inches on March 14 (Appendix A –2001 Gauge Hydrographs). Average groundwater depth in the reference plot during the 2001 growing season was 8.4 inches. Average iron rod oxidation depth for plots A - G ranged from 13.4 inches on April 28 to 9.0 inches on March 14. Average iron rod oxidation depth for the reference area during the growing season was 9.4 inches.

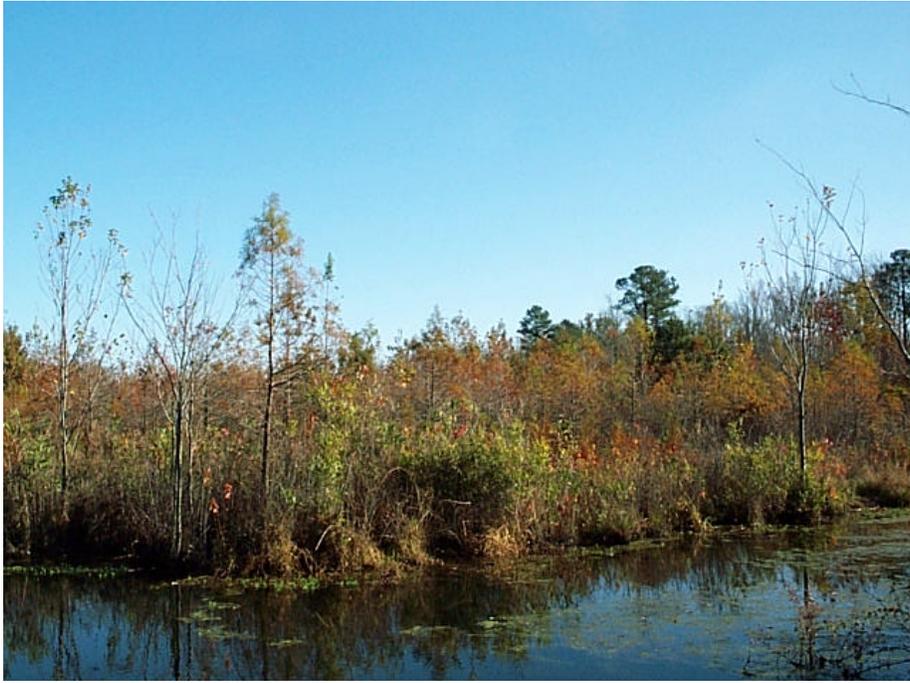
Photo 1 – South side of project area looking Northeast.

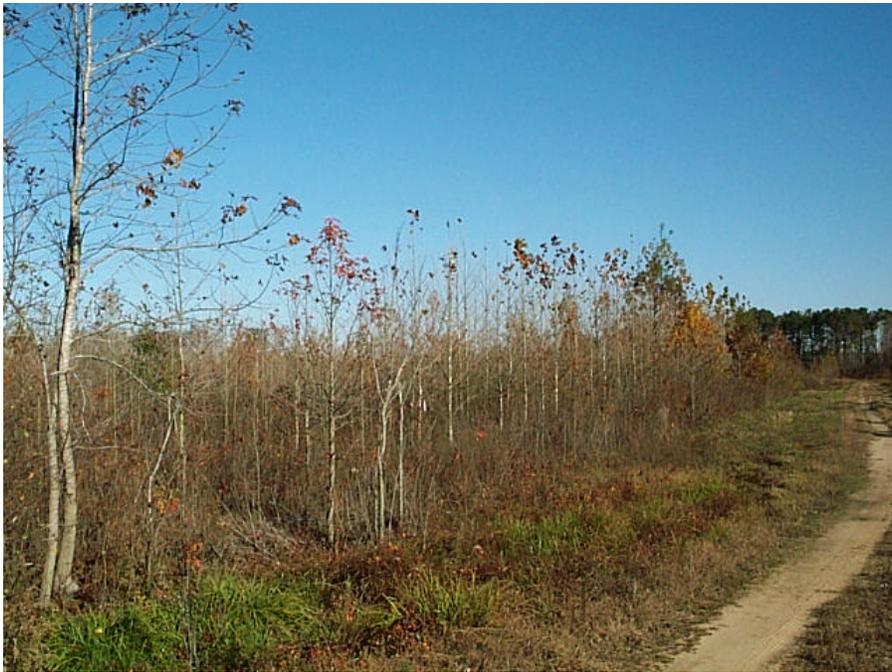
Photo 2 – South side of project area looking Northwest.
