ANNUAL REPORT FOR 2009

**Campbell Creek Phase II Mitigation Site
Beaufort County
TIP No. R-2510WM**

Natural Environment Unit & Roadside Environmental Unit
North Carolina Department of Transportation
December 2009

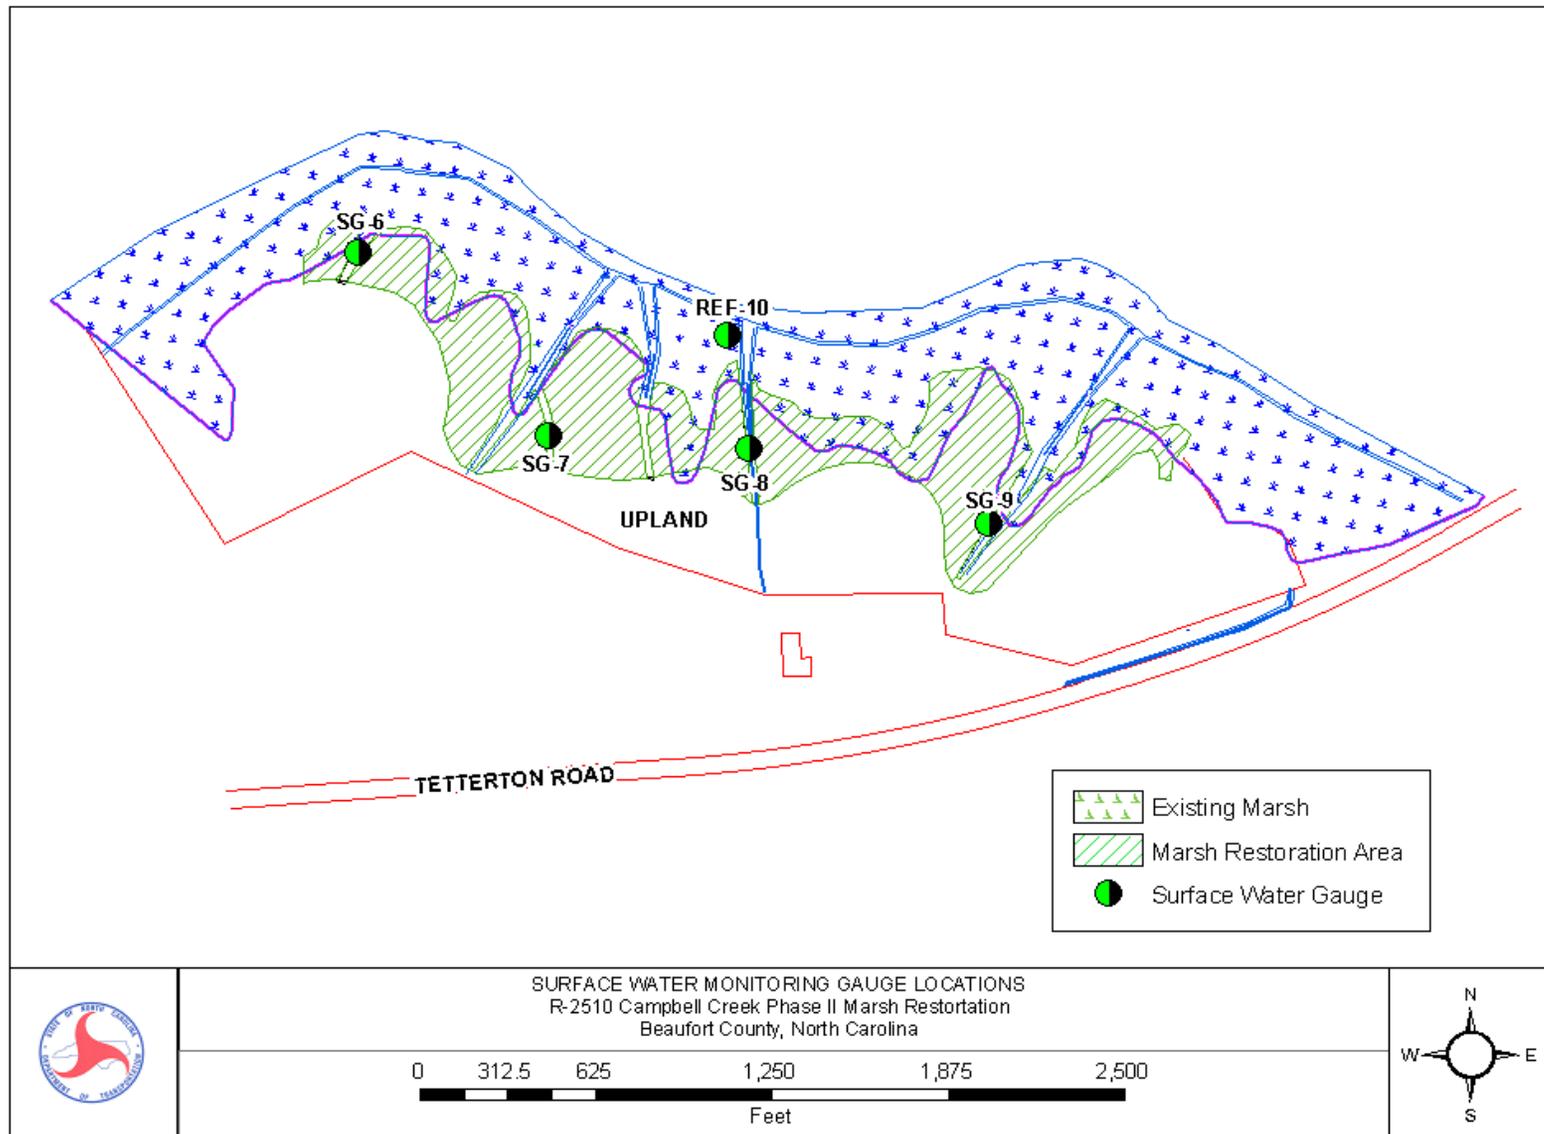
Figure 2. Monitoring Gauge Location Map (Phase II Site)

Wind-driven tides are the primary hydrologic input at the Campbell Creek Phase II Site. Four surface water monitoring gauges were installed within the Phase II site restoration area (SG-6, SG-7, SG-8, SG-9; see Figure 2) in April 2007. There is also one reference gauge (REF-10) located directly adjacent to the constructed site, within the preservation area. The surface gauges record surface water levels every three hours on a daily basis. Monitoring data for 2009 represents the third year of hydrologic monitoring for the Phase II site.

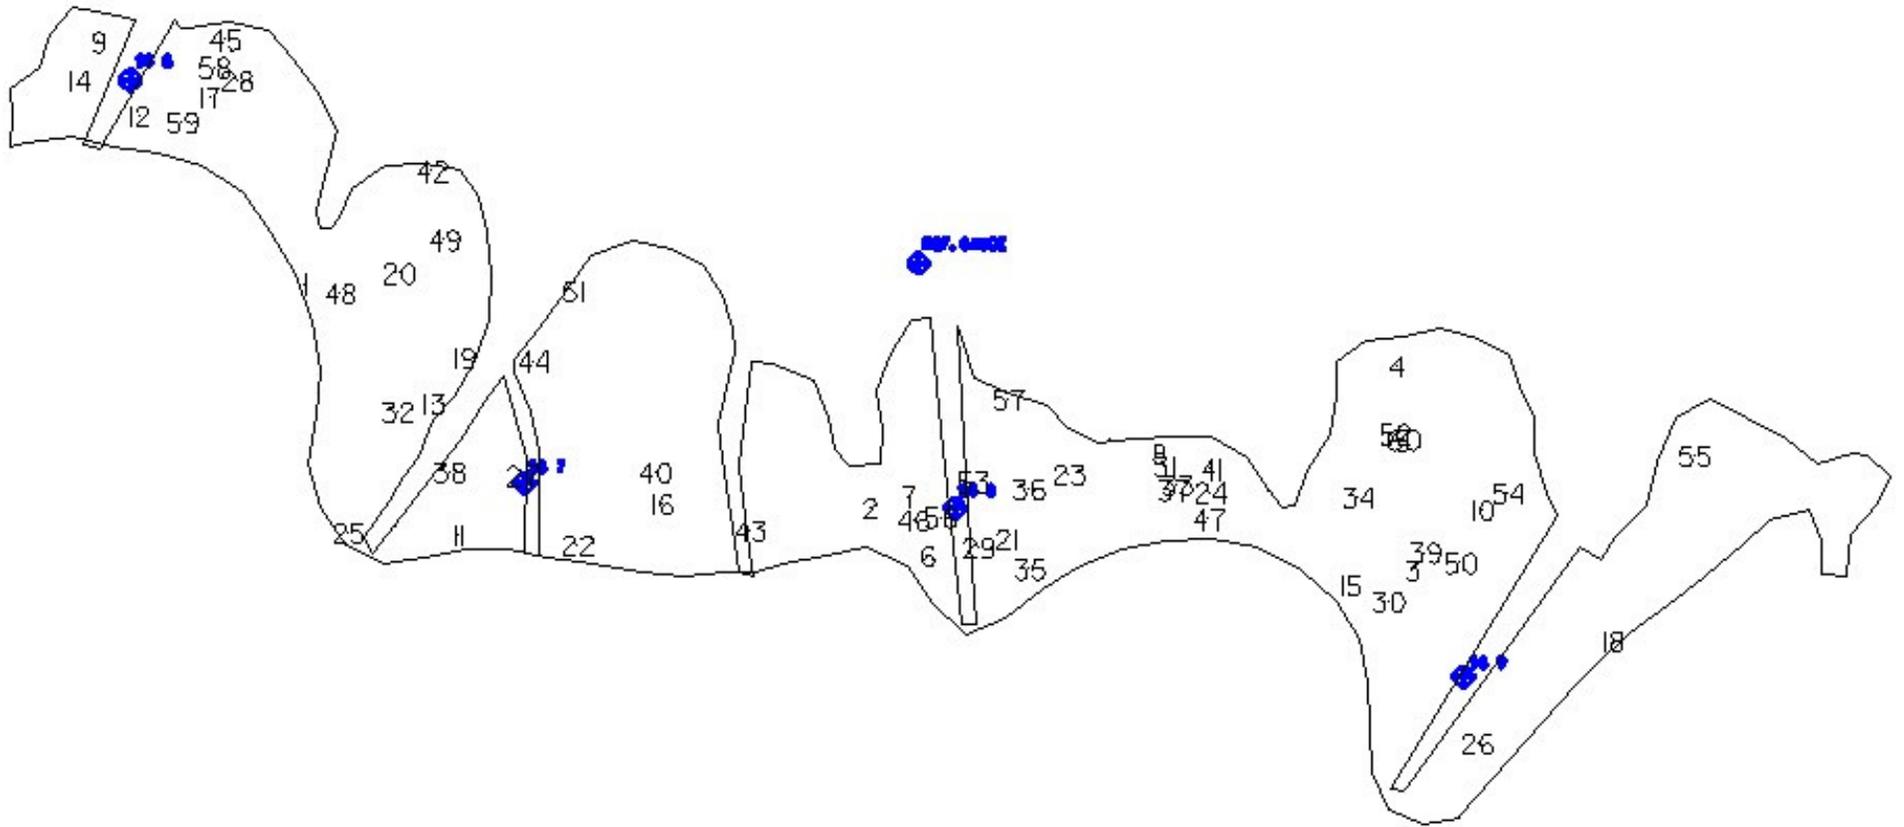
Campbell Creek (Phase II - North Side) 2009 Marsh Grass Random Plots

Site Notes: The number of plots the species were found in is listed in parentheses (i.e. 1 of the plots contain cattail): cattail (1), phragmites (5), *Aster* sp. (34), marsh-elder (7), *Scirpus* sp. (4), *Baccharis* (2), and *Juncus roemerianus* (1).
