ANNUAL REPORT FOR 2001

**Pembroke Creek Mitigation Site
Chowan County
Project No. 8.T010602
TIP No. R-2512**

Prepared By:
Natural Systems Unit & Roadside Environmental Unit
North Carolina Department of Transportation
December 2001

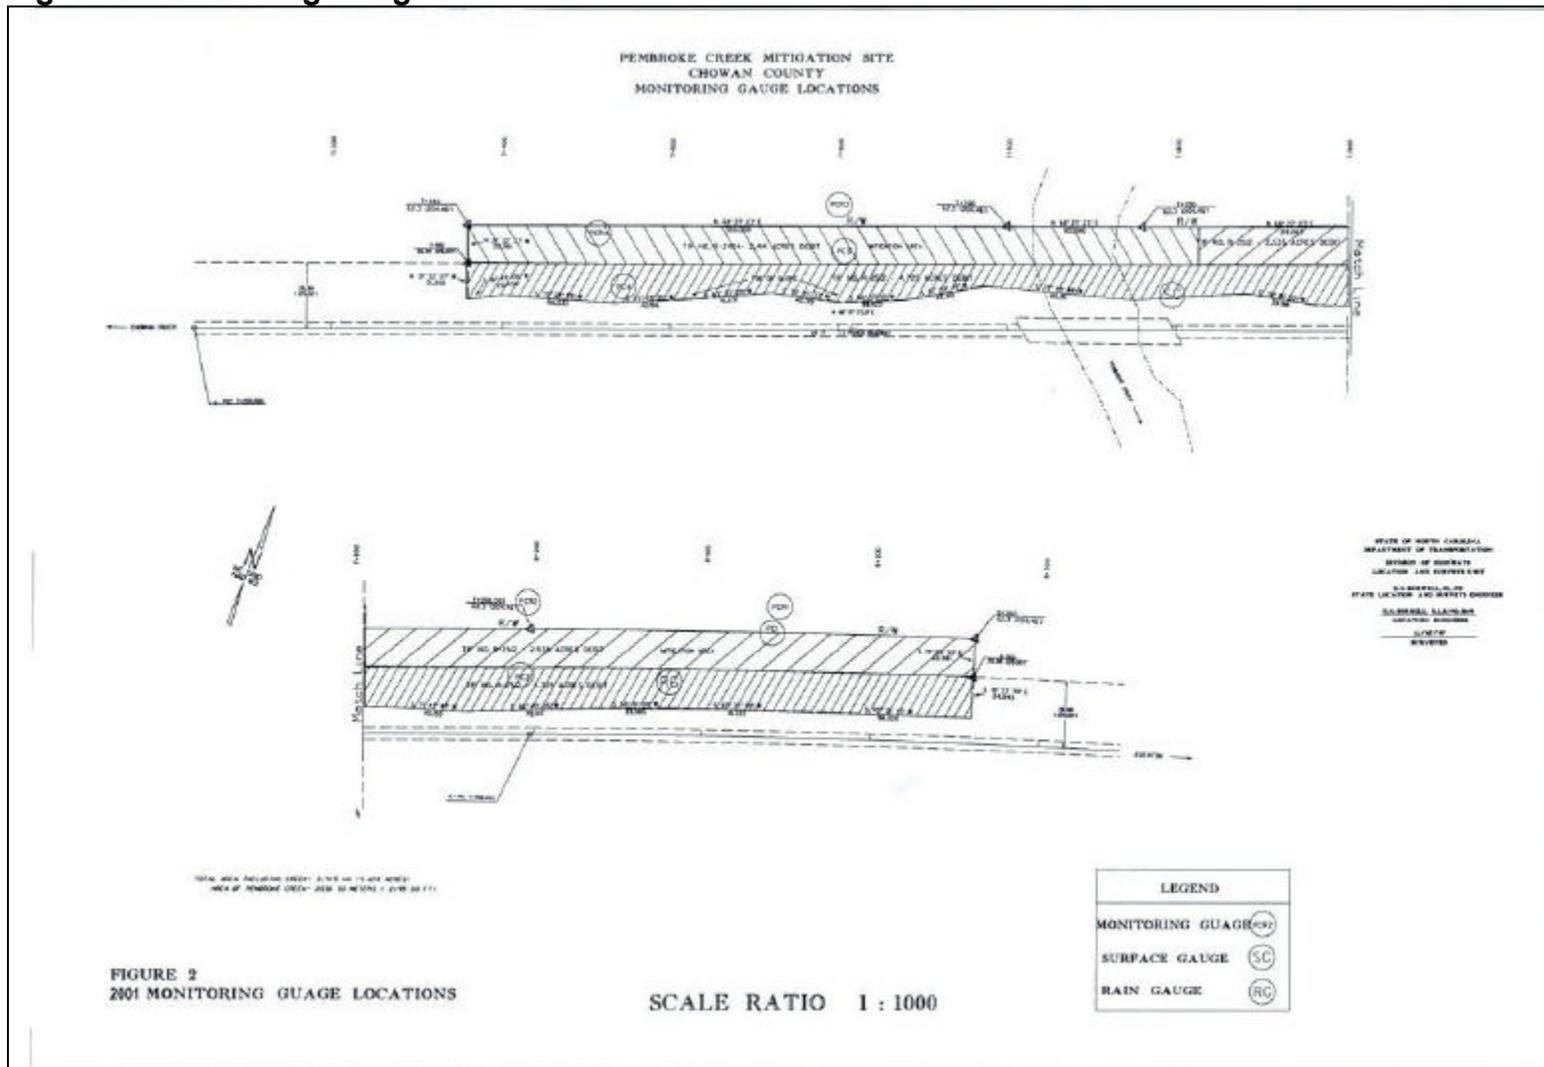
Figure 2. Monitoring Gauge Locations

Eight monitoring gauges (four site gauges, four reference gauges), one rain gauge, and one surface water gauge were installed on site in February 1999 and data was recorded starting in March 1999 (Figure 2). The automatic monitoring gauges and rain gauges record the depth to groundwater and rainfall, respectively. Data was collected on a daily basis throughout the growing season.

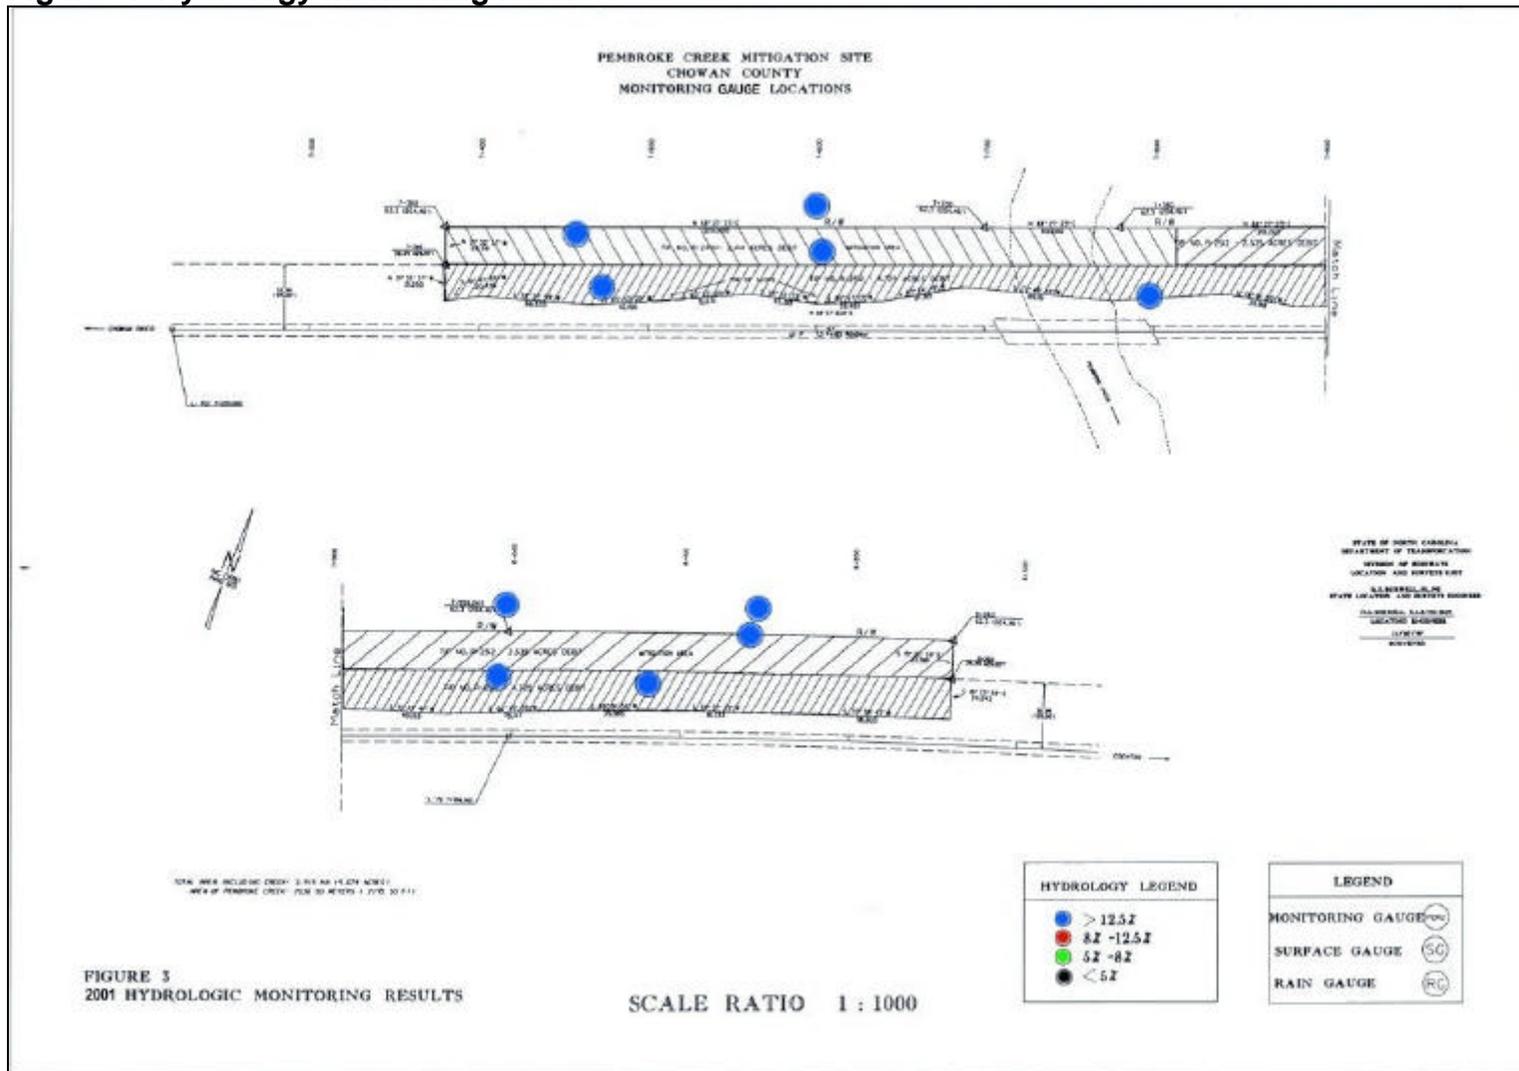
Figure 3. Hydrology monitoring results

Figure 3 is a graphical representation of the hydrologic monitoring results.

The maximum number of consecutive days in which the groundwater was within twelve inches of the surface was determined for each gauge. The number of days was then converted into a percentage of the 262-day growing season. Table 2 gives the results for the 2001 growing season (March 13-December 1).

Hydrologic success for this site is based on the mean depth to groundwater of the gauges in the restoration area within 20% of the mean depth to groundwater of the gauges in the respective reference area. One of the four gauges was within 20% of reference gauges. Three gauges (PC-1, PC-2, and PC-3) did not meet this criteria. However, each of the gauges recorded the water table within 12 inches of surface for more than 12.5% of the growing season, which meets the standard hydrologic criteria. Therefore, monitoring from the 2001-growing season indicates success in hydrology based on federal guidelines, however success criteria for this site were not met.

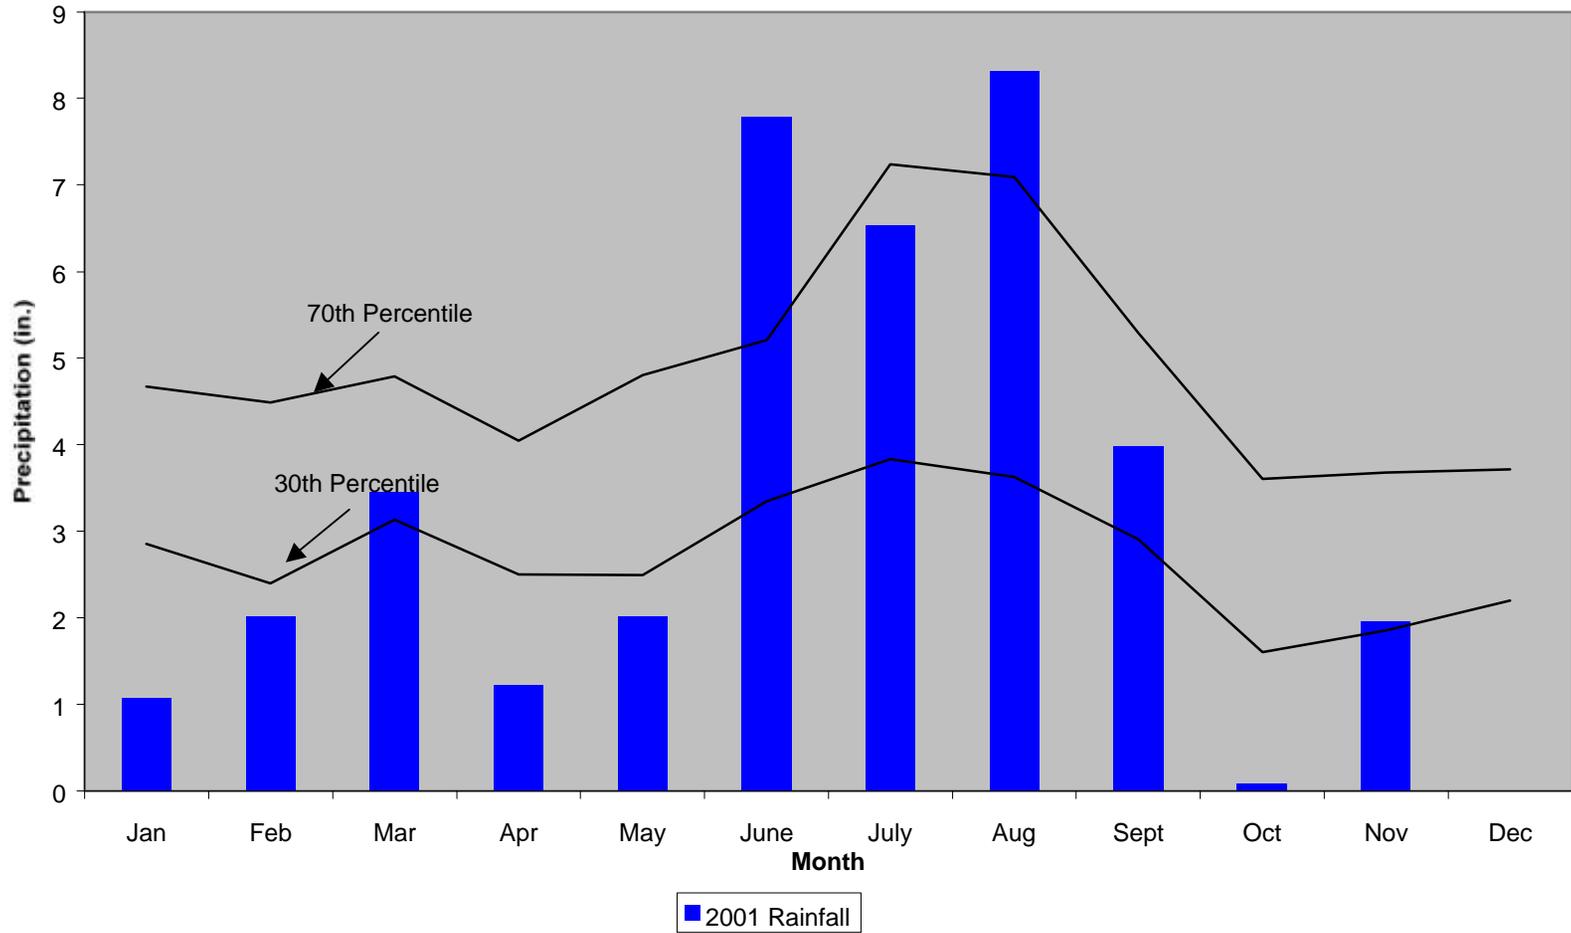
Figure 4. Historical Rainfall Data (30-70 Graph)

Figure 4 is a comparison of 2001 monthly rainfall to historical precipitation for the Edenton area. Rainfall data recorded onsite during the growing season was compared to the historical 30-70 percentile trends for the area. It is assumed that if the 2001 rainfall totals, represented by bars, fall between the average precipitation values for each month, then the local climate was experiencing average conditions for that particular region.

As indicated by Figure 4, April, May, and October experienced below normal rainfall totals. Rainfall in March, July, September, and November fell within the average range. Rainfall in June and August was above the normal rainfall totals for those months.

Below average precipitation during April and May may have lead to significant drops in water table depth. Several of the gauges including PC-2 and PCR-2 showed increases in depth to the water table during these months. While the water table was within 12 inches (for PC-2) for more than 12.5% of the growing season, it is likely that the number of consecutive days within 12 inches would have increased had rainfall amounts been closer to average.

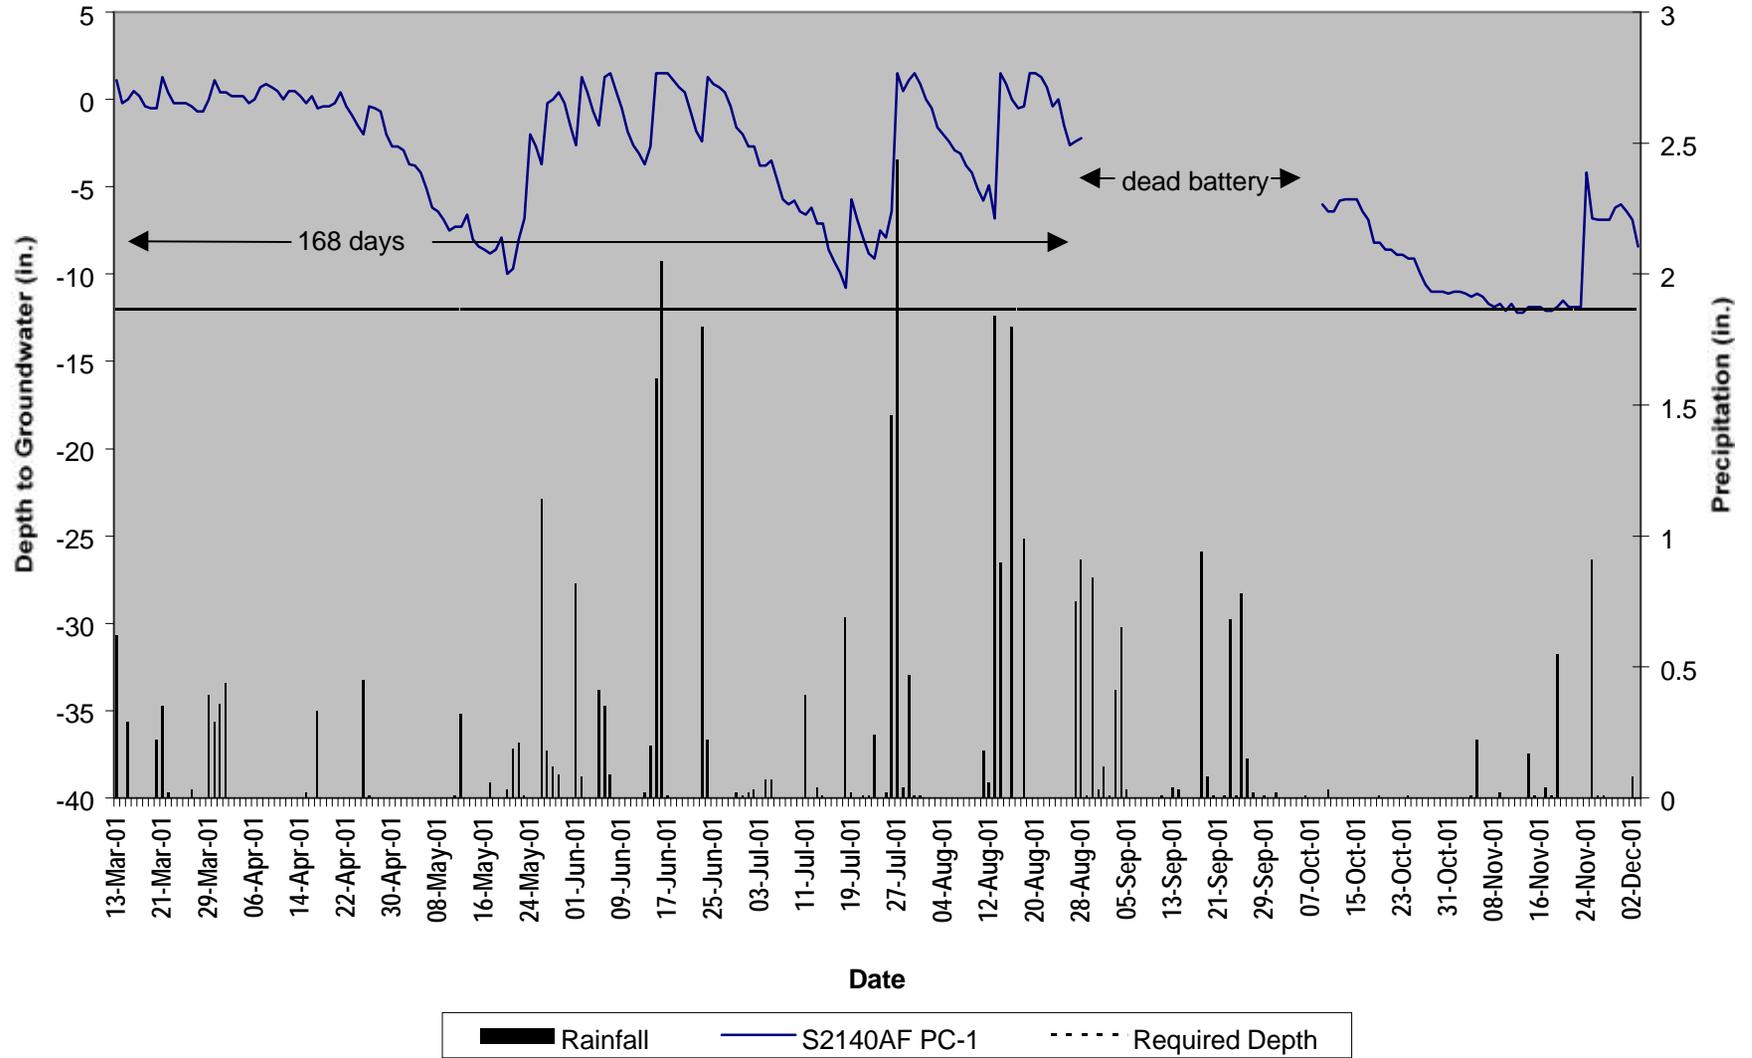
Pembroke Creek PC-1

Specific monitoring gauge problems: Gauge number PC-1 (S2140AF) stopped recording data on 8/28/01. The battery was replaced and the gauge was reset to record data at the proper time and interval beginning on 10/9/01.

PC-1 did not record data during late August through early October due to a dead battery. Based on water table depth before and after that time frame, as well as rainfall during that period, it is likely that the number of consecutive days within 12 inches would have increased had the unit been working properly.

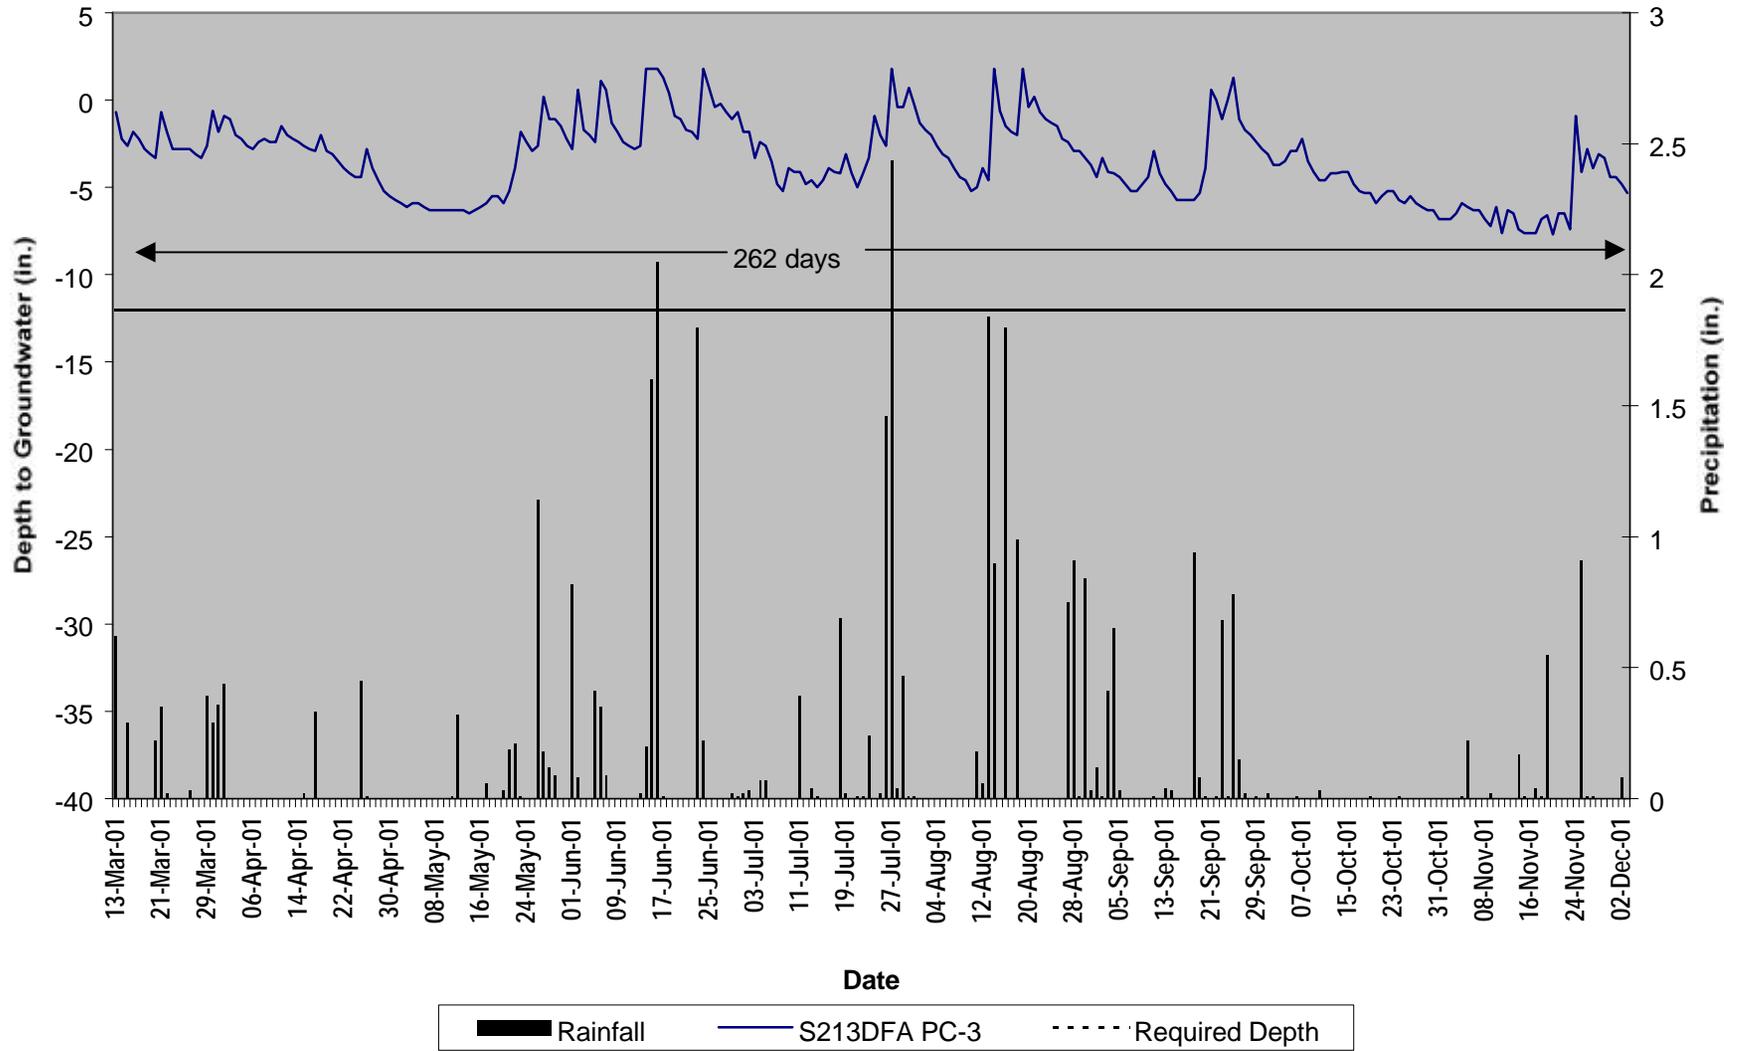
Pembroke Creek PC-3

Appendix A contains a plot of the water depth for each monitoring gauge and surface water gauge in 2001. Precipitation events are included on each graph as bars.
