ANNUAL REPORT FOR 2014

**UT to Middle Fork Creek Site B Mitigation Site
Madison County
TIP No. R-2518A
COE Action ID: SAW-2007-2197-357/300
DWR #: 20071134**

Prepared By:
Natural Environment Section & Roadside Environmental Unit
North Carolina Department of Transportation
November 2014

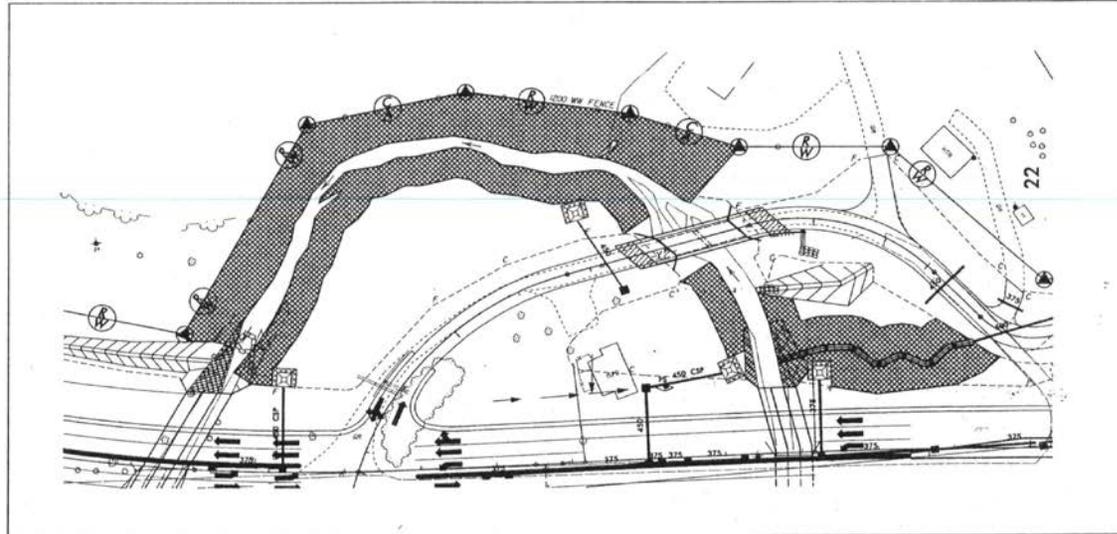
Figure 3. Site B Reforestation Map

.42 HECTARE STREAMBANK REFORESTATION

SEE RF-2, RF-3 AND PROJECT SPECIAL PROVISIONS

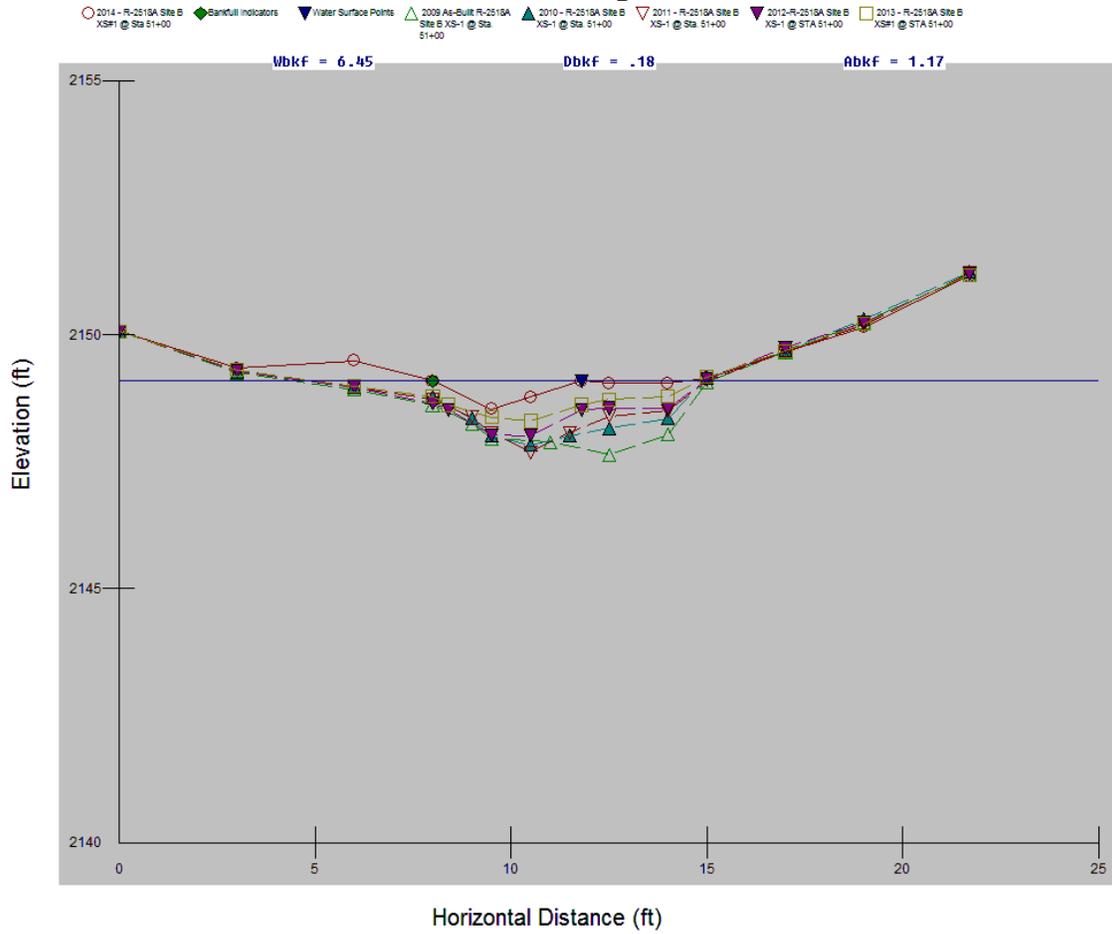
R-2518A Site B XS#1 @ Sta 51+00

Site B: Cross-Section #1 (Pool) Abbreviated Morphological Summary					
	2010	2011	2012	2013	2014
Bankfull Cross Sectional Area (ft ²)	3.77	3.1	1.83	1.31	1.09
Maximum Bankfull Depth (ft.)	0.94	1.05	0.64	0.48	0.56
Bankfull Mean Depth (ft.)	0.58	0.49	0.3	0.22	0.24
Bankfull Width (ft.)	6.52	6.38	6.19	6	4.5

*According to the Rosgen Classification of Natural Rivers floodprone width, entrenchment ratio, and width depth ratio are not measured in pool, glide, or run features.

Based on comparisons of the As-Built to the monitoring data, all of the cross sections appear stable with little or no active bank erosion. Graphs of the cross sections are presented in Appendix A. Future survey data will vary depending on actual location of rod placement and alignment; however, this information should remain similar in appearance. The ACOE and NCDWR agreed with NCDOT on emails sent on April 2, 2012 to not complete the longitudinal profile survey for the remainder of the five year monitoring period due to heavy vegetation within the channel. In lieu of doing the longitudinal profile, visual inspection of the channel stability throughout the reach and photo documentation at the permanent photo point locations would be completed. All other monitoring activities will continue to be completed throughout the five year monitoring period. Photo points 1 and 2 showed an extensive growth of herbaceous and woody vegetation. The channel bed is stable throughout the stream site at this time. Pebble counts were not required per the permit conditions and therefore were not completed. Two bankfull events were documented by a surface water gauge at Site B during the 2014 monitoring year.

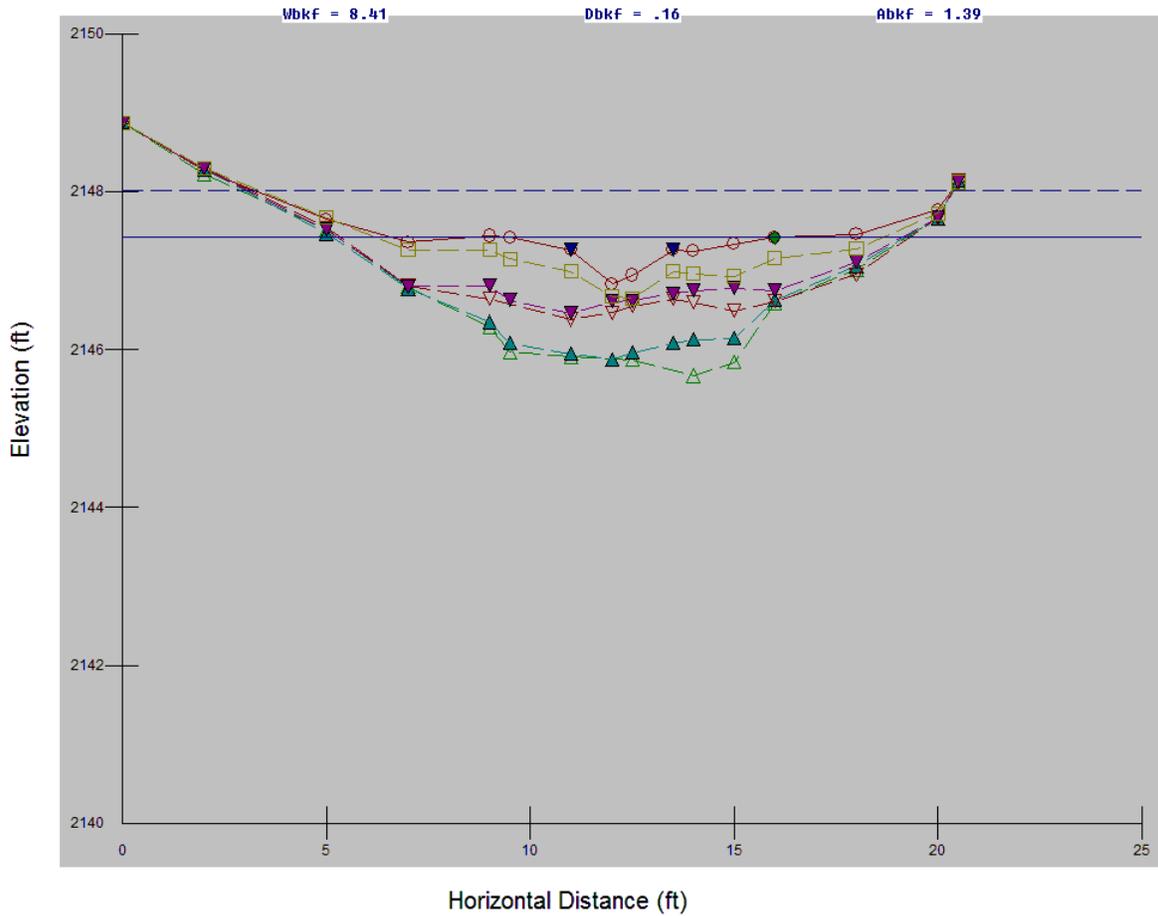
○ 2014 - R-2518A Site B XS#2 @ STA 114+00
 ◆ Bankfull Indicators
 ▼ Water Surface Points
 △ 2009 As-Built R-2518A Site B XS-2 @ Sta. 114+00
 ▲ 2010 - R-2518A Site B XS-2 @ Sta. 114+00
 ▽ 2011 - R-2518A Site B XS-2 @ Sta. 114+00
 ▽ 2012 - R-2518A Site B XS-2 @ STA 114+00
 □ 2013 - R-2518A Site B XS#2 @ STA 114+00

Site B: Cross-Section #2 (Riffle) Abbreviated Morphological Summary					
	2010	2011	2012	2013	2014
Bankfull Cross Sectional Area (ft²)	4	0.58	0.7	1.48	1.33
Maximum Bankfull Depth (ft)	0.75	0.23	0.29	0.51	0.59
Width of the Floodprone Area (ft)	13.81	10.44	11.28	14.77	17.08
Bankfull Mean Depth (ft)	0.48	0.1	0.15	0.23	0.2
Width/Depth Ratio	17.35	60.6	32.2	28.48	32.5
Entrenchment Ratio	1.66	1.72	2.33	2.26	2.63
Bankfull Width (ft)	8.33	6.06	4.83	6.55	6.5

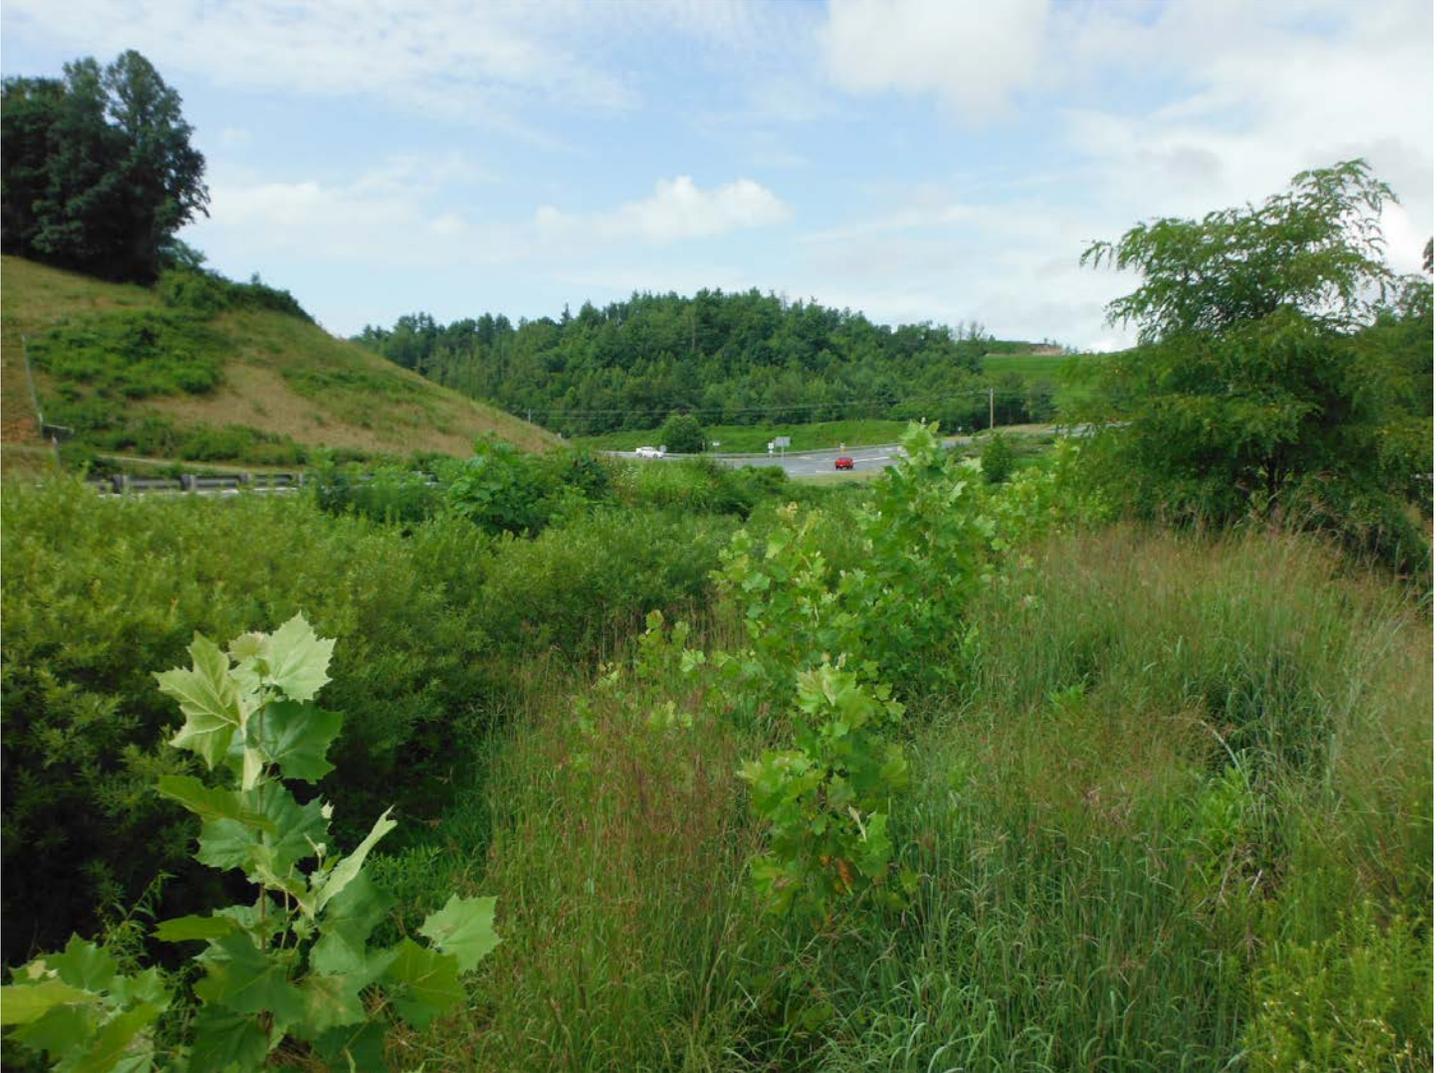
Vegetation Overview Photo

Streambank & Buffer Vegetation: The streambank reforestation was completed in March 2012. The Year 3 vegetation monitoring evaluation noted: Type I: Black Willow and Type II: Sycamore, Green Ash, Tulip Poplar and White Oak were surviving at the time of monitoring evaluation.
