ANNUAL REPORT FOR 2011

**UT to Cold Water Creek Mitigation Site
Cabarrus County
TIP No. R-2533B (Site 23)**

Prepared By:
Natural Environment Unit & Roadside Environmental Unit
North Carolina Department of Transportation
September 2011

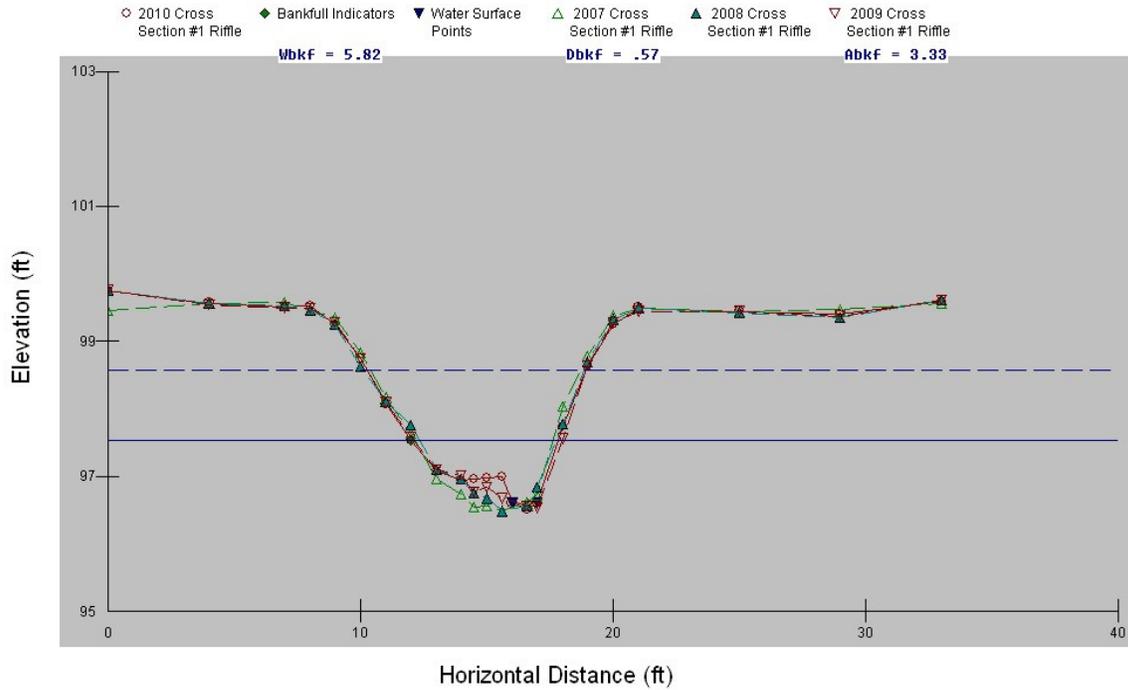
R-2533B Site #23 XS-1 Riffle

Site #23: Cross-Section #1 (Riffle) Abbreviated Morphological Summary				
	2007	2008	2009	2010
Bankfull Cross Sectional Area (ft ²)	4.6	4.8	3.88	3.33
Maximum Bankfull Depth (ft)	1.2	1.3	1.04	1.03
Width of the Floodprone Area (ft)	9.0	10.2	8.78	8.68
Bankfull Mean Depth (ft)	0.8	0.8	0.64	0.57
Width/Depth Ratio	7.0	7.4	9.41	10.21
Entrenchment Ratio	1.6	1.7	1.46	1.49
Bankfull Width (ft)	5.7	6.0	6.02	5.82

Based on comparisons of all four years of monitoring data, all of the cross sections appear stable with little or no active bank erosion. Graphs of the cross sections are presented in Appendix A. Future survey data will vary depending on actual location of rod placement and alignment; however, this information should remain similar in appearance. Pebble counts were not required per the permit conditions and therefore were not completed.

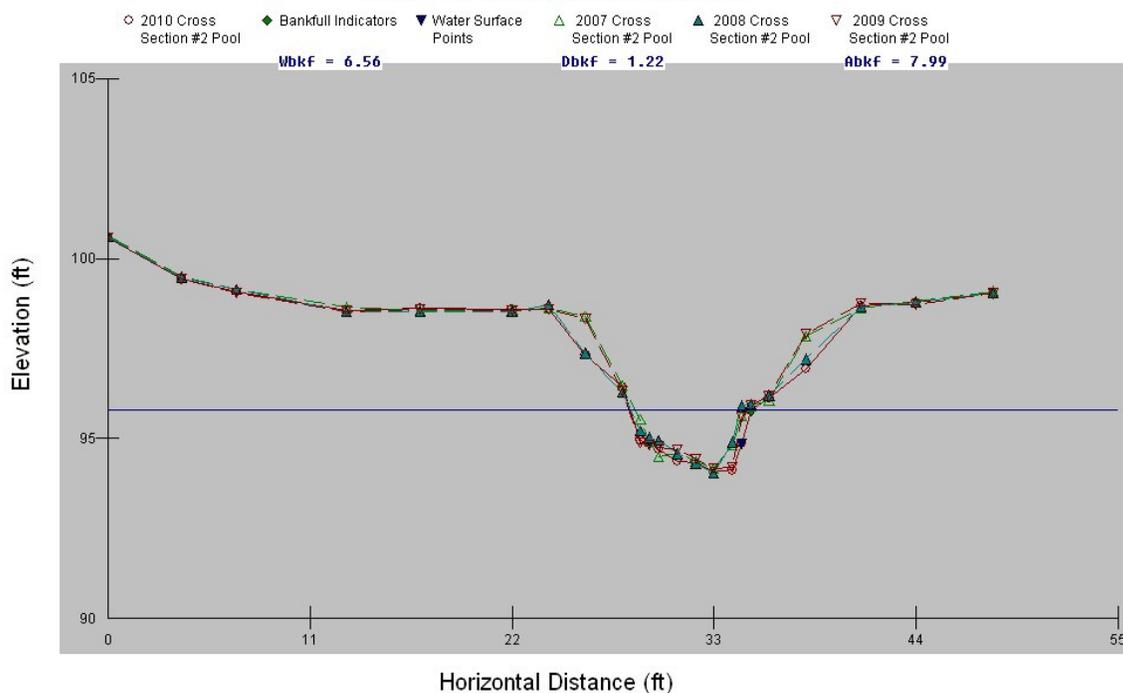
R-2533B Site #23 XS-2 Pool

Site #23: Cross-Section #2 (Pool) Abbreviated Morphological Summary*				
	2007	2008	2009	2010
Bankfull Cross Sectional Area (ft ²)	7.83	7.1	5.86	7.99
Maximum Bankfull Depth (ft)	1.39	1.9	1.41	1.71
Bankfull Mean Depth (ft)	0.86	1.2	0.98	1.22
Bankfull Width (ft)	9.13	6.2	5.99	6.56

* According to the Rosgen Classification of Natural Rivers floodprone width, entrenchment ratio, and width depth ratio are not measured in pool, glide, or run features.
