ANNUAL REPORT FOR 2007

**UT to Adams Creek Mitigation Site
Cabarrus County
TIP No. R-2533B (Site 24)**

Prepared By:
Natural Environment Unit & Roadside Environmental Unit
North Carolina Department of Transportation
May 2007

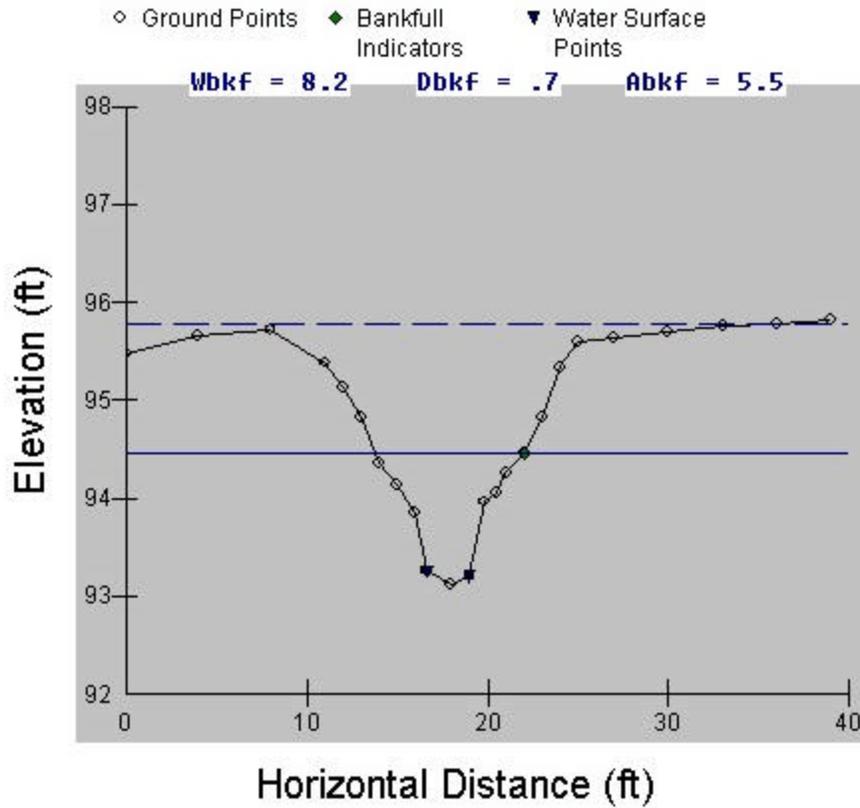
Cross Section #1 Riffle

Site #24: Cross-Section #1 (Riffle) Abbreviated Morphological Summary

2007	2008	2009	2010	2011
Bankfull Cross Sectional Area (ft²)	5.5				
Maximum Bankfull Depth (ft)	1.3				
Width of the Floodprone Area (ft)	36.6				
Bankfull Mean Depth (ft)	0.7				
Width/Depth Ratio	12.1				
Entrenchment Ratio	4.5				
Bankfull Width (ft)	8.2

Based on comparisons of design cross section data and Year 2007 monitoring data, all of the cross sections appear stable with little or no active bank erosion. Graphs of the cross sections are presented in Appendix A. Future survey data will vary depending on actual location of rod placement and alignment, however, this information should remain similar in appearance. Pebble counts were not required per the permit conditions and therefore were not completed.

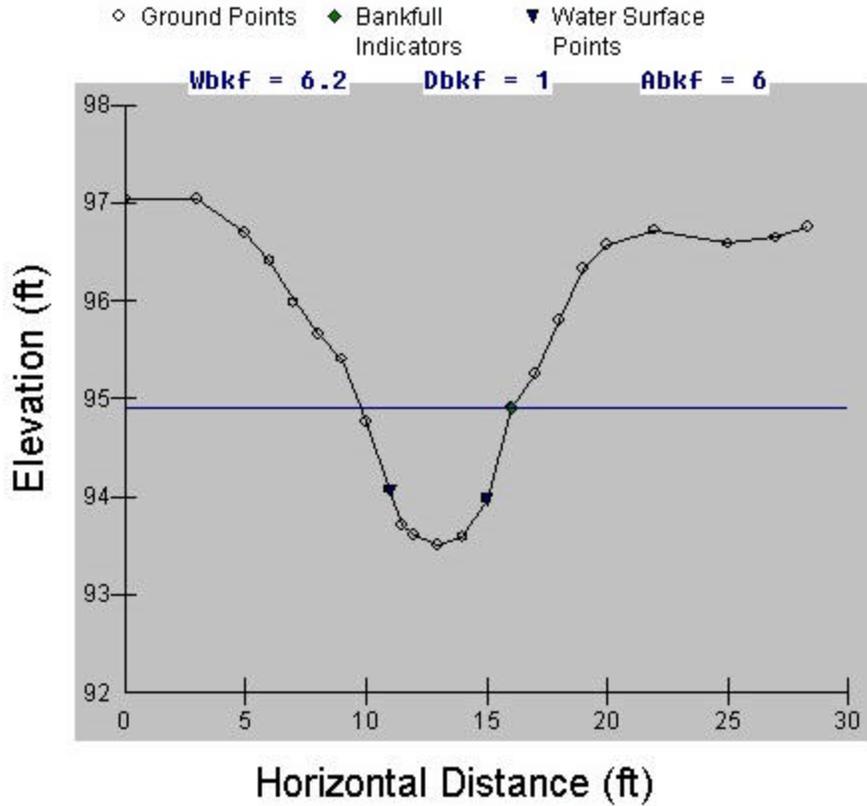
Cross Section #2 Pool

Site #24: Cross-Section #2 (Pool) Abbreviated Morphological Summary*

2007	2008	2009	2010	2011
Bankfull Cross Sectional Area (ft²)	6.0				
Maximum Bankfull Depth (ft)	1.4				
Bankfull Mean Depth (ft)	1.0				
Bankfull Width (ft)	6.2

* According to the Rosgen Classification of Natural Rivers floodprone width, entrenchment ratio, and width depth ratio are not measured in pool, glide, or run features.
