ANNUAL REPORT FOR 2006

**Marks Creek Mitigation Site
Wake County
TIP No. R-2547WM**

Prepared By:
Natural Environment Unit & Roadside Environmental Unit
North Carolina Department of Transportation
January 2007

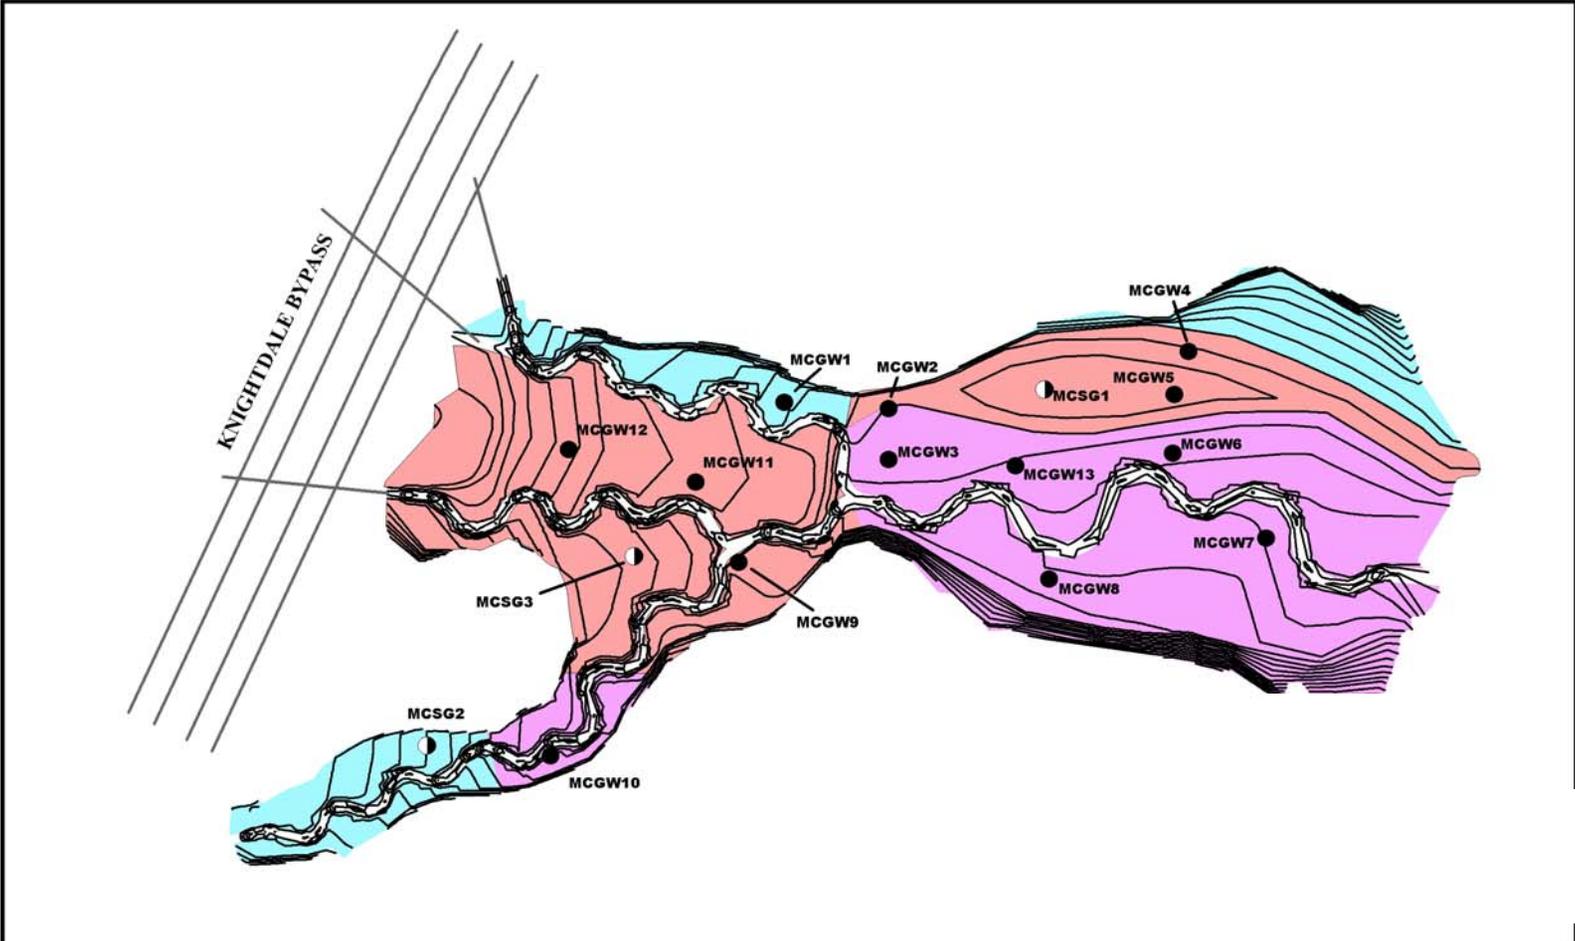
Figure 2. Gauge Location Map

In June of 2003, twelve groundwater-monitoring gauges and three surface water-monitoring gauges were installed across the site (Figure 2). In July of 2005, one additional groundwater gauge was installed. The groundwater gauges are set to record daily water levels, while the surface water gauges are set to record at 4-hour intervals. A rain gauge is also located on the site in order to get accurate site rainfall measurements. The hydrologic response (groundwater) to rainfall events is evaluated using this data.

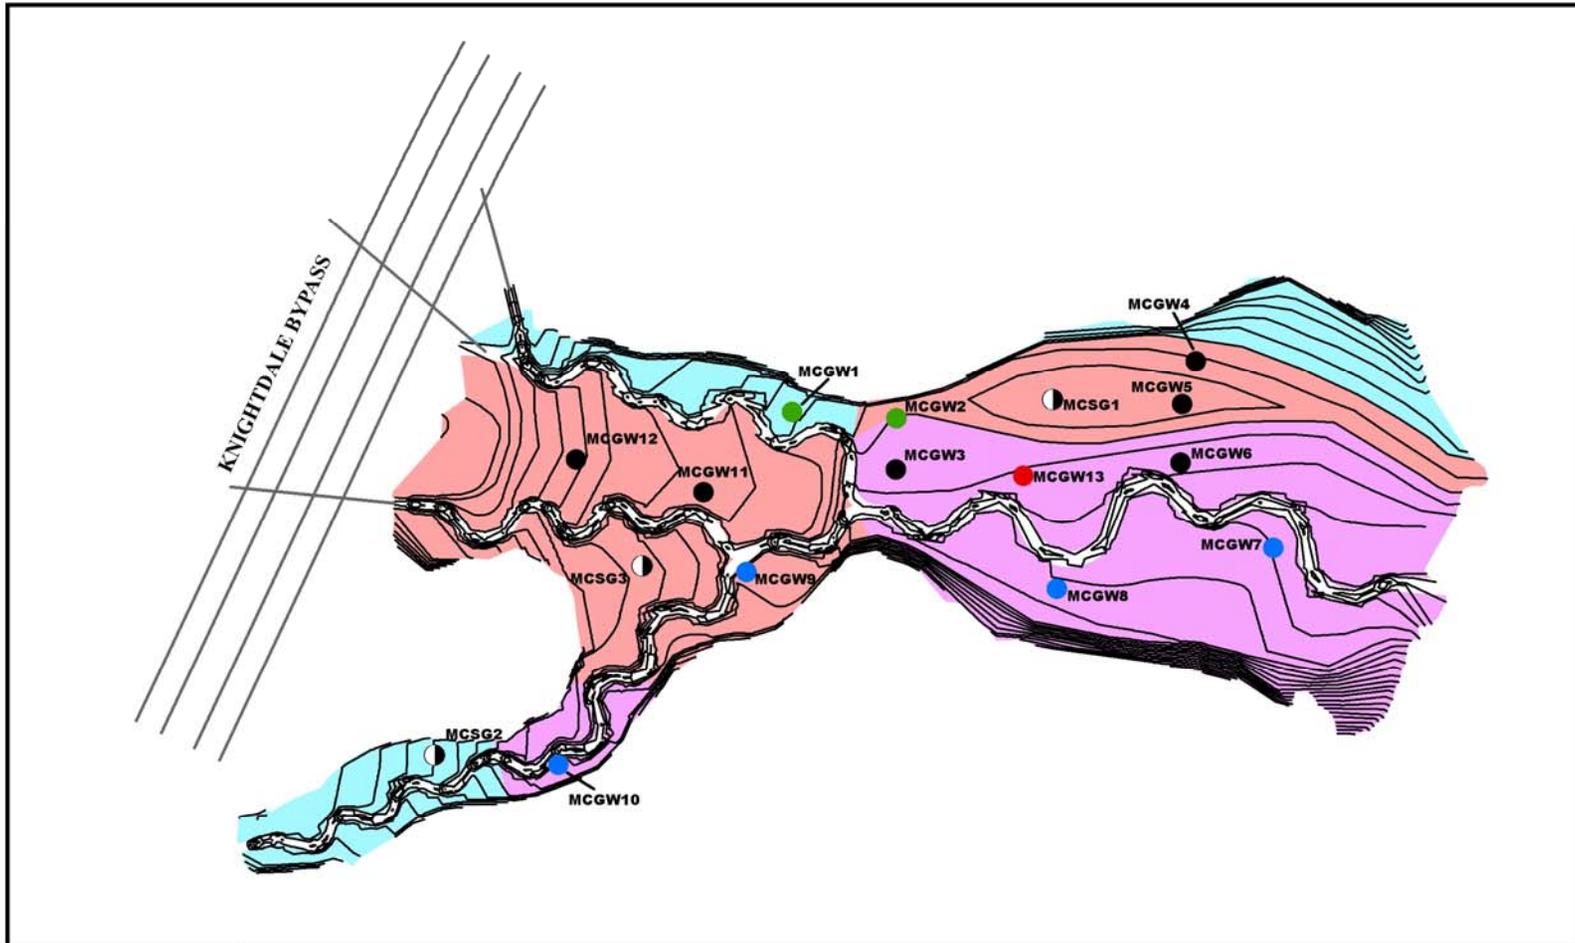
Figure 3. 2006 Hydrologic Monitoring Gauge Results

Figure 3 provides a graphical representation of the hydrologic results. Gauges highlighted in blue indicate wetland hydrology for more than 12.5% of the growing season. Gauges highlighted in red show hydrology between 8% and 12.5% of the season, while those in green indicate hydrology between 5% and 8% of the season. Gauges highlighted in black indicate no wetland hydrology (less than 5% of the growing season). Please note that gauges shown in red or blue meet the hydrology criteria in Zones 2 & 3.

Monitoring Well	Zone	Expected	<5%	5-8%	8-12.5%	>12.5%	Actual %	Success Dates
MCGW 1	3	>8.0		×			7.8	
MCGW 2	1	>12.5		×			7.8	
MCGW 3	1	>12.5	×				2.6	
MCGW 4	2	>8.0	×				1.7	
MCGW 5	2	>8.0	×				0.9	
MCGW 6	1	>12.5	×				3.5	
MCGW 7+	1	>12.5				×	100.0	March 26-Nov 10
MCGW 8+	1	>12.5				×	63.9	March 26-May 17 June 17-Nov 10
MCGW 9+	2	>8.0				×	63.9	March 26-May 14 June 17-Nov 10
MCGW 10+	1	>12.5				×	63.9	March 26-May 25 June 17-Nov 10
MCGW 11	2	>8.0	×				3.5	
MCGW 12	2	>8.0	×				2.2	
MCGW 13	1	>12.5			×		10.4

- Gauge (MC-11) experienced numerous gauge malfunctions during the beginning of the growing season (February - May 3rd).

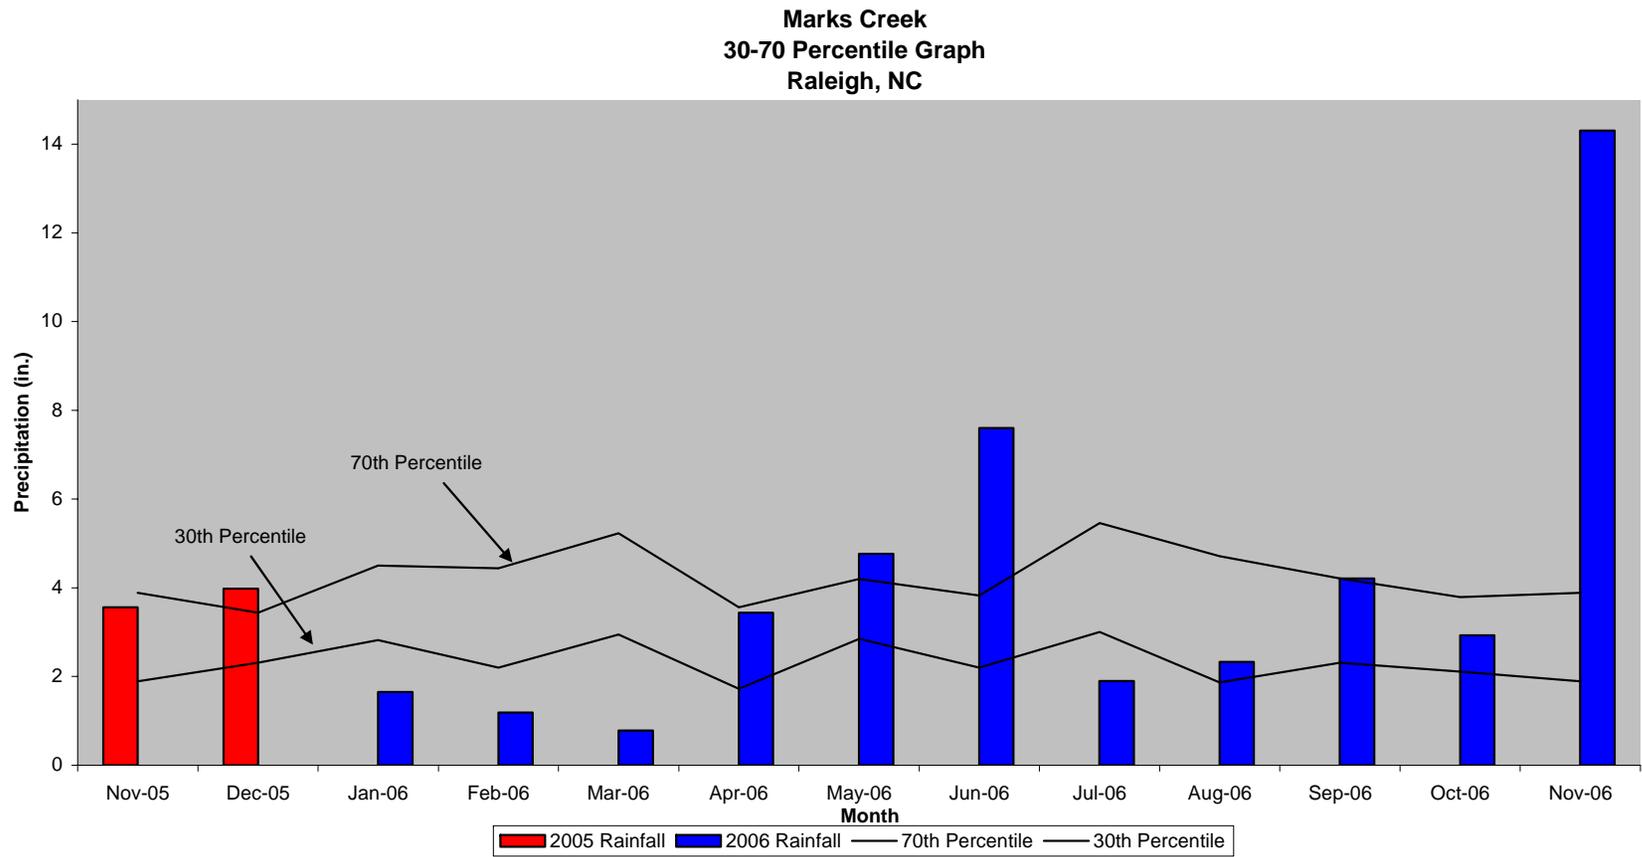
FIGURE 4. 30-70 Percentile Graph

Figure 4 provides an examination of the local climate in comparison with historical data in order to determine whether 2006 was “average” in terms of climate conditions. The two lines represent the 30th and 70th percentiles of monthly precipitation for Raleigh. The bars are the monthly rainfall totals for November 2005 through November 2006. The NC State Climate Office collected the historical data for the Raleigh/Durham weather station.

For the 2006-year the below average rainfall months include: January, February, March, and July. April, August, and October experienced average rainfall. May, June, September, and November experienced above average rainfall for the year. Overall, the site experienced average rainfall in 2006.
