ANNUAL REPORT FOR 2014

**Unnamed Tributary to Little River
Wayne County
TIP No. R-2554A – Site 7
USACE Action ID: SAW-2008-00252
DWQ Project # 20080570**

Prepared By:
Roadside Environmental Unit & Natural Environment Section
North Carolina Department of Transportation
November 2014

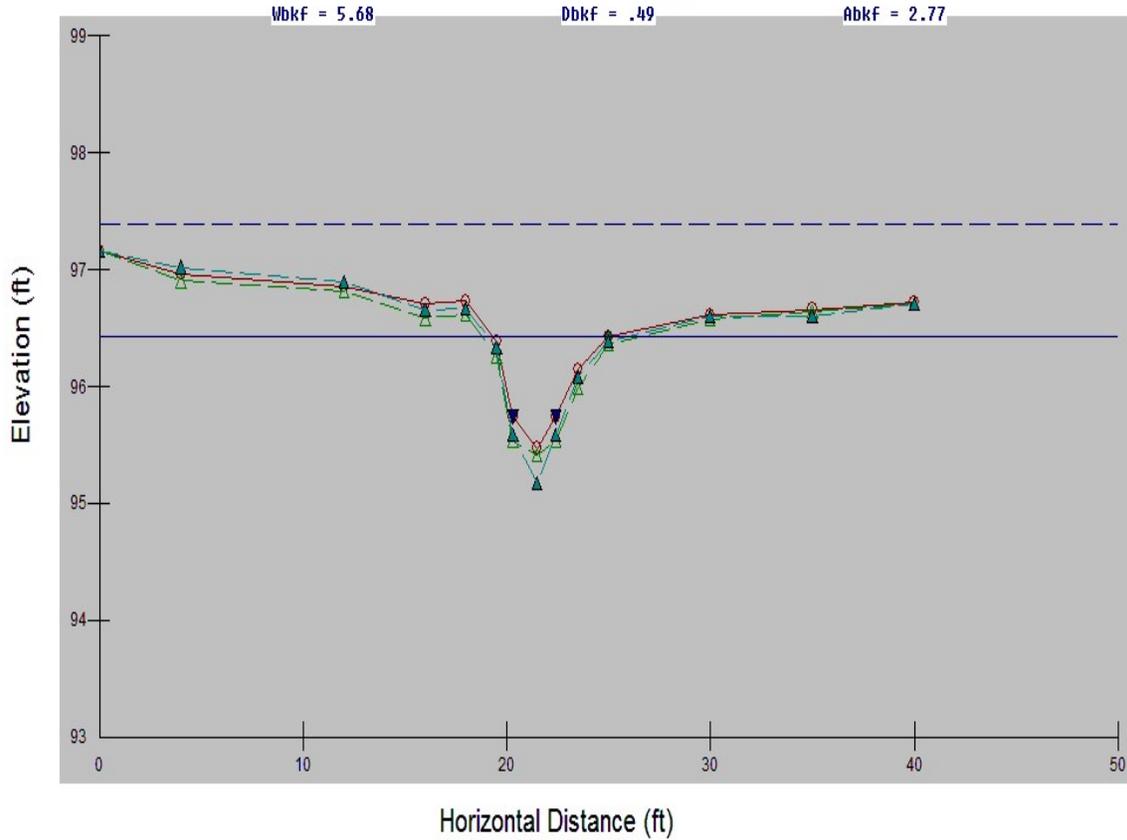
R-2554A Site 7 XS1 @ Sta. 130+00

Cross-Section #1 (Riffle) Abbreviated Morphological Summary					
	2013	2014	2015	2016	2017
Bankfull Width (ft.)	5.76	5.68			
Bankfull Mean Depth (ft.)	0.58	0.49			
Width/Depth Ratio	9.93	11.59			
Bankfull Cross Sectional Area (ft ²)	3.32	2.77			
Maximum Bankfull Depth (ft.)	1.22	0.96			
Width of the Floodprone Area (ft.)	40	40			
Entrenchment Ratio	6.94	7.05

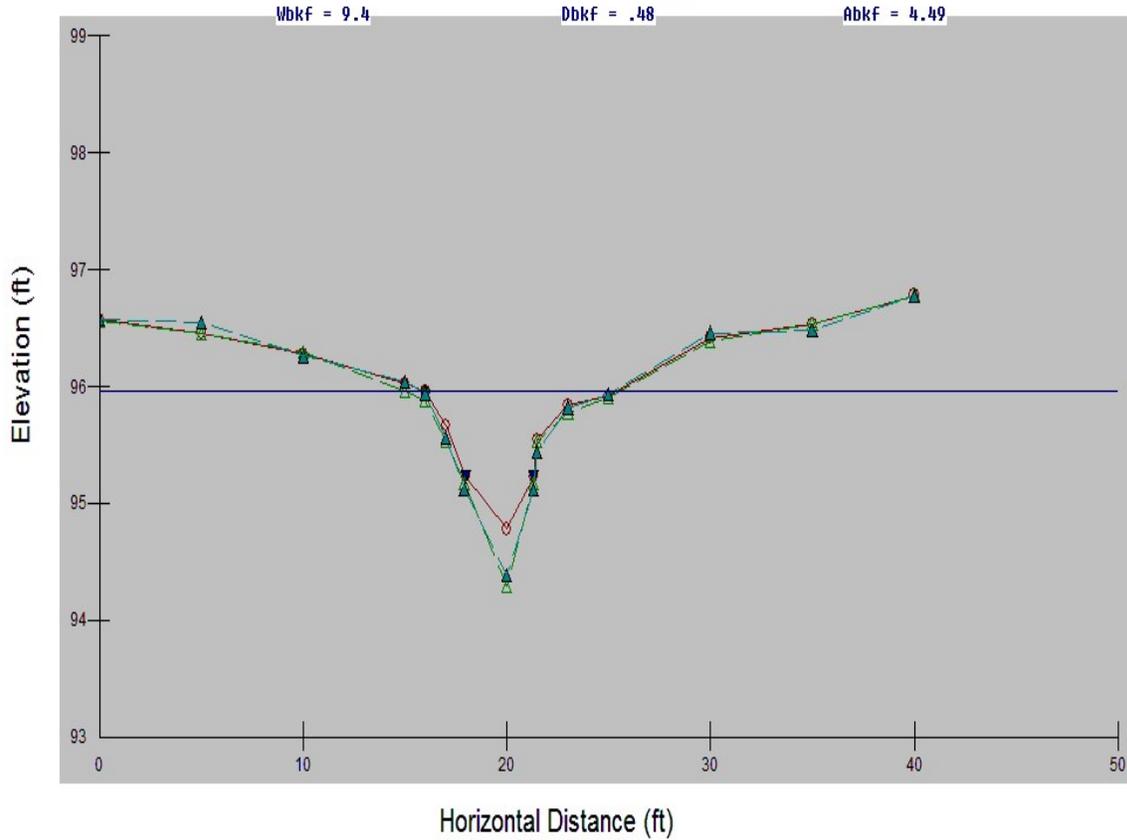
R-2554A Site 7 XS2 @ Sta. 255+00

Cross-Section #2 (Pool) Abbreviated Morphological Summary*					
	2013	2014	2015	2016	2017
Bankfull Cross Sectional Area (ft²)	5.49	4.49			
Maximum Bankfull Depth (ft.)	1.55	1.18			
Bankfull Mean Depth (ft.)	0.6	0.48			
Bankfull Width (ft.)	9.09	9.4

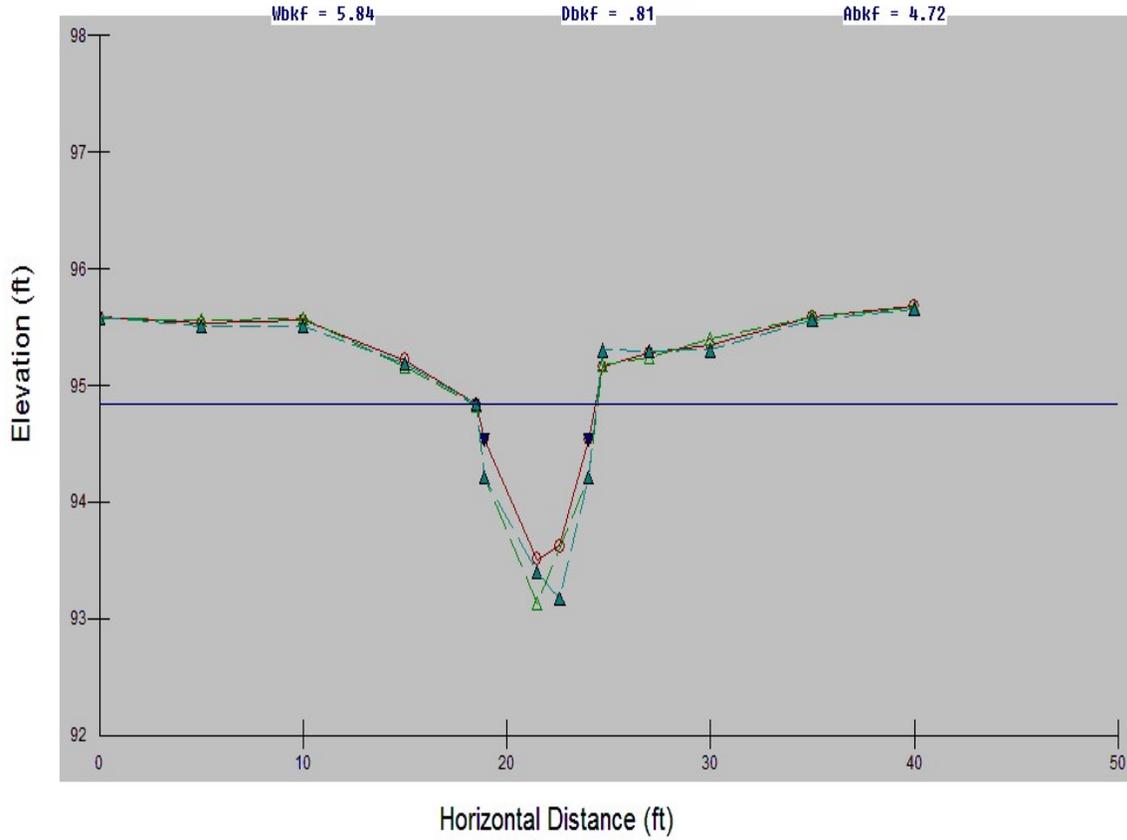
R-2554A Site 7 XS3 @ Sta. 369+00

Cross-Section #3 (Pool) Abbreviated Morphological Summary*					
	2013	2014	2015	2016	2017
Bankfull Cross Sectional Area (ft²)	6.26	4.72			
Maximum Bankfull Depth (ft.)	1.67	1.33			
Bankfull Mean Depth (ft.)	1.06	0.81			
Bankfull Width (ft.)	5.9	5.84

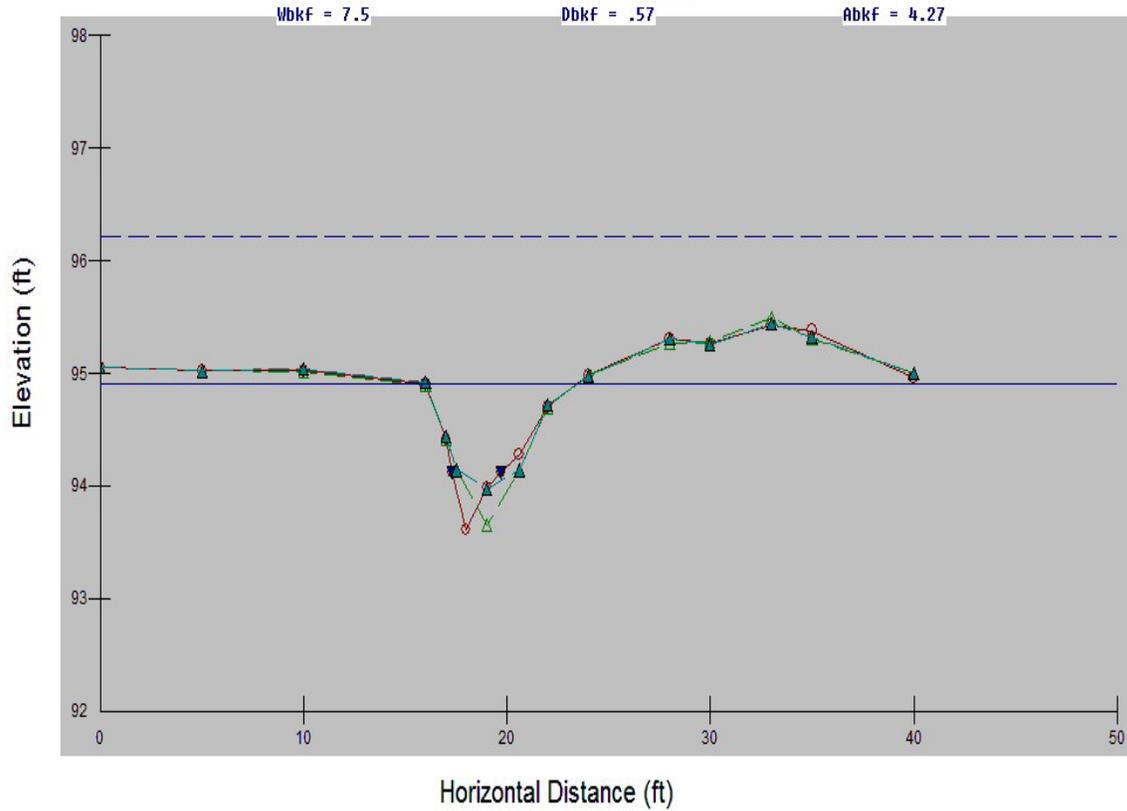
R-2554A Site 7 XS4 @ Sta. 412+00

Cross-Section #4 (Riffle) Abbreviated Morphological Summary					
	2013	2014	2015	2016	2017
Bankfull Width (ft.)	7.6	7.5			
Bankfull Mean Depth (ft.)	0.54	0.57			
Width/Depth Ratio	14.07	13.16			
Bankfull Cross Sectional Area (ft ²)	4.08	4.27			
Maximum Bankfull Depth (ft.)	0.95	1.3			
Width of the Floodprone Area (ft.)	40	40			
Entrenchment Ratio	5.26	5.33

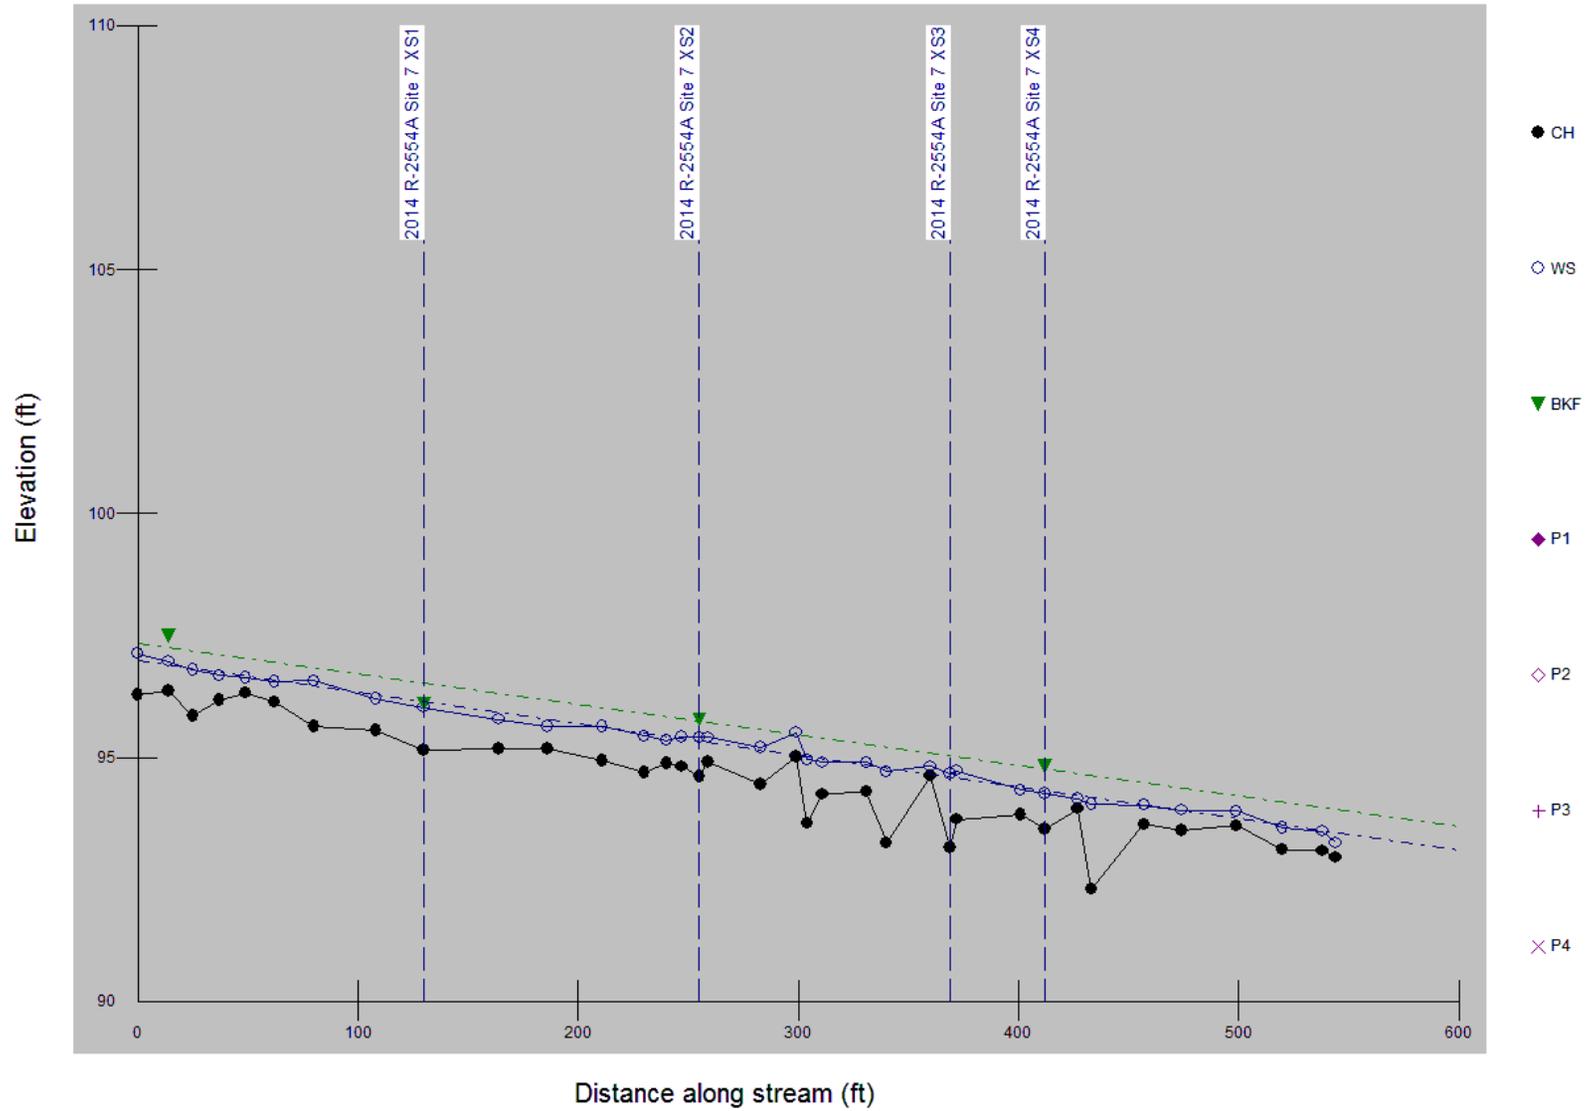
2014 R-2554A UT to Little River (Site 7) Longitudinal Profile

Based on comparisons of the as-built to 2014 monitoring data, all four cross sections appear stable with little or no active bank erosion. Graphs of the cross sections are presented in Appendix A. Future survey data will vary depending on actual location of rod placement and alignment; however this information should remain similar in appearance. The longitudinal profile shows that the channel is stable for the 2014 monitoring evaluation.

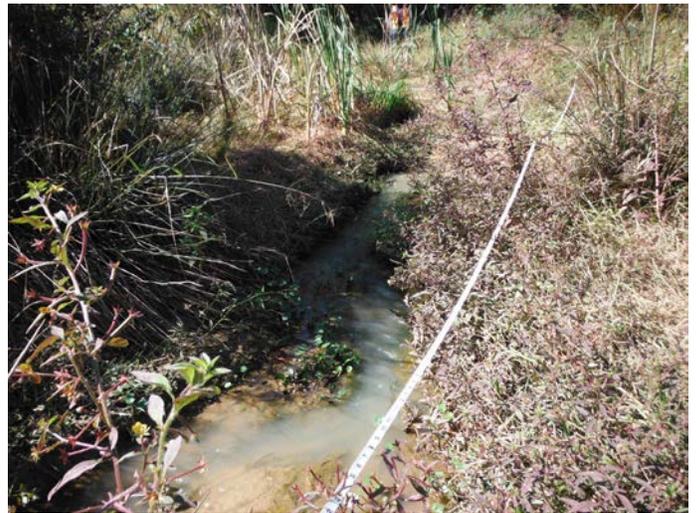
Last 45ft. of relocation in need of live staking (Oct. 2014)

Site Notes: The black willow and silky dogwood live stakes were surviving along the streambank. Additional live staking is needed on a new tie in channel that was constructed coming from a storm water basin that was installed to the east of the mitigation site and along the last approximate 45 feet of stream relocation which is missing live stake material (see photos). Other vegetation noted included lespedeza, soft rush, cattail, woolgrass, alder, briars, *Juncus* sp., and various grasses. The buffer surrounding Plot #1 was supplementally planted on January 9, 2014 due to missing or dead tree seedlings noted during the 2013 monitoring evaluation.

There were two vegetation monitoring plots established throughout the buffer area. The 2014 vegetation monitoring of the site revealed an average tree density of 655 trees per acre. This average is well above the minimum success criteria of 320 trees per acre after year two monitoring. NCDOT will continue to monitor the vegetation and install additional live staking by March 2015 at the areas noted within the vegetation site notes at the UT to Little River Mitigation Site.

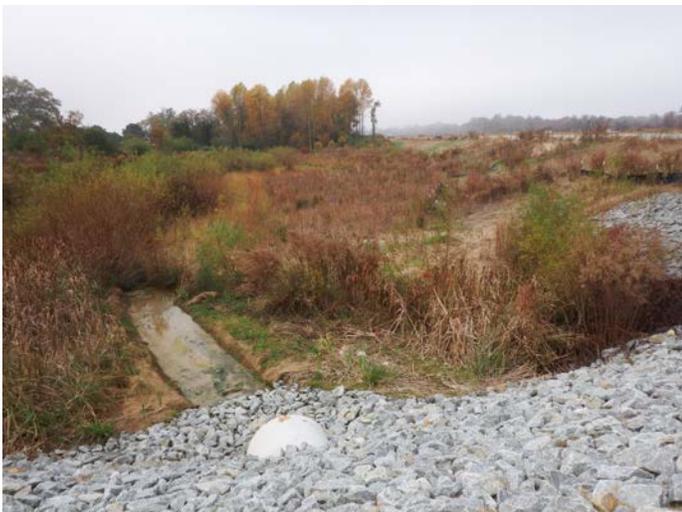
Channel tie in from storm water basin in need of live staking (Nov. 2014)
