# ANNUAL REPORT FOR 2013

**Unnamed Tributary to Little River  
Wayne County  
TIP No. R-2554A – Site 7  
USACE Action ID: SAW-2008-00252  
DWQ Project # 20080570**

Prepared By:  
Roadside Environmental Unit & Natural Environment Section  
North Carolina Department of Transportation  
August 2013

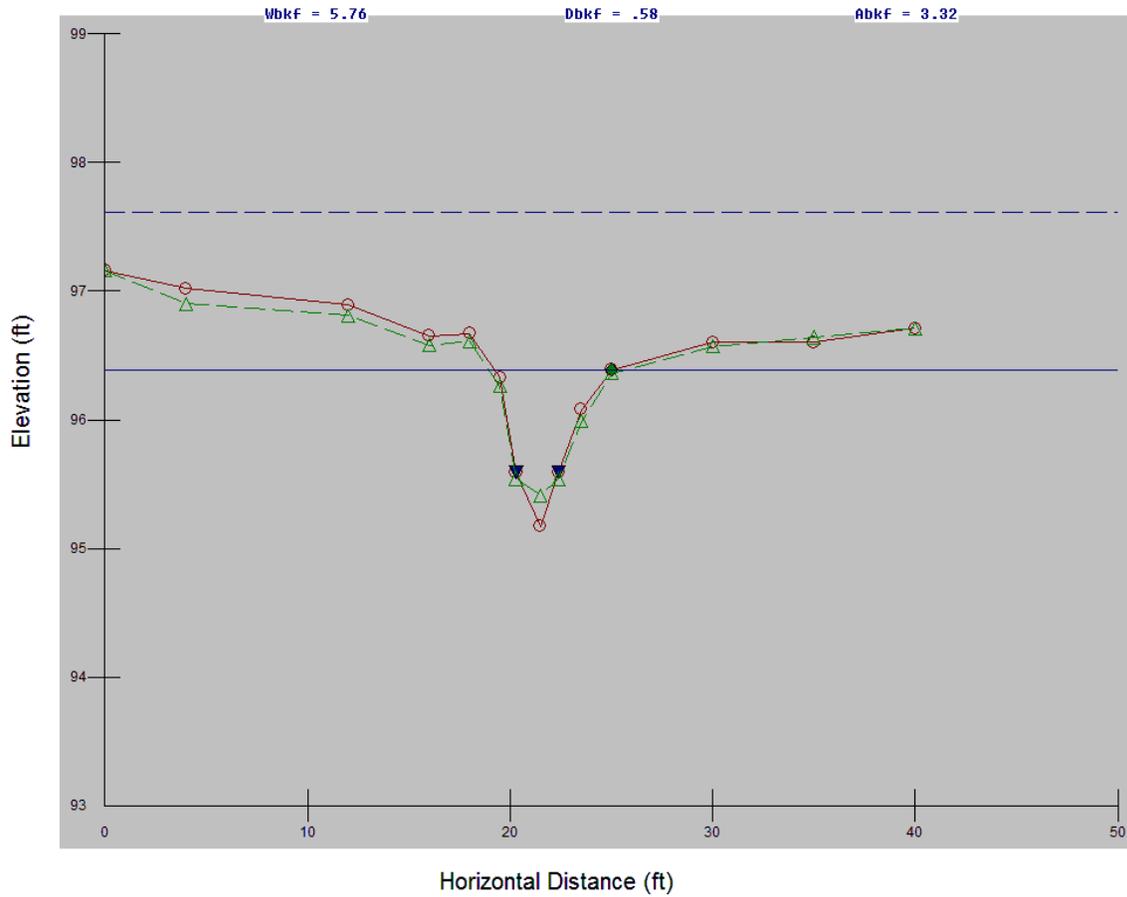
### R-2554A Site 7 XS1 @ Sta. 130+00

Based on comparisons of the as-built to 2013 monitoring data, all four cross sections appear stable with little or no active bank erosion. Graphs of the cross sections are presented in Appendix A. Future survey data will vary depending on actual location of rod placement and alignment; however this information should remain similar in appearance. The longitudinal profile shows that the channel is stable for the 2013 monitoring evaluation.

Cross-Section #1 (Riffle) Abbreviated Morphological Summary					
	2013	2014	2015	2016	2017
Bankfull Width (ft.)	5.76				
Bankfull Mean Depth (ft.)	0.58				
Width/Depth Ratio	9.93				
Bankfull Cross Sectional Area (ft <sup>2</sup> )	3.32				
Maximum Bankfull Depth (ft.)	1.22				
Width of the Floodprone Area (ft.)	40				
Entrenchment Ratio	6.94

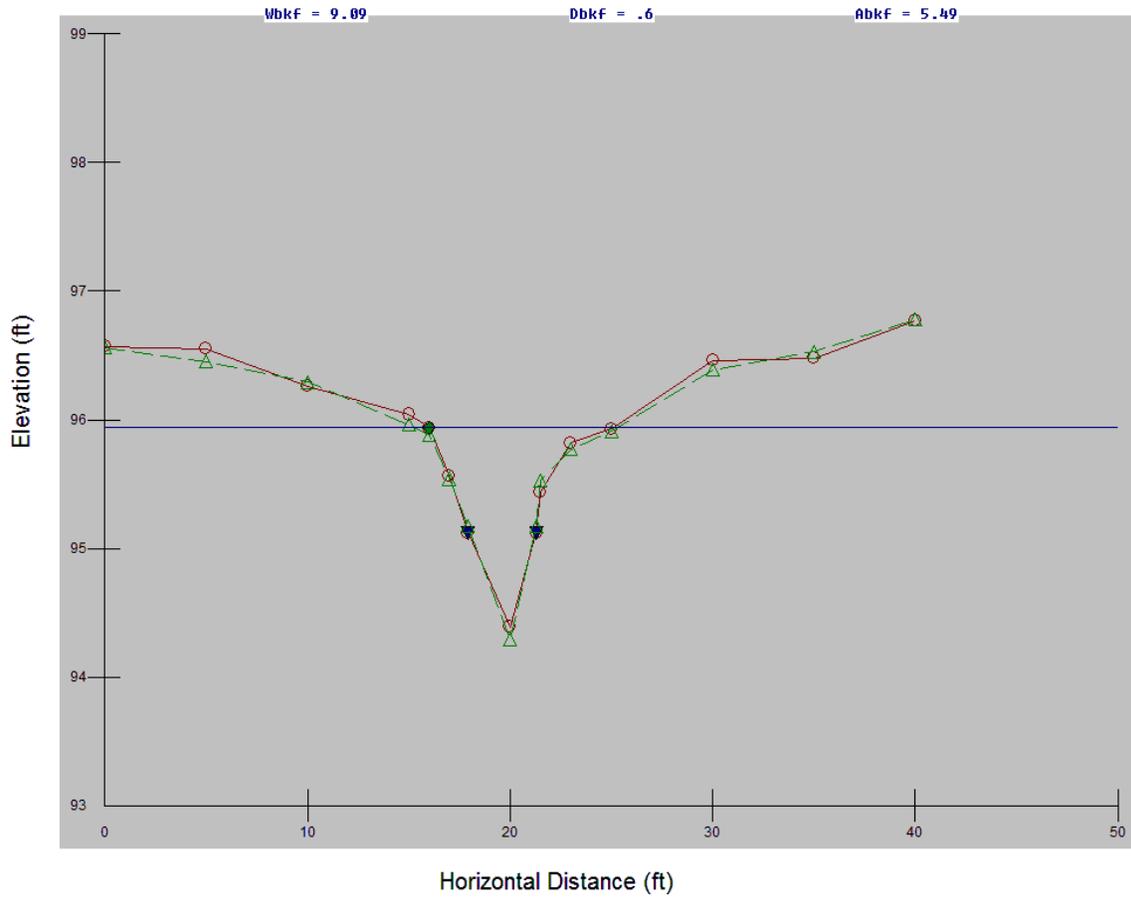
### R-2554A Site 7 XS2 @ Sta. 255+00

Cross-Section #2 (Pool) Abbreviated Morphological Summary*					
	2013	2014	2015	2016	2017
Bankfull Cross Sectional Area (ft <sup>2</sup> )	5.49				
Maximum Bankfull Depth (ft.)	1.55				
Bankfull Mean Depth (ft.)	0.6				
Bankfull Width (ft.)	9.09

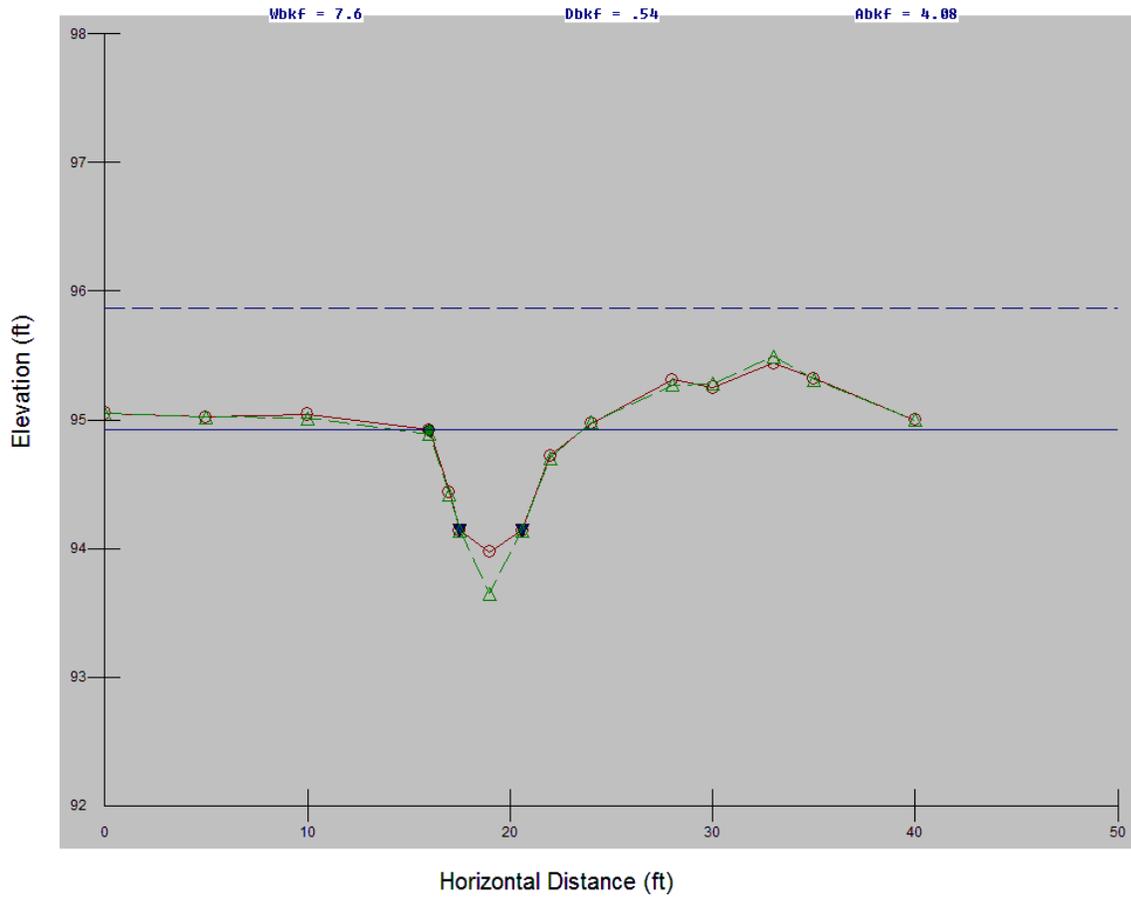
### R-2554A Site 7 XS4 @ Sta. 412+00

Cross-Section #4 (Riffle) Abbreviated Morphological Summary					
	2013	2014	2015	2016	2017
Bankfull Width (ft.)	7.6				
Bankfull Mean Depth (ft.)	0.54				
Width/Depth Ratio	14.07				
Bankfull Cross Sectional Area (ft <sup>2</sup> )	4.08				
Maximum Bankfull Depth (ft.)	0.95				
Width of the Floodprone Area (ft.)	40				
Entrenchment Ratio	5.26
