# ANNUAL REPORT FOR 2011

**Unnamed Tributary to Smith Mill Run  
Wayne County  
TIP No. R-2554BA – Permitted Site 4**

Prepared By:  
Roadside Environmental Unit & Natural Environment Unit  
North Carolina Department of Transportation  
November 2011

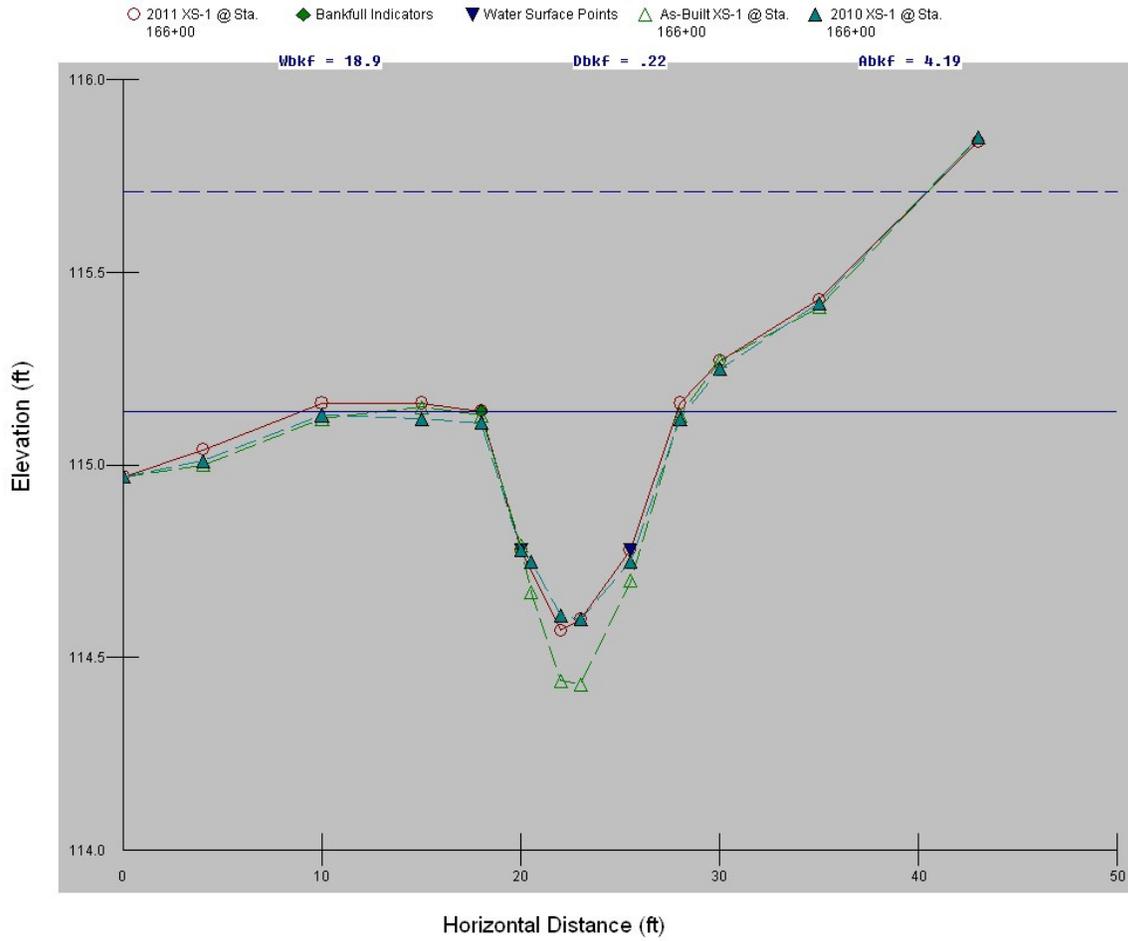
### R-2554BA Site 4 XS-1 @ Sta. 166+00

Cross-Section #1 (Riffle) Abbreviated Morphological Summary					
	2010	2011	2012	2013	2014
Bankfull Width (ft)	9.93	9.87			
Bankfull Mean Depth (ft)	0.32	0.34			
Width/Depth Ratio	31.03	29.03			
Bankfull Cross Sectional Area (ft <sup>2</sup> )	3.18	3.4			
Maximum Bankfull Depth (ft)	0.51	0.57			
Width of the Floodprone Area (ft)	43	40.46			
Entrenchment Ratio	3.9	4.1

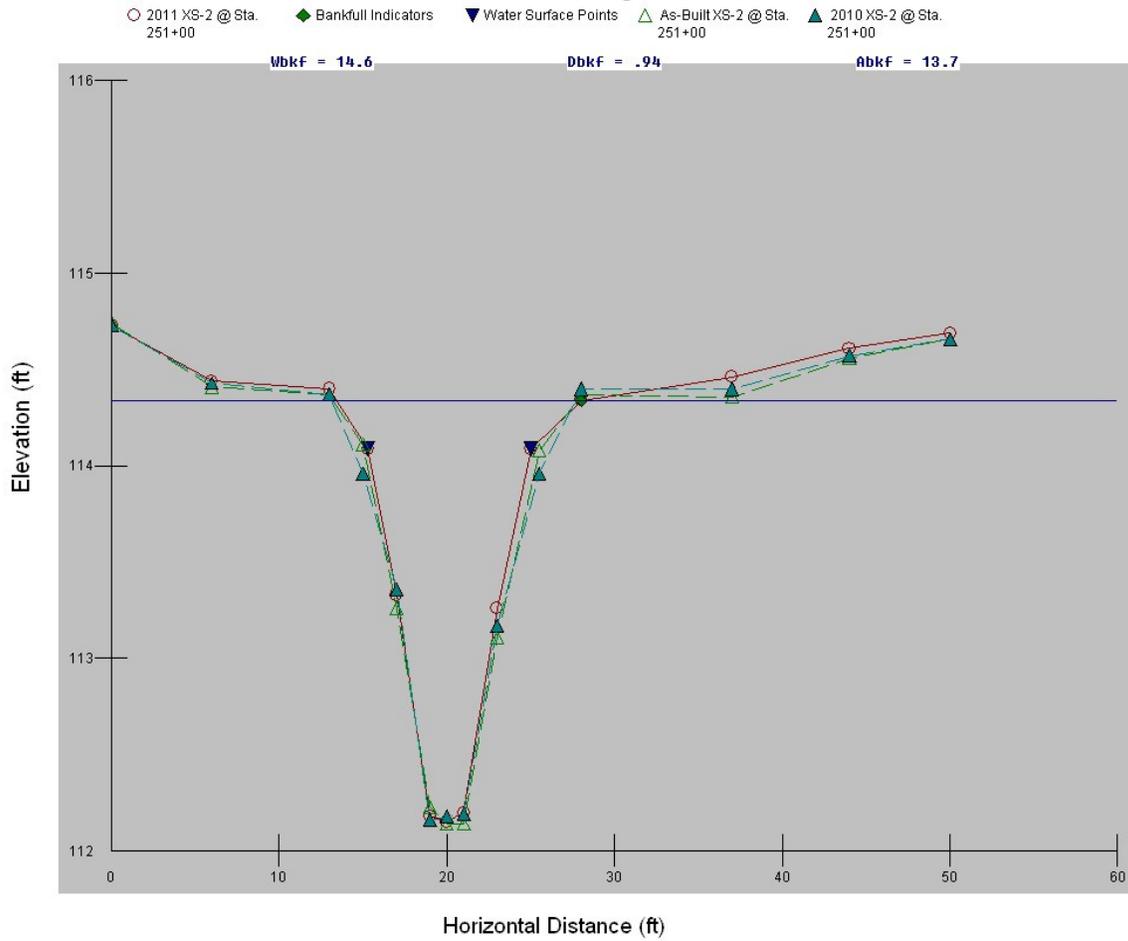
### R-2554BA Site 4 XS-2 @ Sta. 251+00

Cross-Section #2 (Pool) Abbreviated Morphological Summary*					
	2010	2011	2012	2013	2014
Bankfull Cross Sectional Area (ft <sup>2</sup> )	15.81	13.74			
Maximum Bankfull Depth (ft)	2.24	2.19			
Bankfull Mean Depth (ft)	0.85	0.94			
Bankfull Width (ft)	18.5	14.55

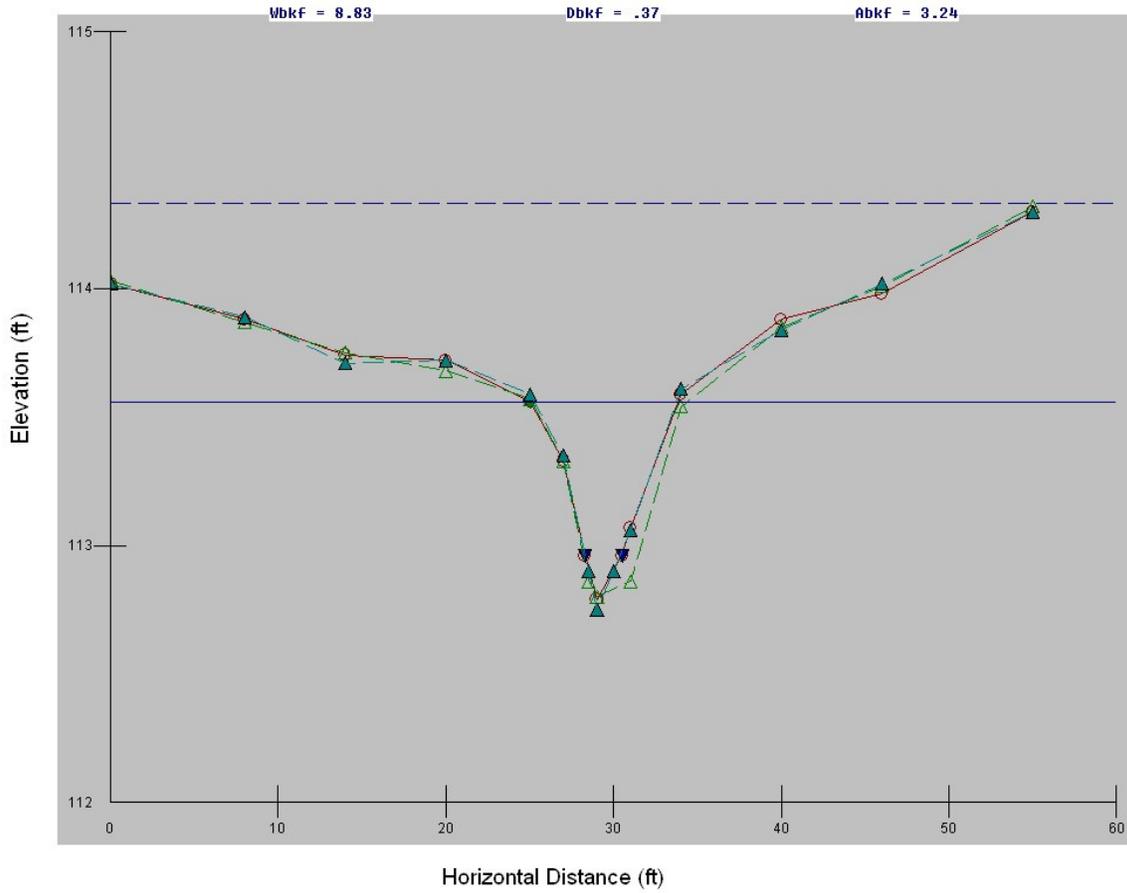
### R-2554BA Site 4 XS-3 @ Sta. 329+00

Cross-Section #3 (Riffle) Abbreviated Morphological Summary					
	2010	2011	2012	2013	2014
Bankfull Width (ft)	8.89	8.83			
Bankfull Mean Depth (ft)	0.39	0.37			
Width/Depth Ratio	22.79	23.86			
Bankfull Cross Sectional Area (ft <sup>2</sup> )	3.46	3.24			
Maximum Bankfull Depth (ft)	0.84	0.77			
Width of the Floodprone Area (ft)	55	55			
Entrenchment Ratio	6.19	6.23

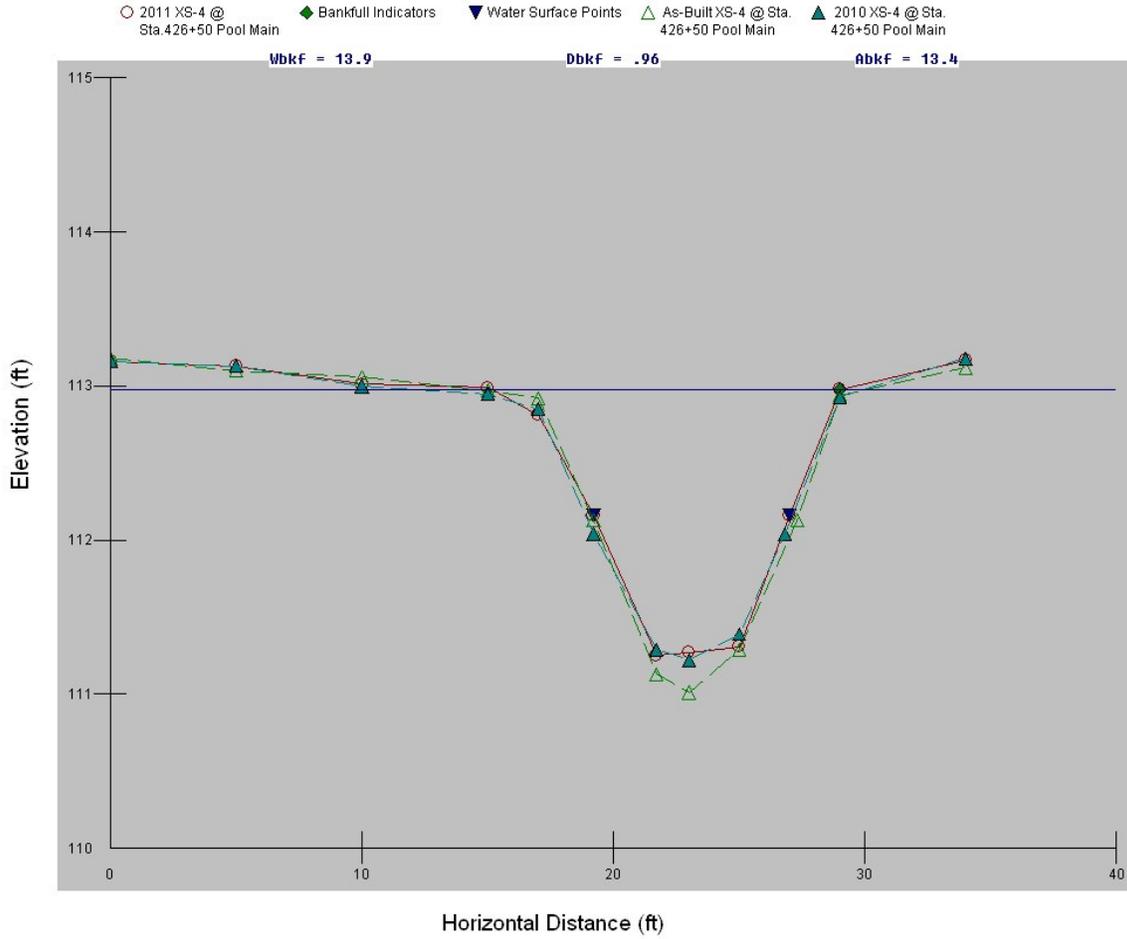
### R-2554BA Site 4 Pool XS-4 @ Sta.426+50 on the Main Channel

Cross-Section #4 (Main Pool) Abbreviated Morphological Summary*					
	2010	2011	2012	2013	2014
Bankfull Cross Sectional Area (ft <sup>2</sup> )	12.89	13.36			
Maximum Bankfull Depth (ft)	1.71	1.73			
Bankfull Mean Depth (ft)	0.95	0.96			
Bankfull Width (ft)	13.6	13.89

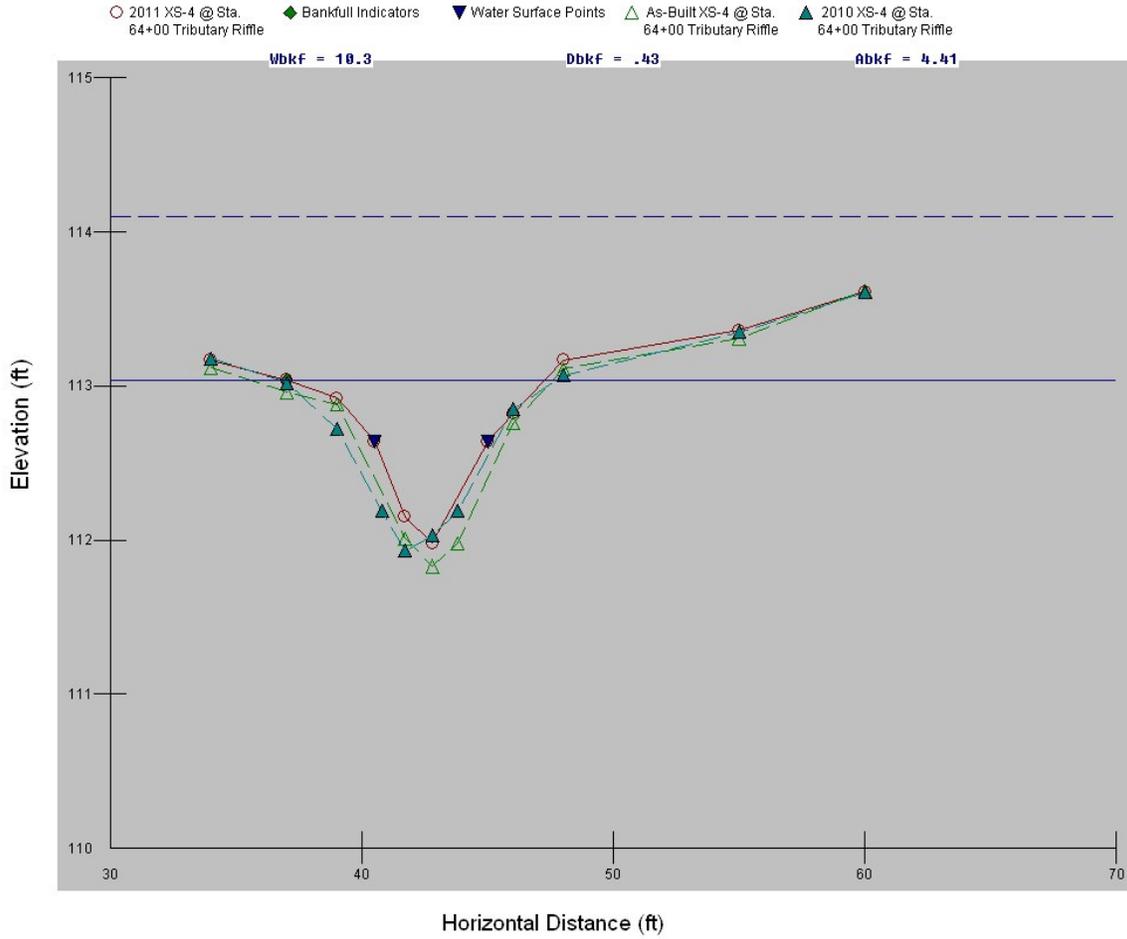
### R-2554BA Site 4 Riffle XS-4 @ Sta. 64+00 on the Tributary

Cross-Section #4 (Tributary Riffle) Abbreviated Morphological Summary					
	2010	2011	2012	2013	2014
Bankfull Width (ft)	10.55	10.26			
Bankfull Mean Depth (ft)	0.52	0.43			
Width/Depth Ratio	20.29	23.86			
Bankfull Cross Sectional Area (ft <sup>2</sup> )	5.47	4.41			
Maximum Bankfull Depth (ft)	1.09	1.06			
Width of the Floodprone Area (ft)	26	26			
Entrenchment Ratio	2.47	2.53

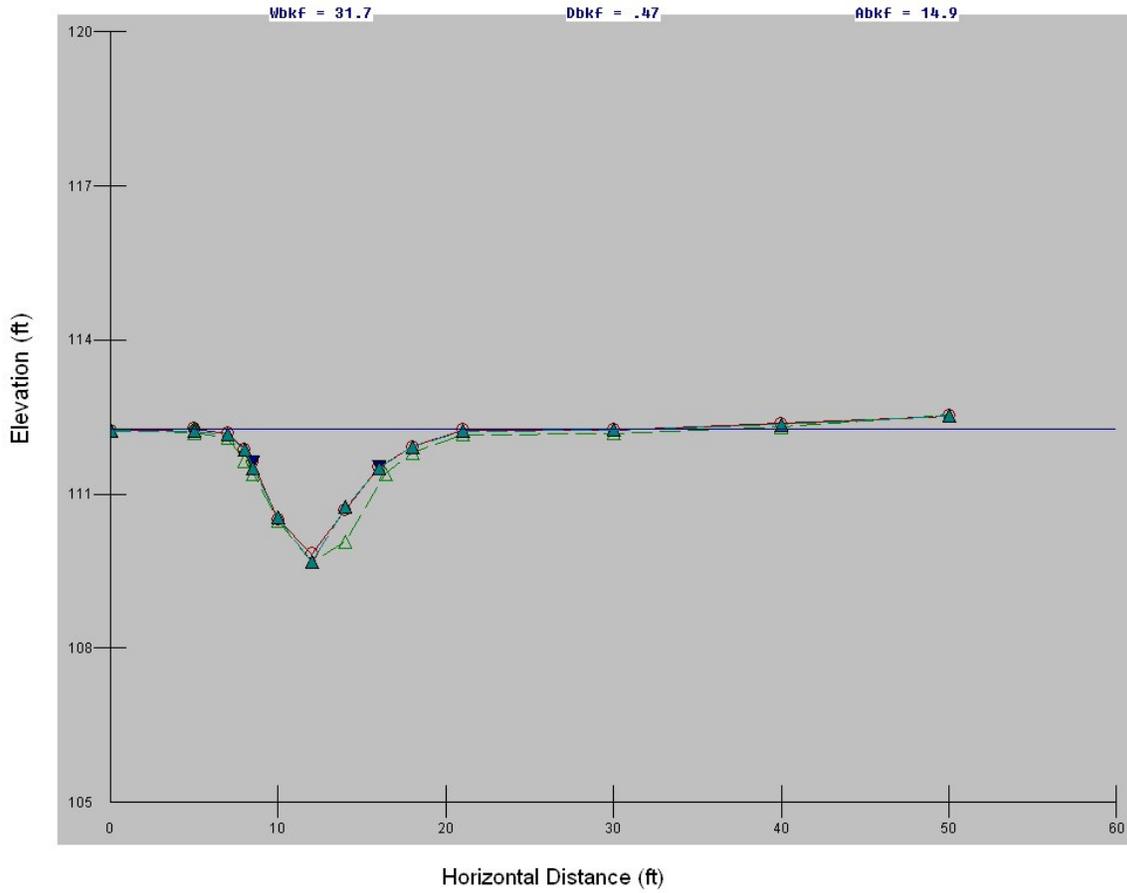
### R-2554BA Site 4 XS-5 @ Sta. 593+50

Cross-Section #5 (Pool) Abbreviated Morphological Summary*					
	2010	2011	2012	2013	2014
Bankfull Cross Sectional Area (ft <sup>2</sup> )	14.34	14.6			
Maximum Bankfull Depth (ft)	2.55	2.43			
Bankfull Mean Depth (ft)	0.9	0.91			
Bankfull Width (ft)	16	16

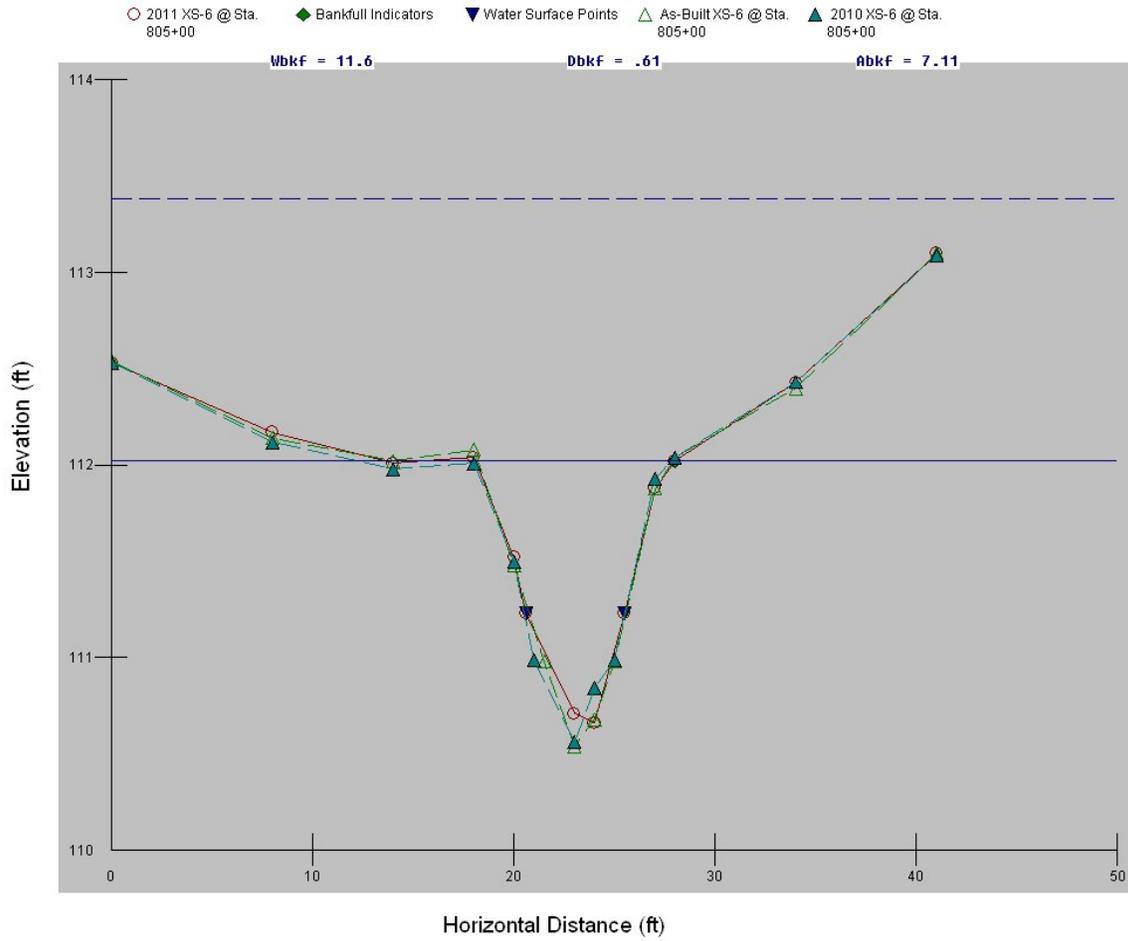
### R-2554BA Site 4 XS-6 @ Sta. 805+00

Cross-Section #6 (Riffle) Abbreviated Morphological Summary					
	2010	2011	2012	2013	2014
Bankfull Width (ft)	9.73	9.92			
Bankfull Mean Depth (ft)	0.75	0.72			
Width/Depth Ratio	12.97	13.78			
Bankfull Cross Sectional Area (ft <sup>2</sup> )	7.28	7.1			
Maximum Bankfull Depth (ft)	1.45	1.36			
Width of the Floodprone Area (ft)	41	41			
Entrenchment Ratio	4.21	4.13

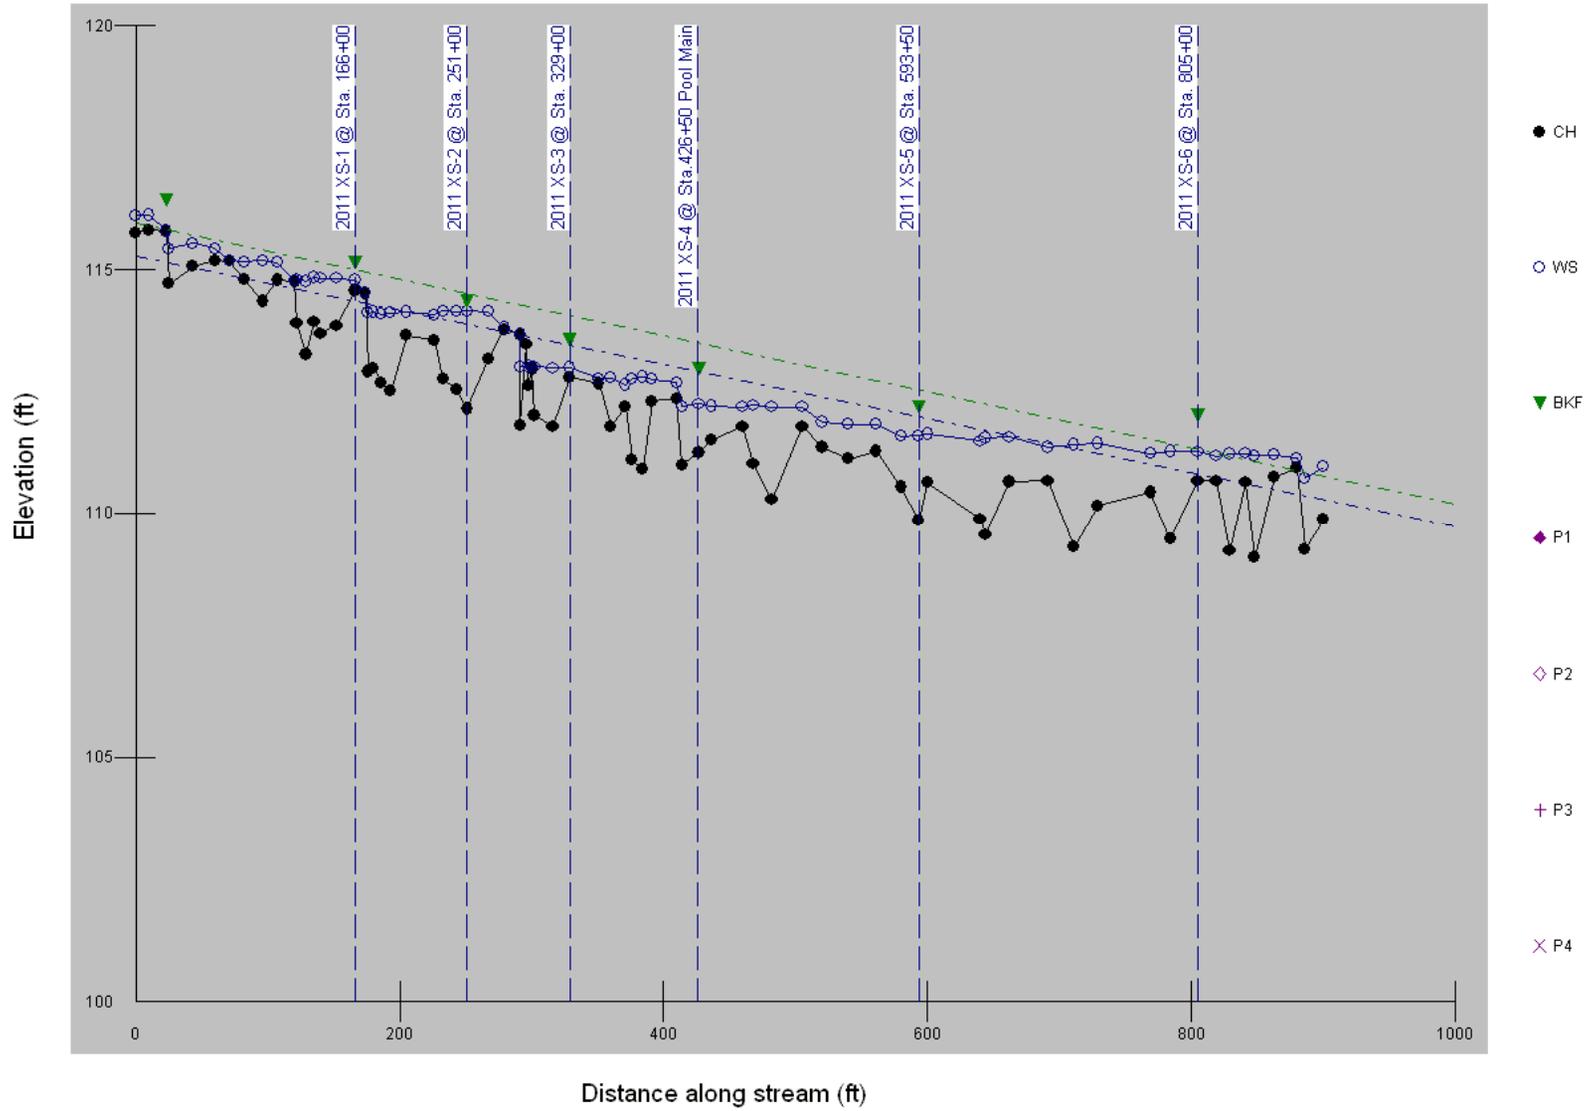
UT to Smith Mill Run (Site 4) Longitudinal Profile of Main Channel

Based on comparisons of the as-built to the monitoring data, all six cross sections appear stable with little or no active bank erosion. Graphs of the cross sections are presented in Appendix A. Future survey data will vary depending on actual location of rod placement and alignment; however this information should remain similar in appearance. The longitudinal profile shows that the channel is stable for the 2011 monitoring evaluation.
