# ANNUAL REPORT FOR 2014

**Tommy's Road Wetland Mitigation Site**  
**Wayne County**  
**TIP No. R-2554BA**  
**COE Action ID: SAW 2008-00252**  
**DWR: 20080570**

Prepared By:  
Natural Environment Section & Roadside Environmental Unit  
North Carolina Department of Transportation  
December 2014

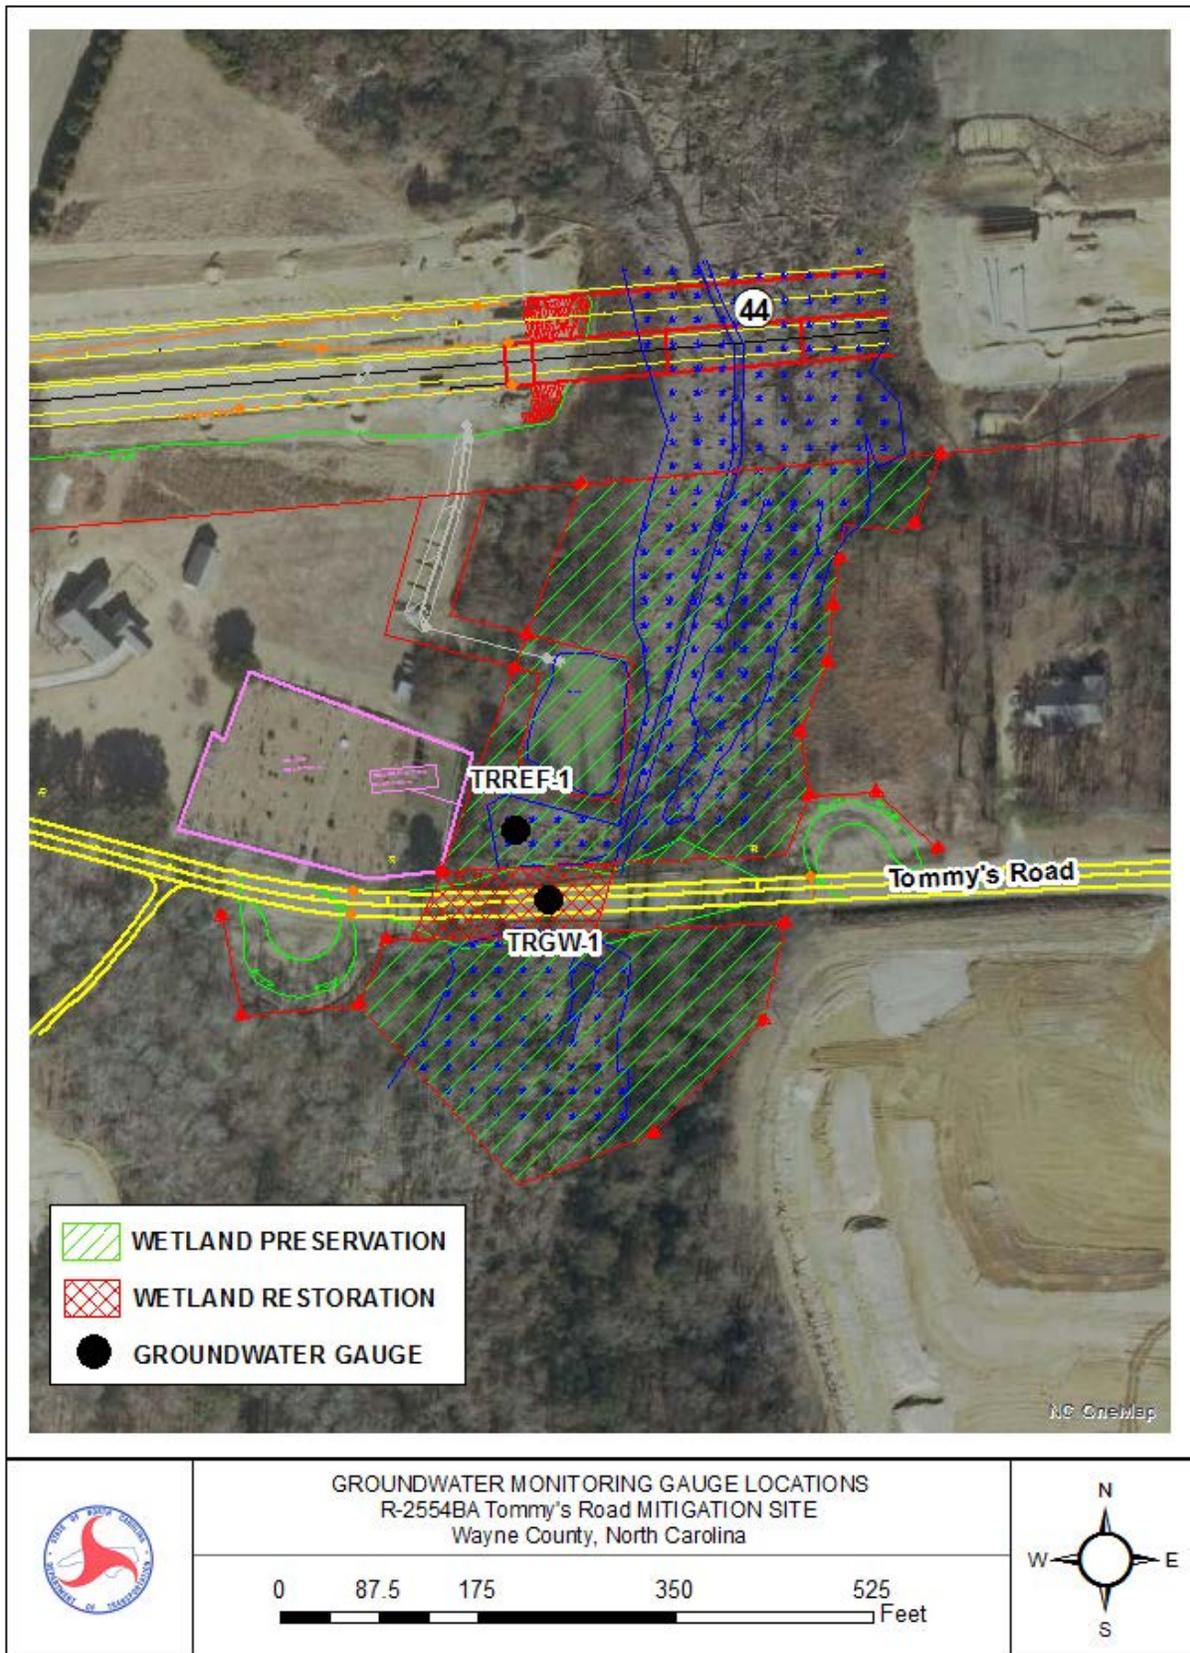
**Figure 2.** Monitoring Gauge Location Map

Two groundwater monitoring gauges are used to record site hydrologic data including one in the restoration area and one reference gauge in the preservation area. The groundwater gauges are set to record daily water levels. The hydrologic response (groundwater) to rainfall events is evaluated using data provided by the North Carolina State Climate Office.

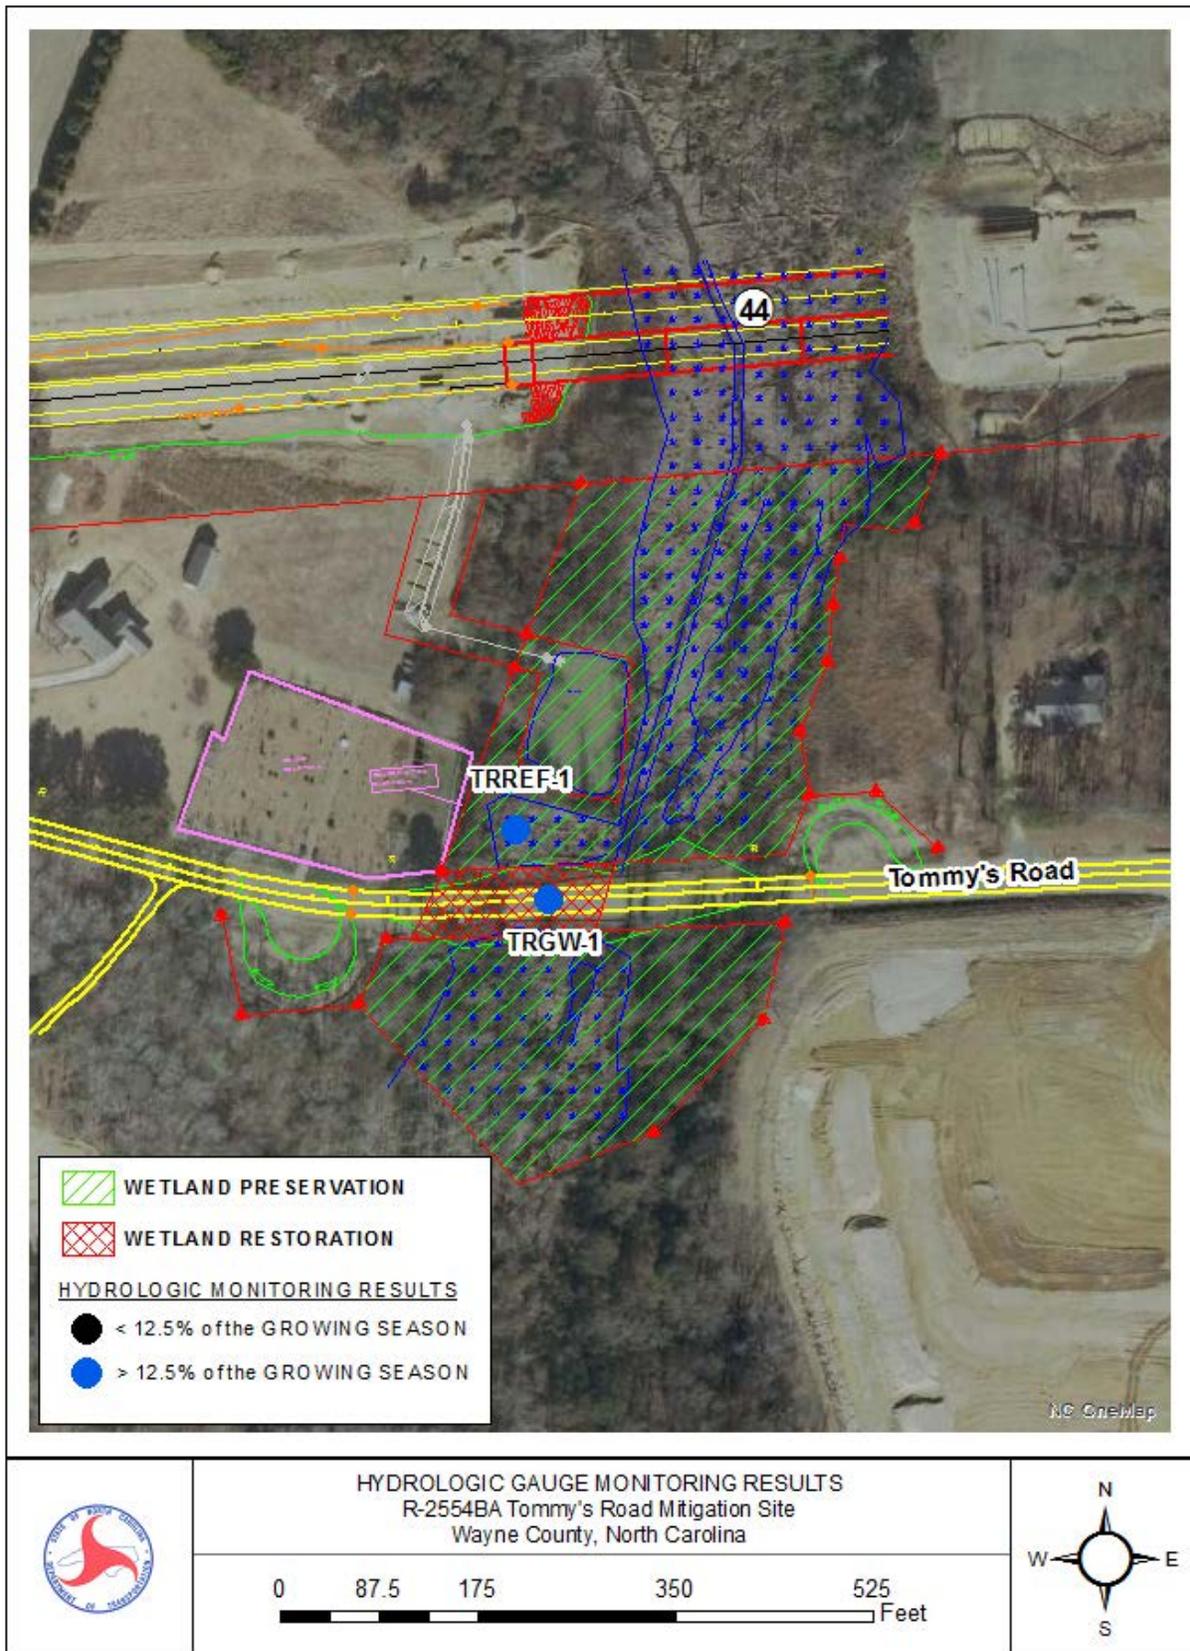
**Figure 3.** 2014 Hydrologic Monitoring Results

The total number of consecutive days that the groundwater was within twelve inches of the surface was determined for each groundwater monitoring gauge. This number was converted into a percentage of the growing season. Table 1 presents the hydrologic results for 2014. Table 2 presents the hydrologic results at the site since construction was completed. Figure 3 is a graphical representation of the hydrologic monitoring results for 2014.

Monitoring Gauge	< 5%	5 – 12.5%	> 12.5%	Actual %	Dates of Success
TRGW-1			X	47.3	Mar 17-July 9; July 11-Aug 26; Sept 4-Nov 14
*TRREF-1			X	100.0	Mar 17-Nov 14

The 2015 year represents the third year that hydrologic data has been collected on the Tommy’s Road mitigation site. Both of the groundwater monitoring gauges met the jurisdictional criteria for wetland hydrology (>12.5% of the growing season) in the 2014 monitoring year.

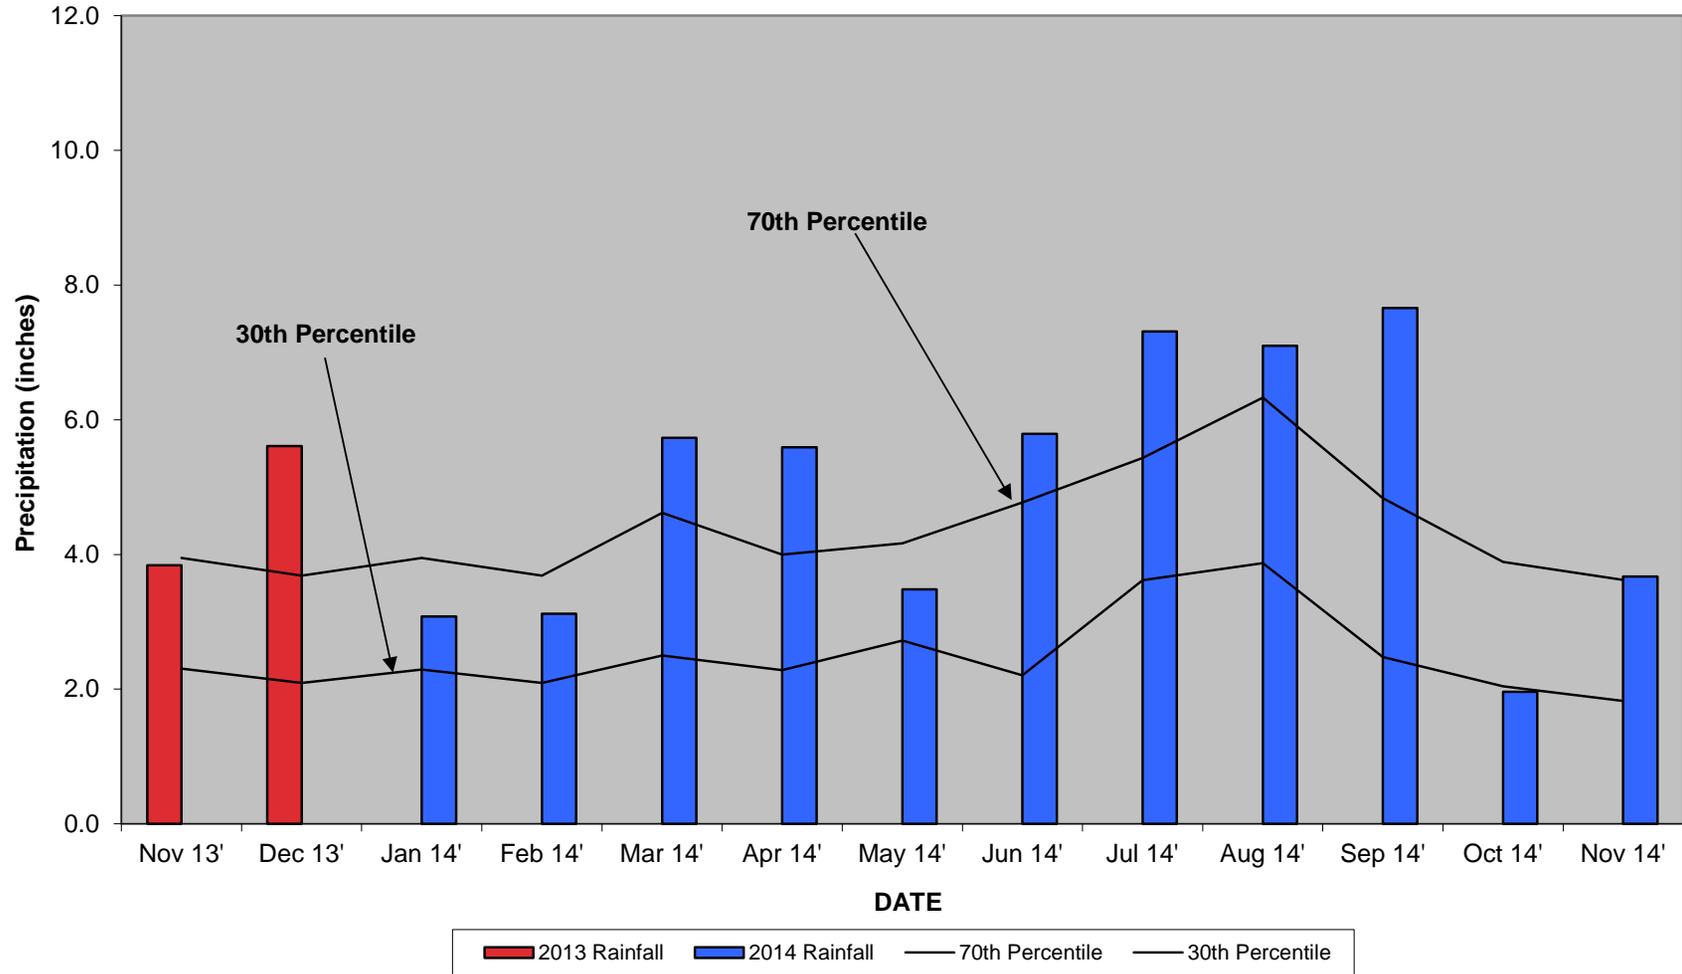
**Figure 4. 30-70 Percentile Graph 2014**

Figure 4 is a comparison of monthly rainfall for the period of January 2014 through November 2014 to historical precipitation (collected between 1984 and 2013) for Cherry Research Station in Wayne County. This comparison gives an indication of how 2014 relates to historical data in terms of climate conditions. The NC State Climate Office provided all local rainfall information.

For the 2014-year, January, February, May and November experienced average rainfall. October recorded below average rainfall while March, April, June, July, August and September recorded above average rainfall. Overall 2014 experienced an above average rainfall year.

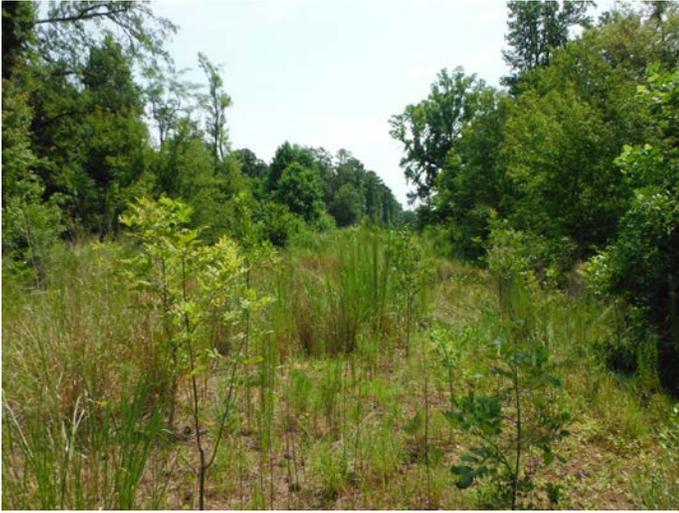
Photo Point #1 Looking at Vegetation Plot 1

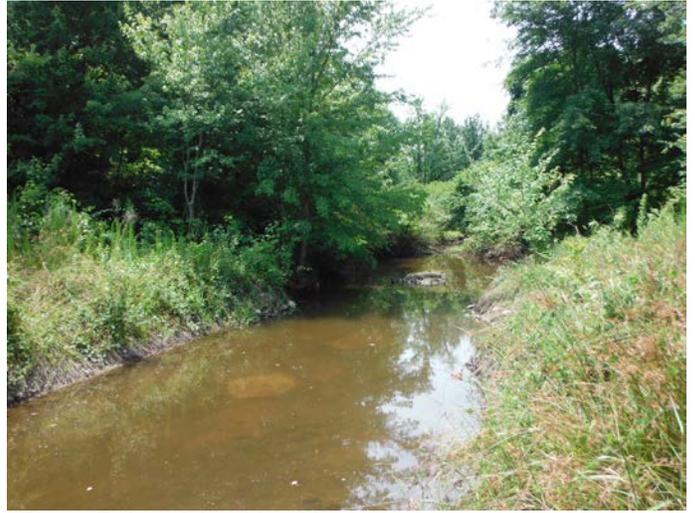
Photo Point #2 Looking Upstream

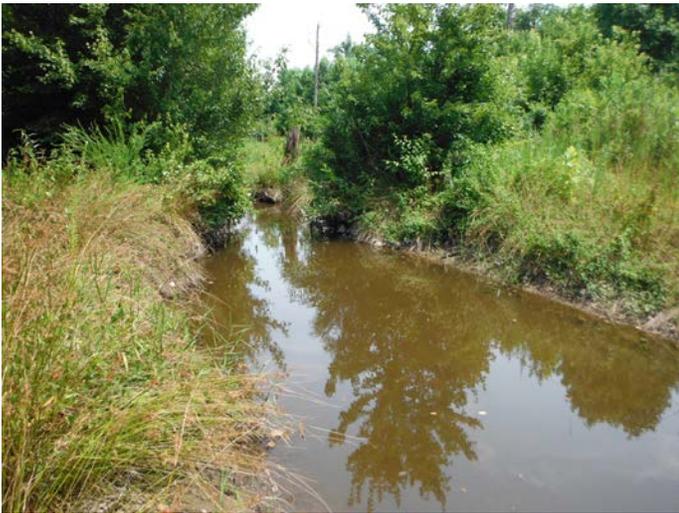
Photo Point #2 Looking Downstream

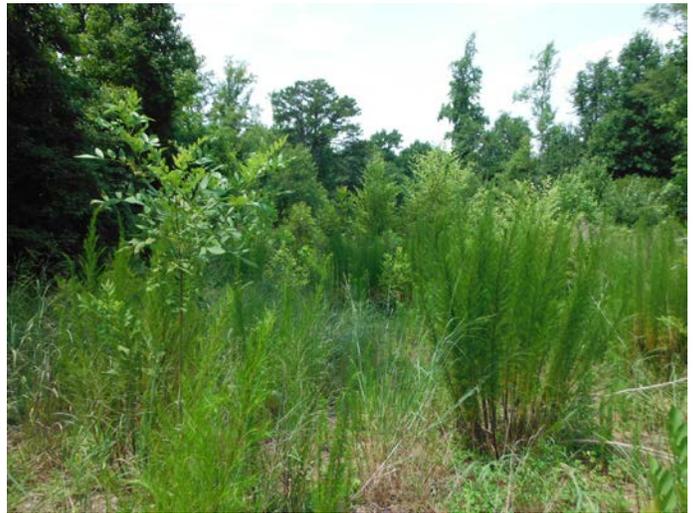
Photo Point #3 Looking at Vegetation Plot 2

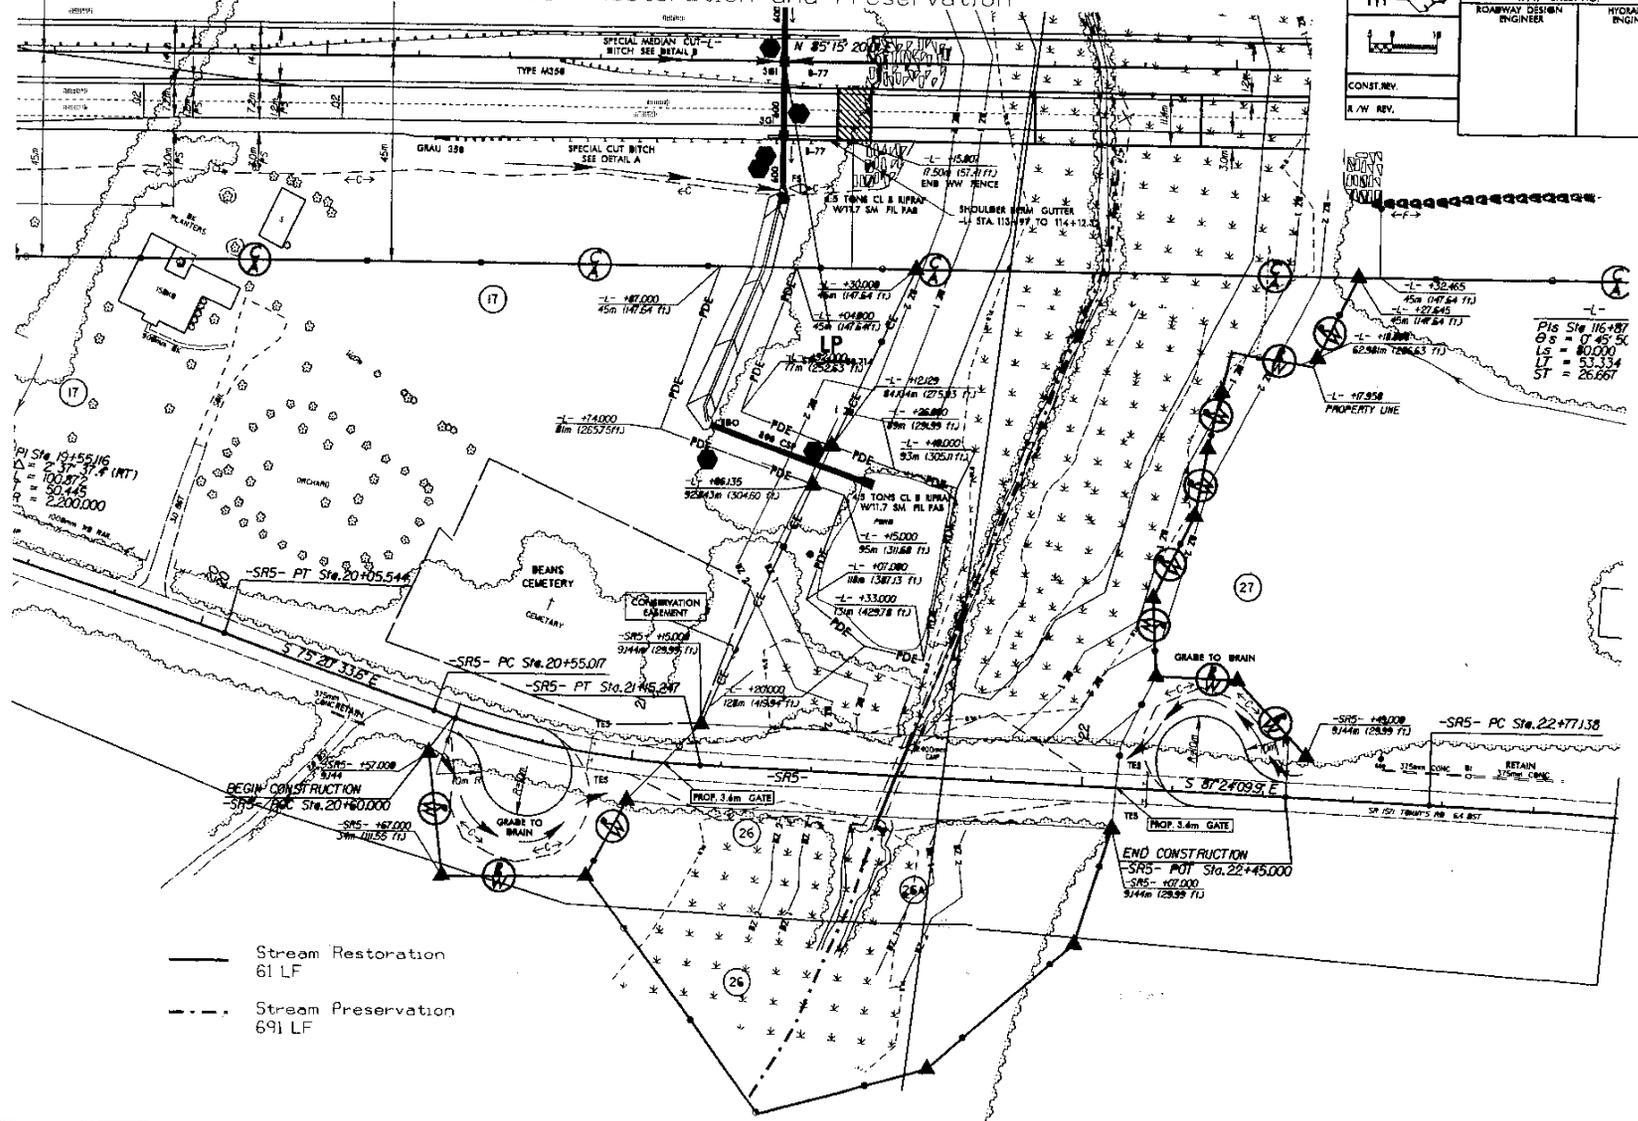
# Tommy's Road As-built Stream Restoration and Preservation

— Stream Restoration  
 61 LF  
 - - - Stream Preservation  
 691 LF

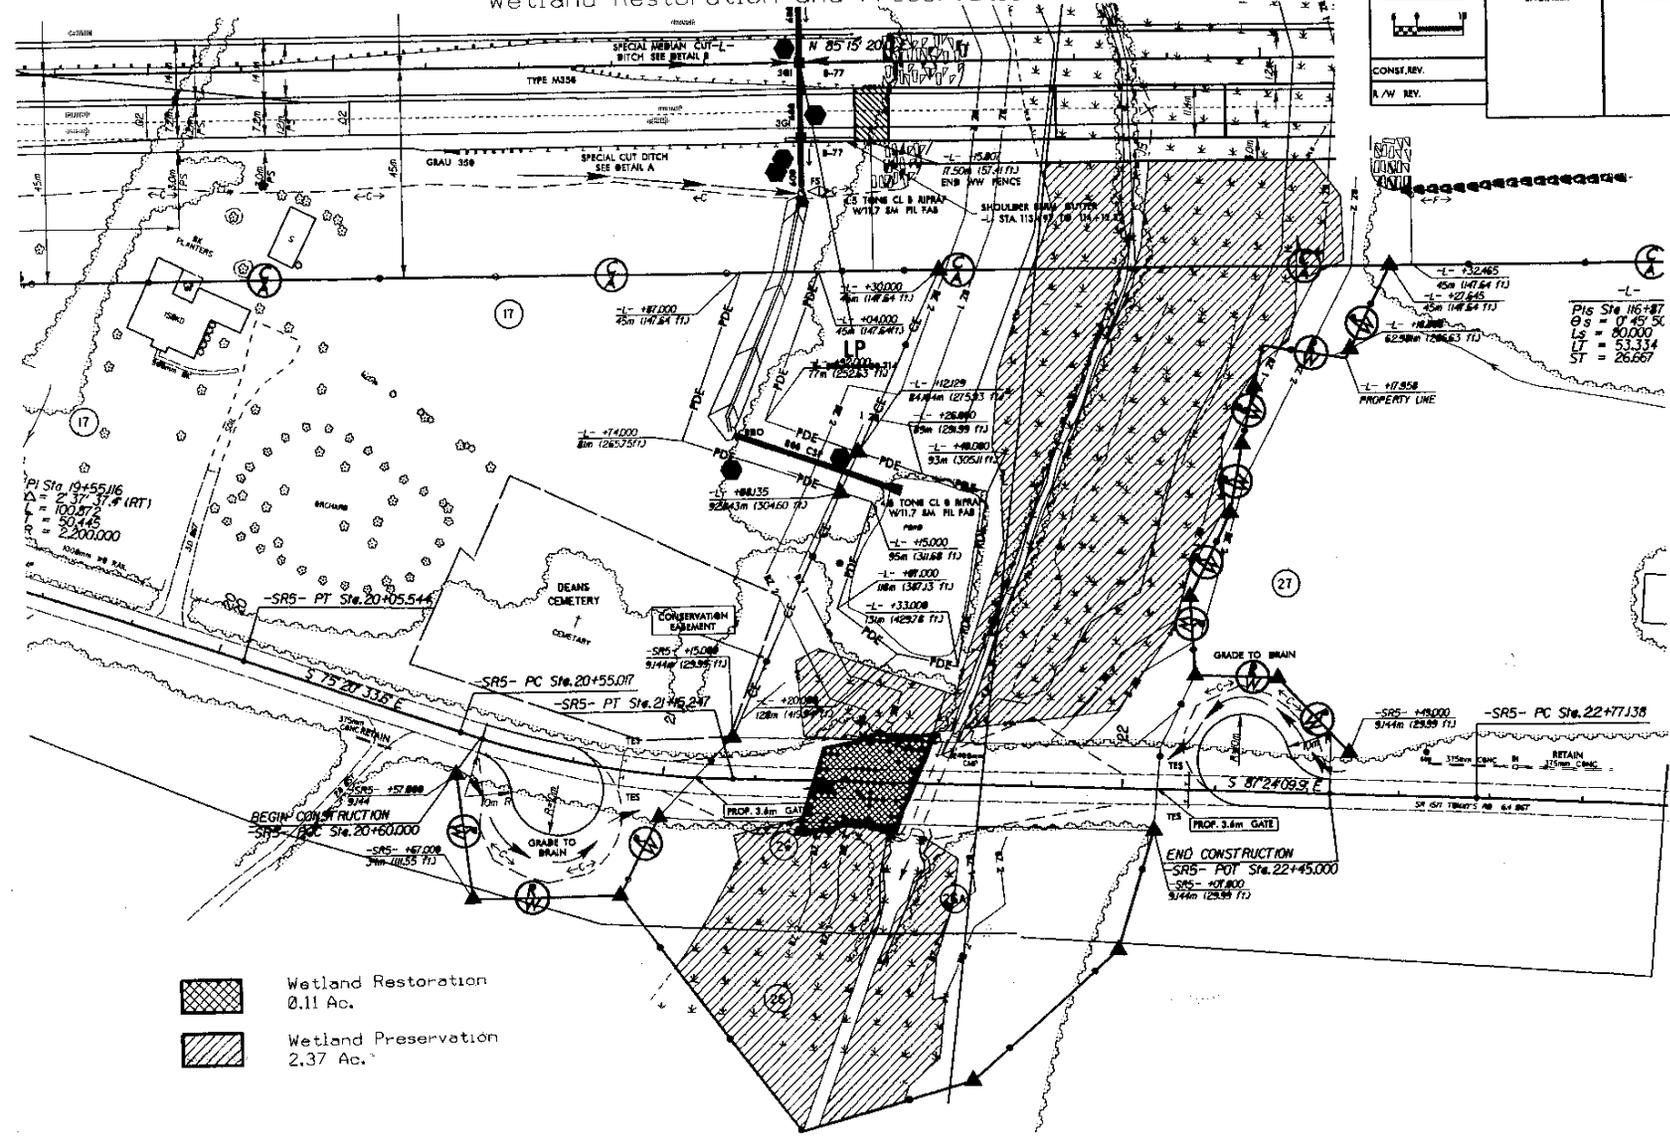
# Tommy's Road As-built Wetland Restoration and Preservation

Wetland Restoration  
0.11 Ac.  
 Wetland Preservation  
2.37 Ac.

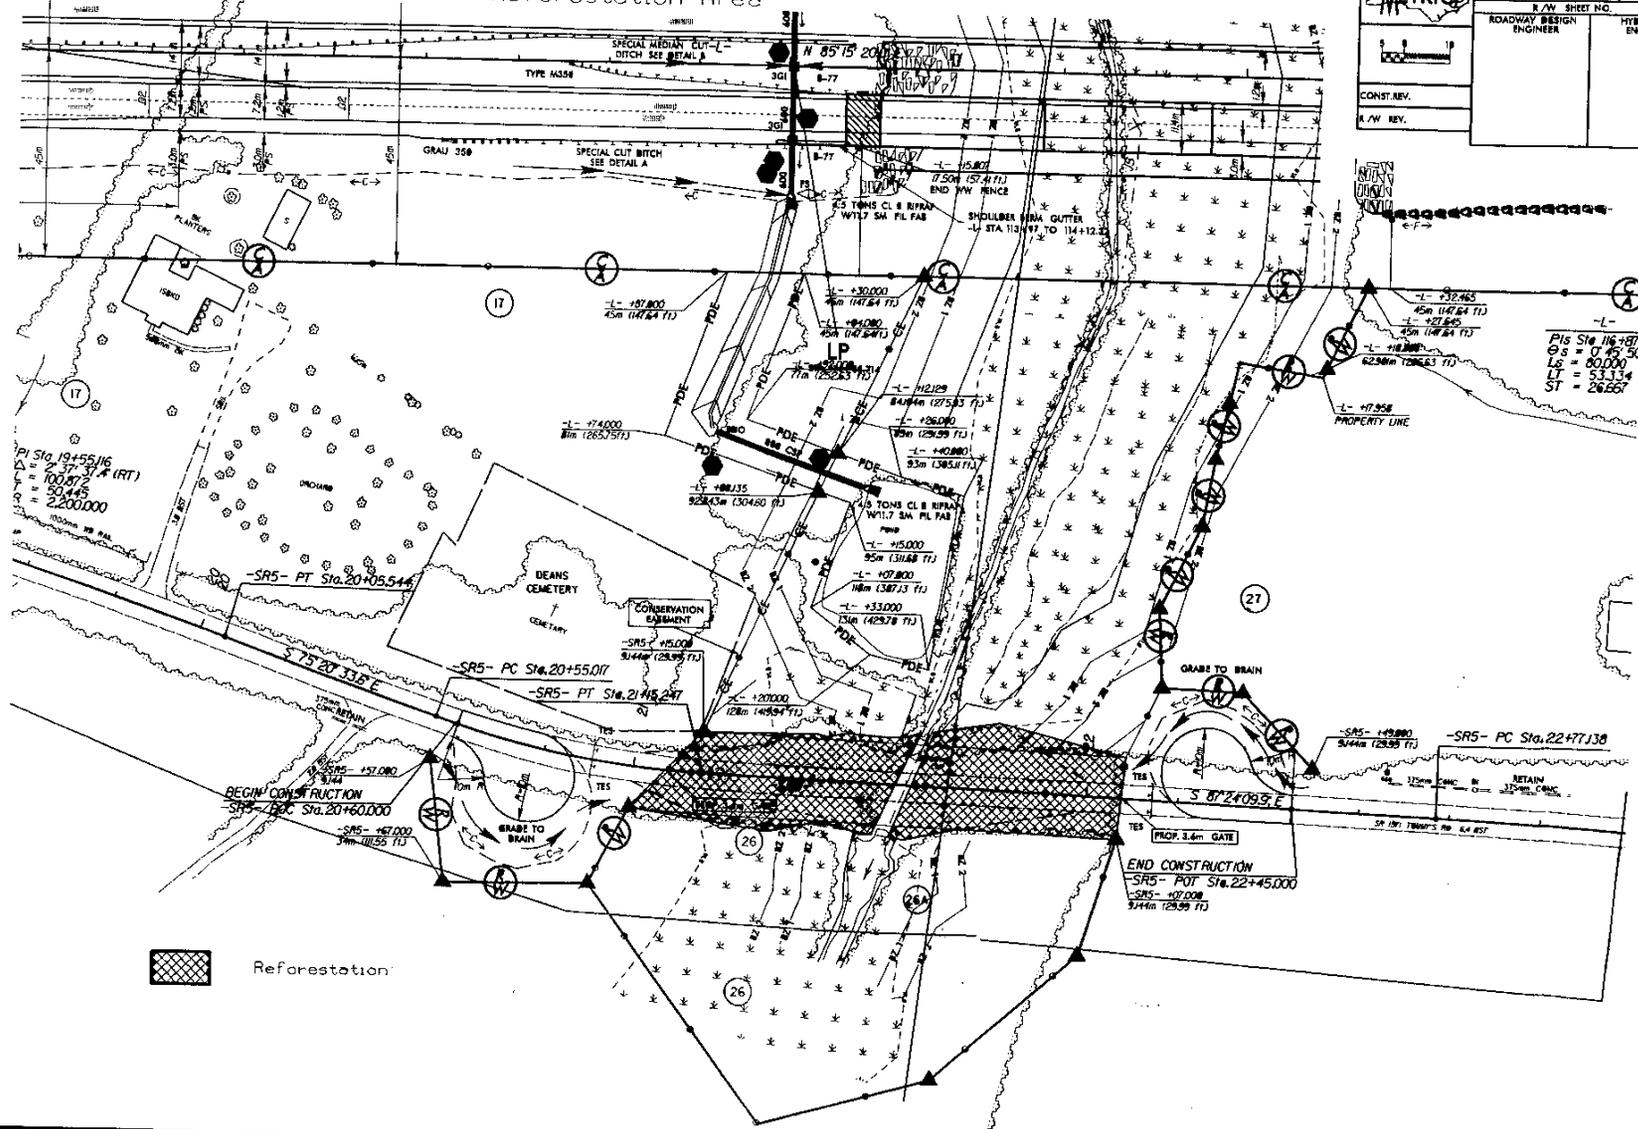
# Tommy's Road As-built Reforestation Area

Reforestation

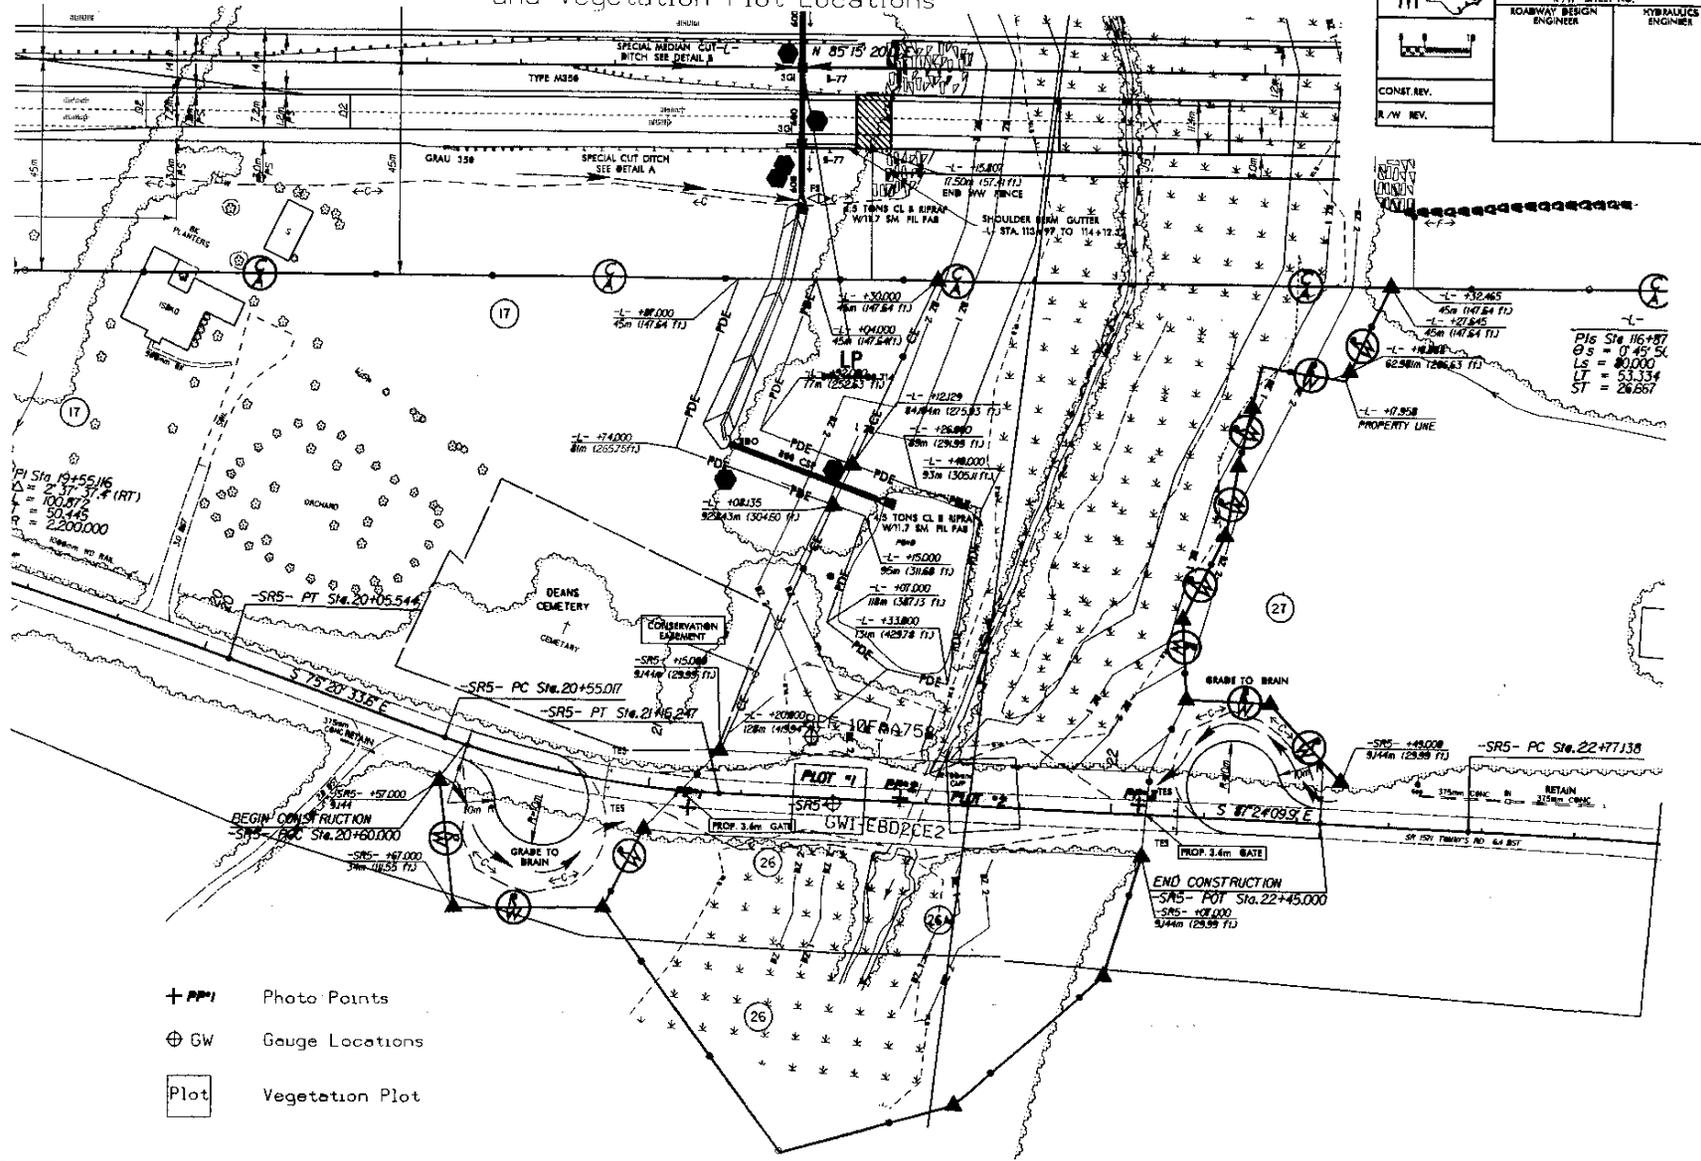
# Tommy's Road As-built - Gauge, Photo Point and Vegetation Plot Locations

- + PPI Photo Points
- ⊕ GW Gauge Locations
- Plot Vegetation Plot
